Plank S18

Except for trimming the bungs, plank S19 is now complete, so it's on to the next plank down; i.e., S18.

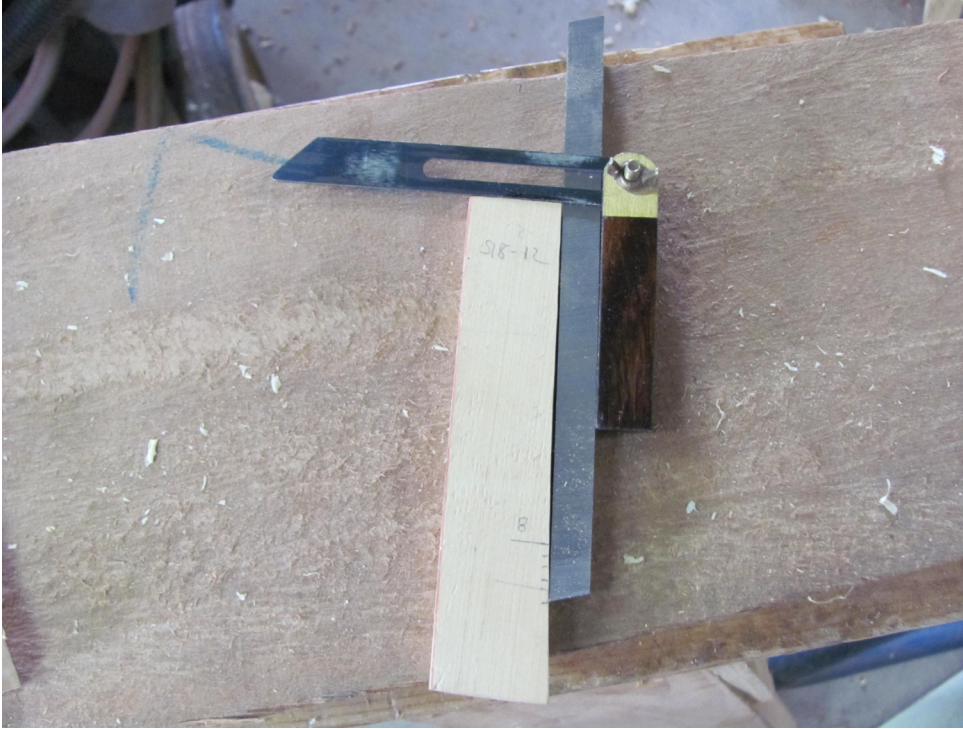
Here we have the scrubbing template for plank S18 at frame 12. This template is also suitable for frames 8 through 13, but the plank widths differ as indicated by the tick marks on the template. Typically, the top of the template is cut at an angle matching the bottom edge of the plank above (S19). The angle that we're interested in is between the face of the S18 and the bottom edge of S19. Because of the curvature, it's difficult to measure this angle directly with a bevel gage. To circumvent this problem I place a piece of tool steel along the template so that the end intersects the tick mark at the appropriate plank width. Now the face of the tool steel is parallel to the plank face and I can measure the angle using my bevel gage.

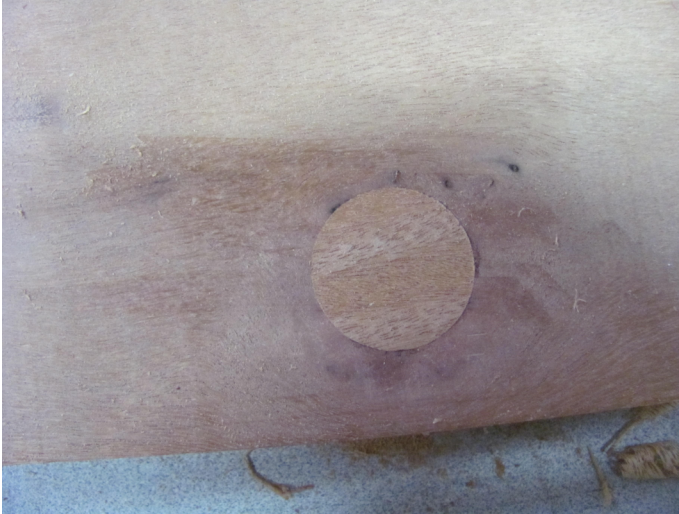
- Bad knot. Most of the knots that I've encountered are solid, but occasionally I'll run into one that is either rotted or cracked. For those, I drill them out with the appropriate size Forstner bit and plug them with a bung set in either G/flex epoxy or resorcinol (depending on what's handy at the time). In some cases, it's hard to

get the Forstner bit started – it tends to wander if the point isn't constrained. In such cases, I make a fixture to hold the bit in place (just a piece of scrap that I pre-drill to the size of the bit).

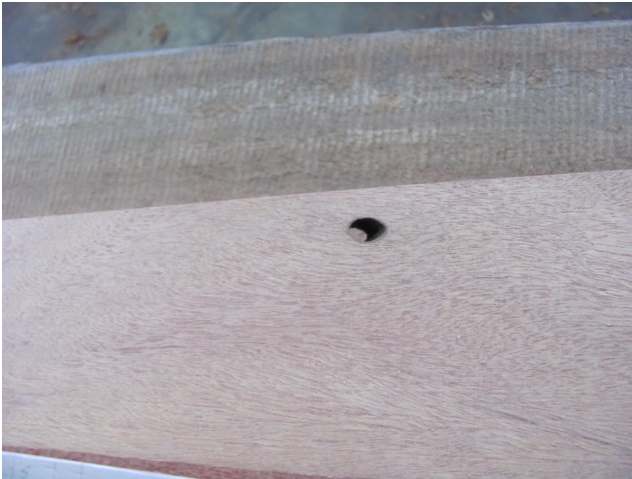
- Worm hole. This is a small diameter hole that passes through the plank.

The goal is to clean out the hole with a drill bit and then plug the hole with one or more bungs. The problem is that sometimes the hole is at a significantly oblique angle, which makes starting the drill difficult. In that case I make a drill guide out of scrap wood, clamp the guide to the plank the drill.

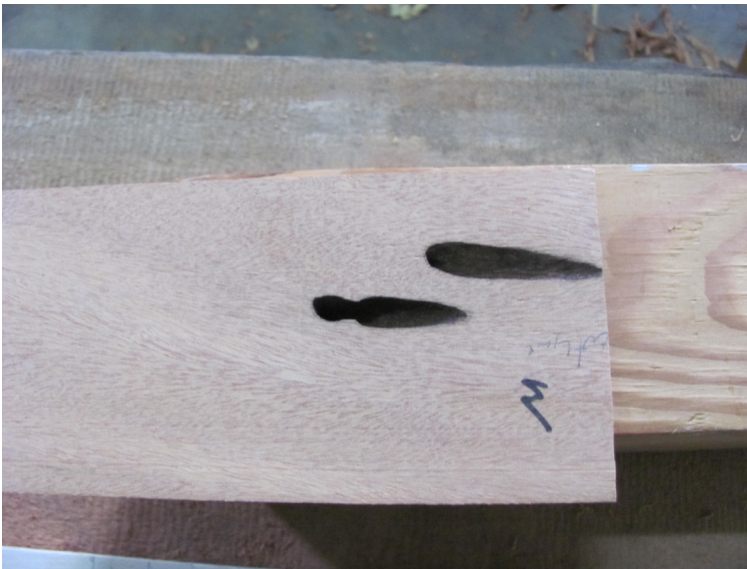
- The third defect is either a sap pocket or worm hole that lies at the surface of the plank but not through it.

For these, I use a Dutchman repair; i.e., a rectangular plug much like a mortise and tenon joint.

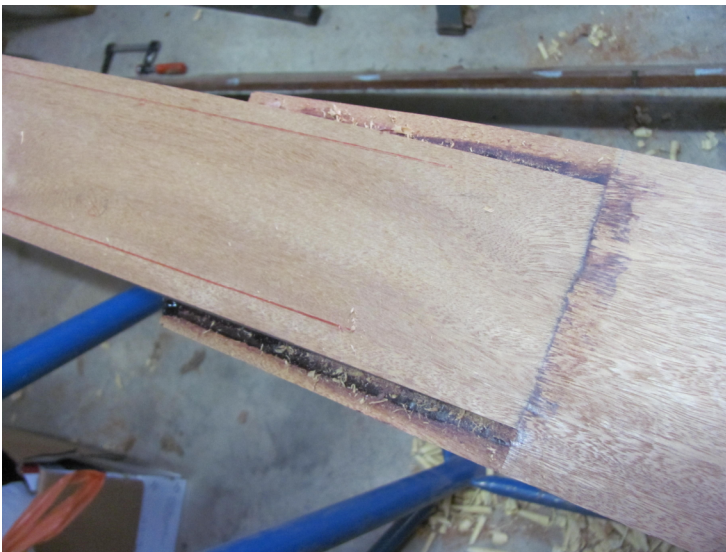
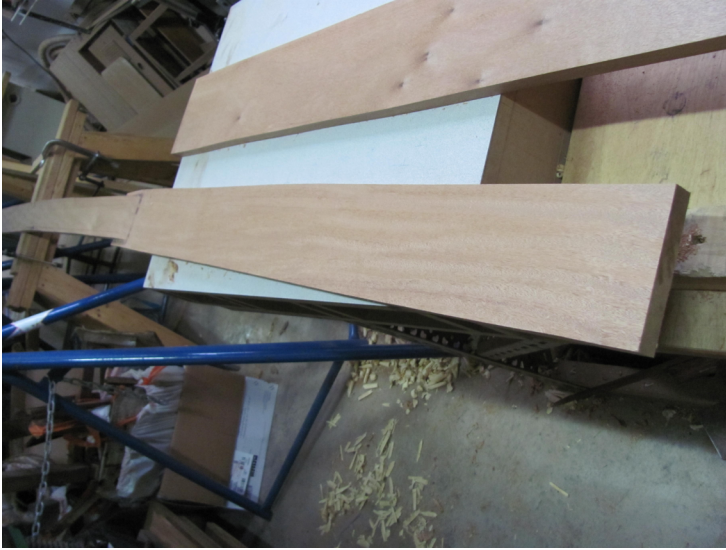
I had to make about ½ dozen repairs, but even then I had to replace a 4-foot section of the forward section because of the extent of the defects (became a structural concern). So I cut off the offending piece and scarfed on a replacement.

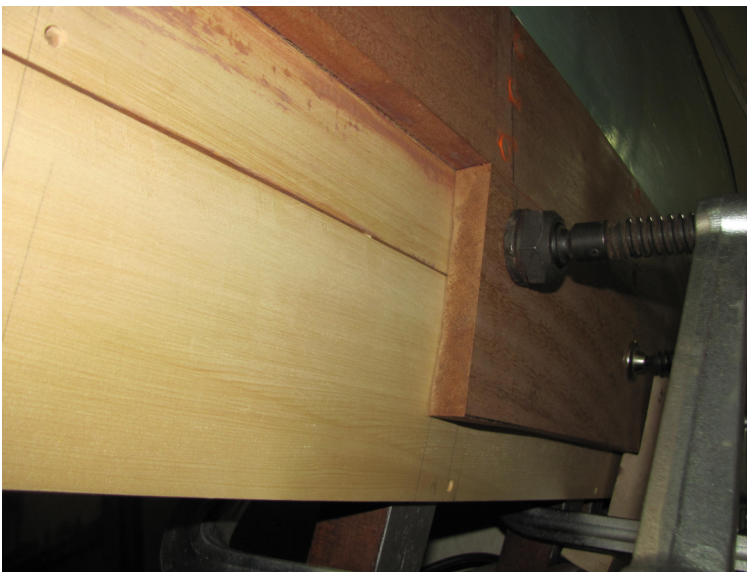
After cutting the bevels, I then scrubbed the inside face of the plank to match my scrubbing templates. The largest curvature for this section occurs at the end of the plank as can be seen in the pic below. The outside face also needs scrubbing, but I'll wait until after scarfing all three sections together so that I have a flat surface for scarfing.
