Cabin Sides (2010)

4/28/2010:

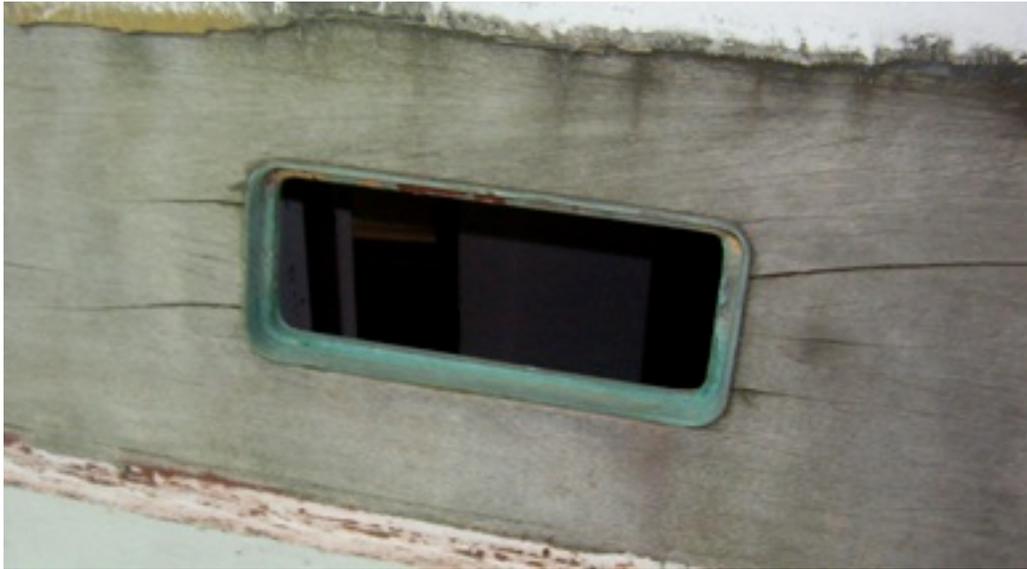
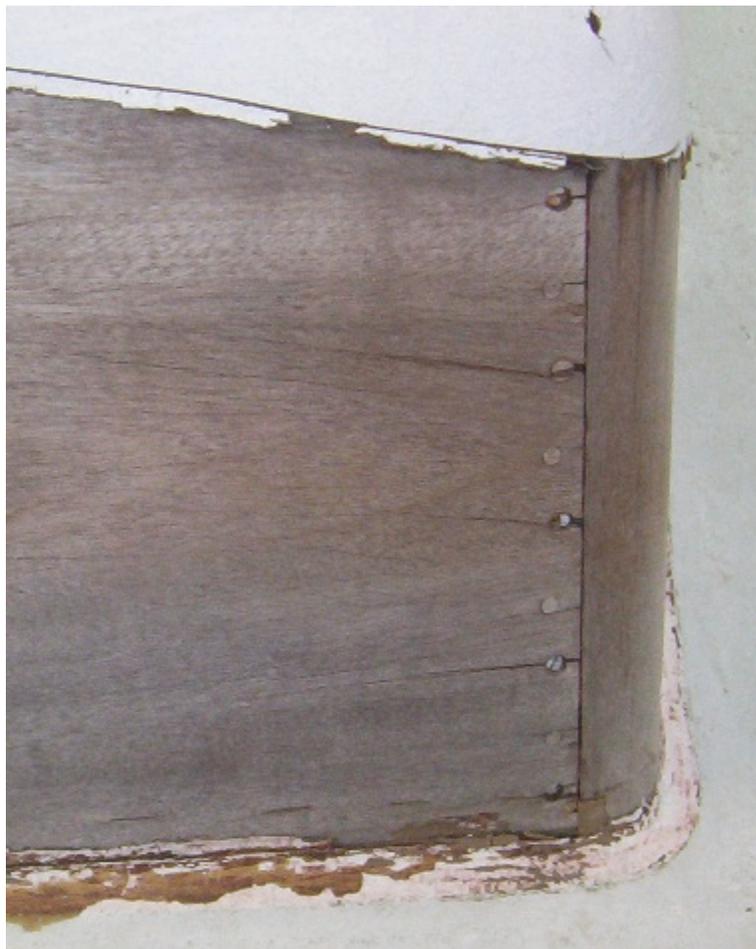
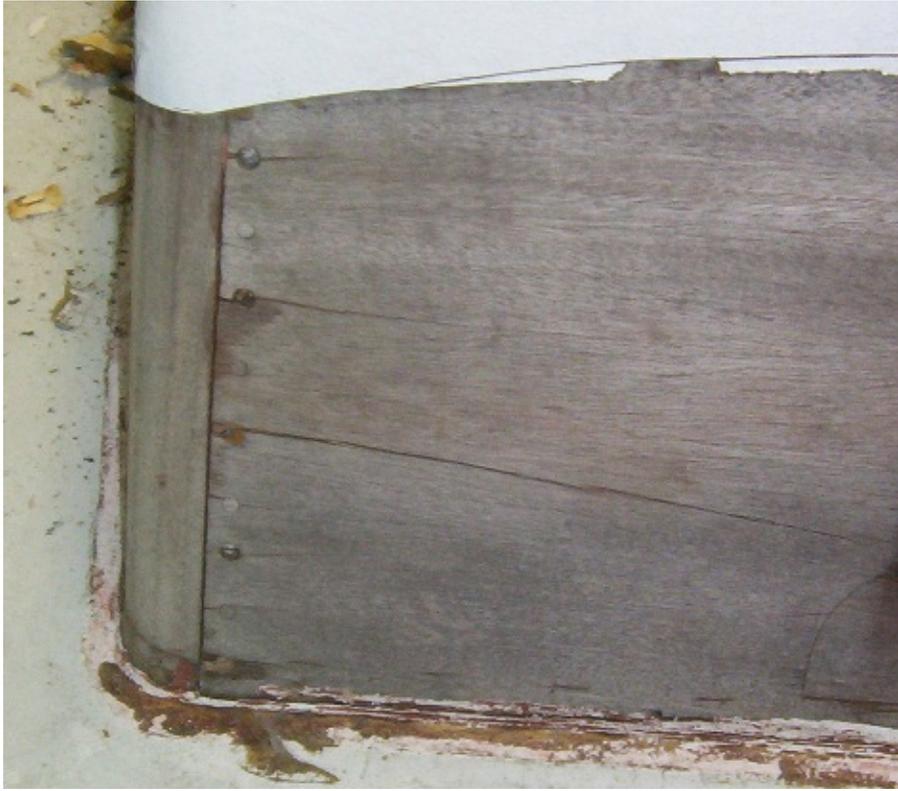
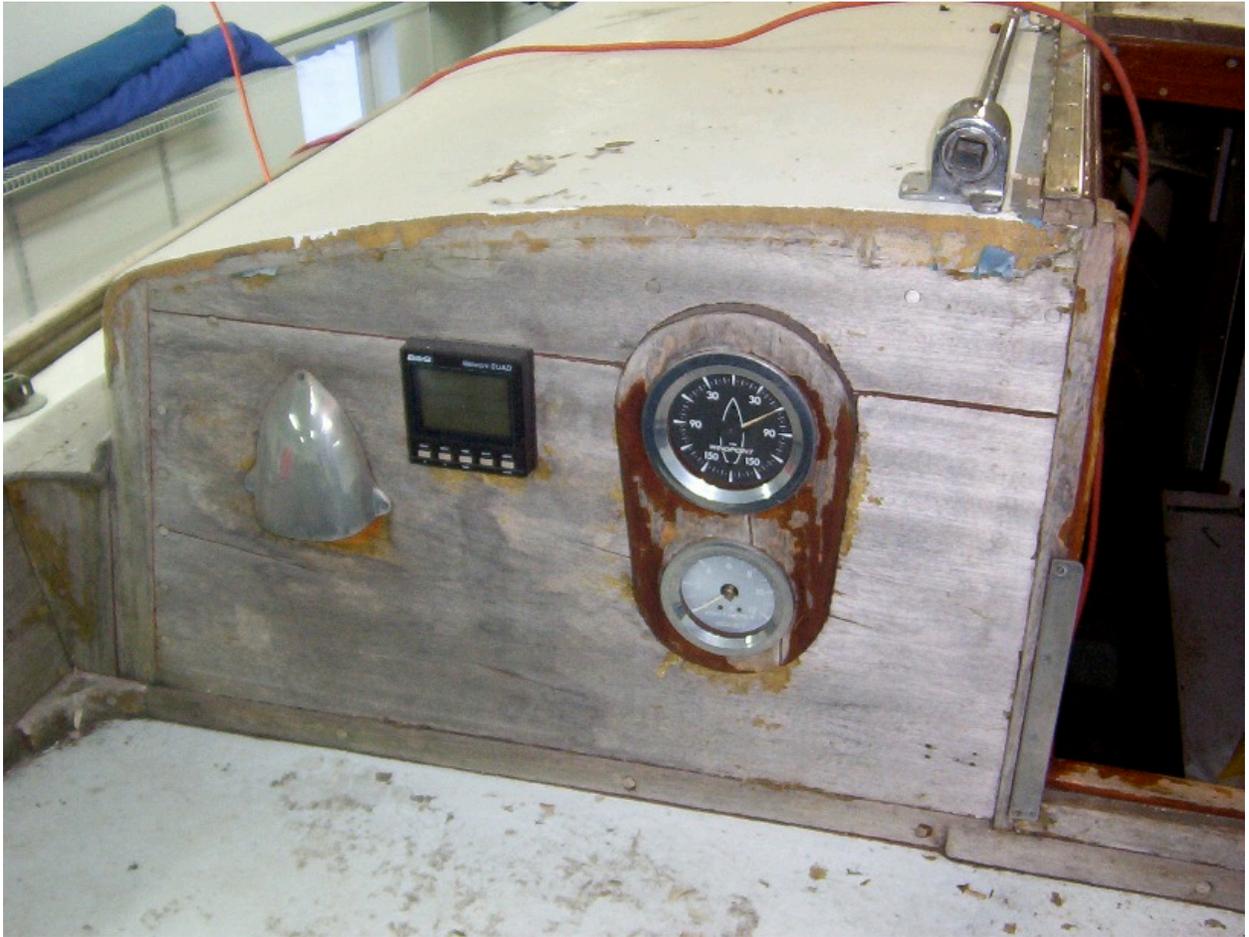
The cabin sides were exposed to the weather for some time without a protective finish. This resulted in excessive shrinkage and eventually large checks appeared.

The front and back panels of the cabin are also badly checked.

I could fill the cracks with epoxy and then paint (probably the most practical approach), but I'm rather fond of varnished cabin sides (at least fond of the look not the work). I've considered covering the sides with a veneer; however, a veneer thick enough to last would make the cabin sides proud of the port lights. I've also thought about replacing the sides either with solid Mahogany or Mahogany over a plywood core. Price and availability are problems with this approach. I originally thought that repairing the cabin sides was not an option; however, recent feedback from the WoodenBoat Forum has given me hope (thanks Bob Smalser). To do the job right, I need to remove the cabin sides.

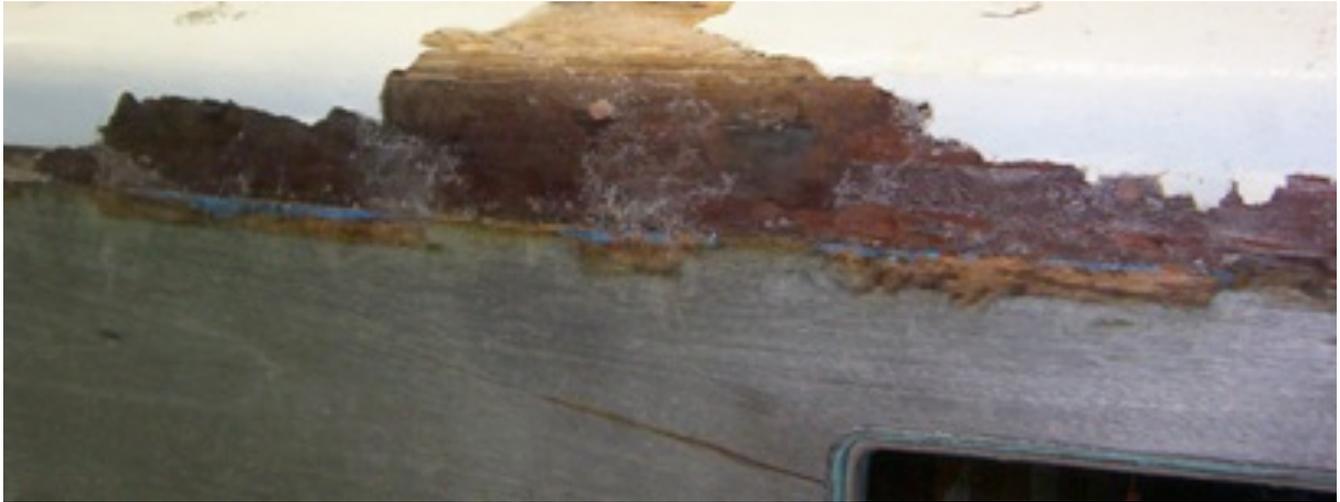
With the portlights out, it's time to deal with the cabin top. It will have to be removed to get at the sides. The plywood top is screwed and glued to the cabin beams and the trunk. To get at the screws, I need to remove the sheathing material (Dyneel or glass?). The sheathing covering the cabin top was recently replaced, but as you can see in this pic it is already delaminating in spots. So I don't feel too bad about removing it.

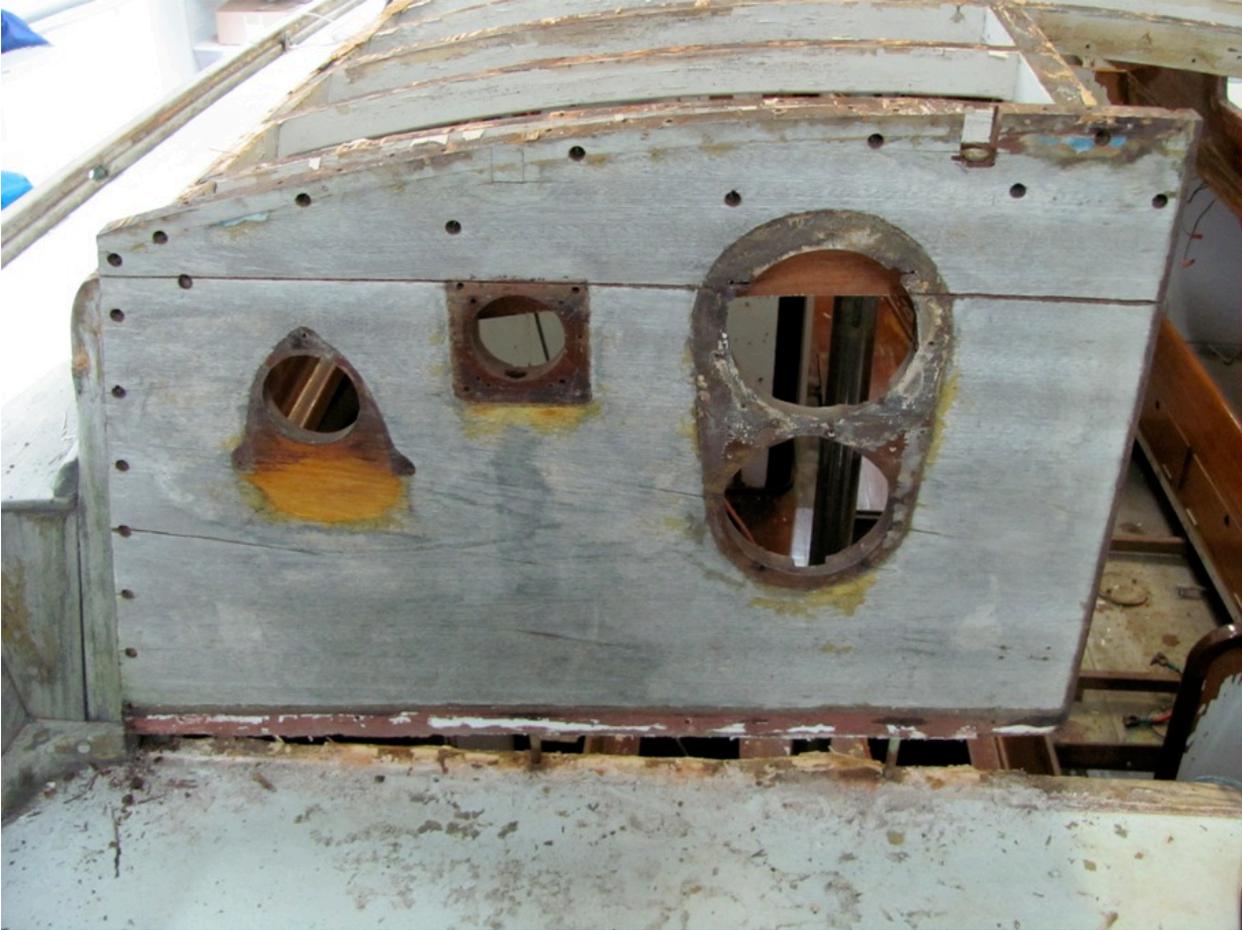
Before attempting to remove the cabin sides, I thought that I'd test the waters by removing the aft cabin panel first. The problem is dealing with the long bronze bolts that fasten the panel to the carlin. These are 3/8" bolts that enter near the top edge of the panel and extend through the carlin. The bolts cannot be removed from the panel, so it's either cut them at the panel-carlin interface or pry the panel away from the carlin. Since I plan to reuse the cabin sides, I need to preserve the bolts. If not, I'd have to drill for new bolts, weakening the panel. Also replacement bolts would have to be custom made from bronze rod.

So here goes ... First remove all the wood screws. Next separate the panel from the deck sheathing. The deck is sheathed with about 10 oz fiberglass. The sheathing extends up the side of the panel about 1". I use the Fein Multitasker with a bi-metal blade to cut the glass. Works great! Then remove the nuts from the bolts and pry the panel upwards. You can see the two bolts in the

picture, one just to the right of the two big holes. Both the head of the bolt and where the bolt enters the carlin are visible.

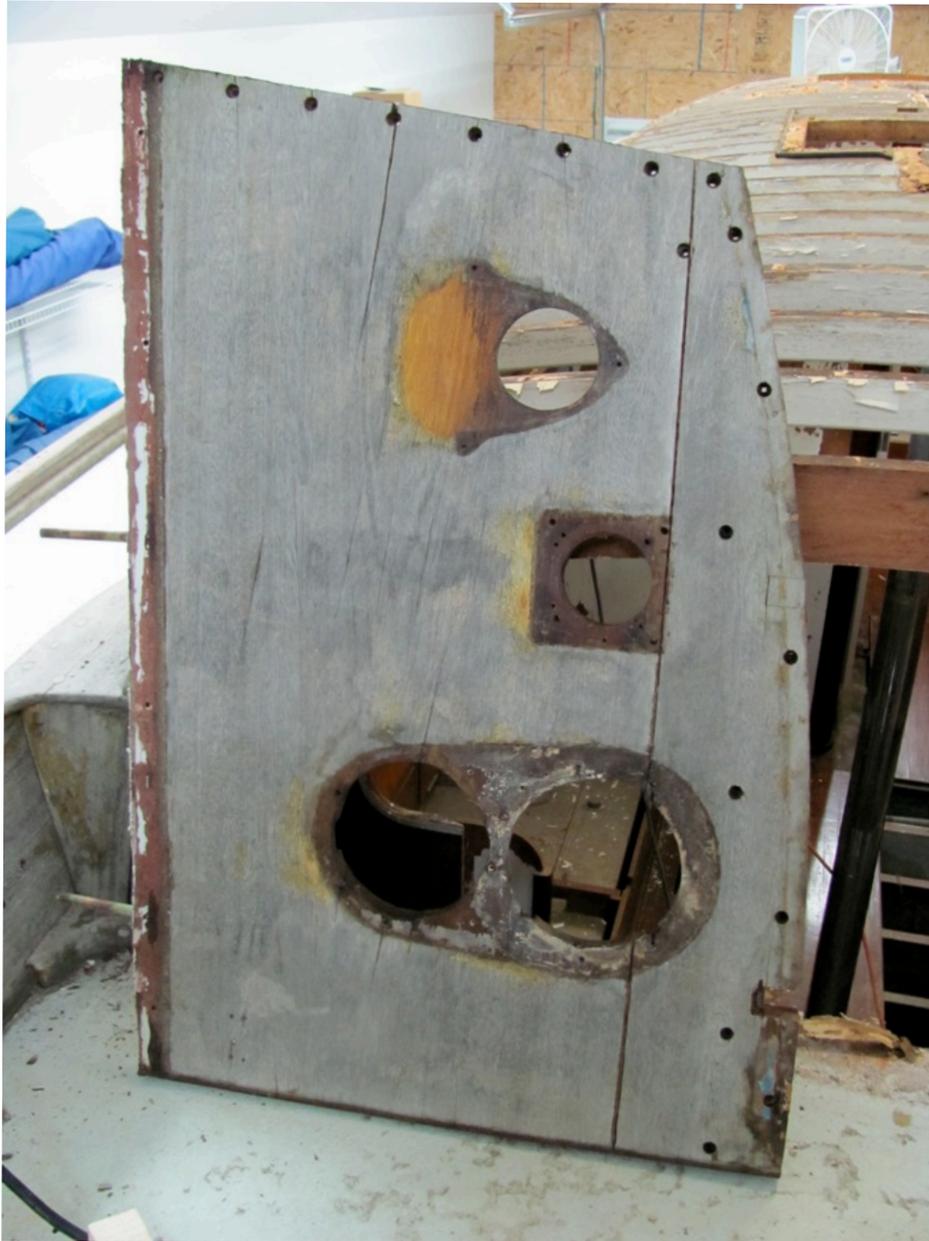
Removal was complicated by the fact that the port cabin post was canted inward (towards the centerline of the boat), so the panel bound up after a few inches of prying. This was not a problem during installation because the bolts would have been driven through the panel after it was in place. In this case, I had to force things a bit, but I plan to replace the wood in this area anyway.

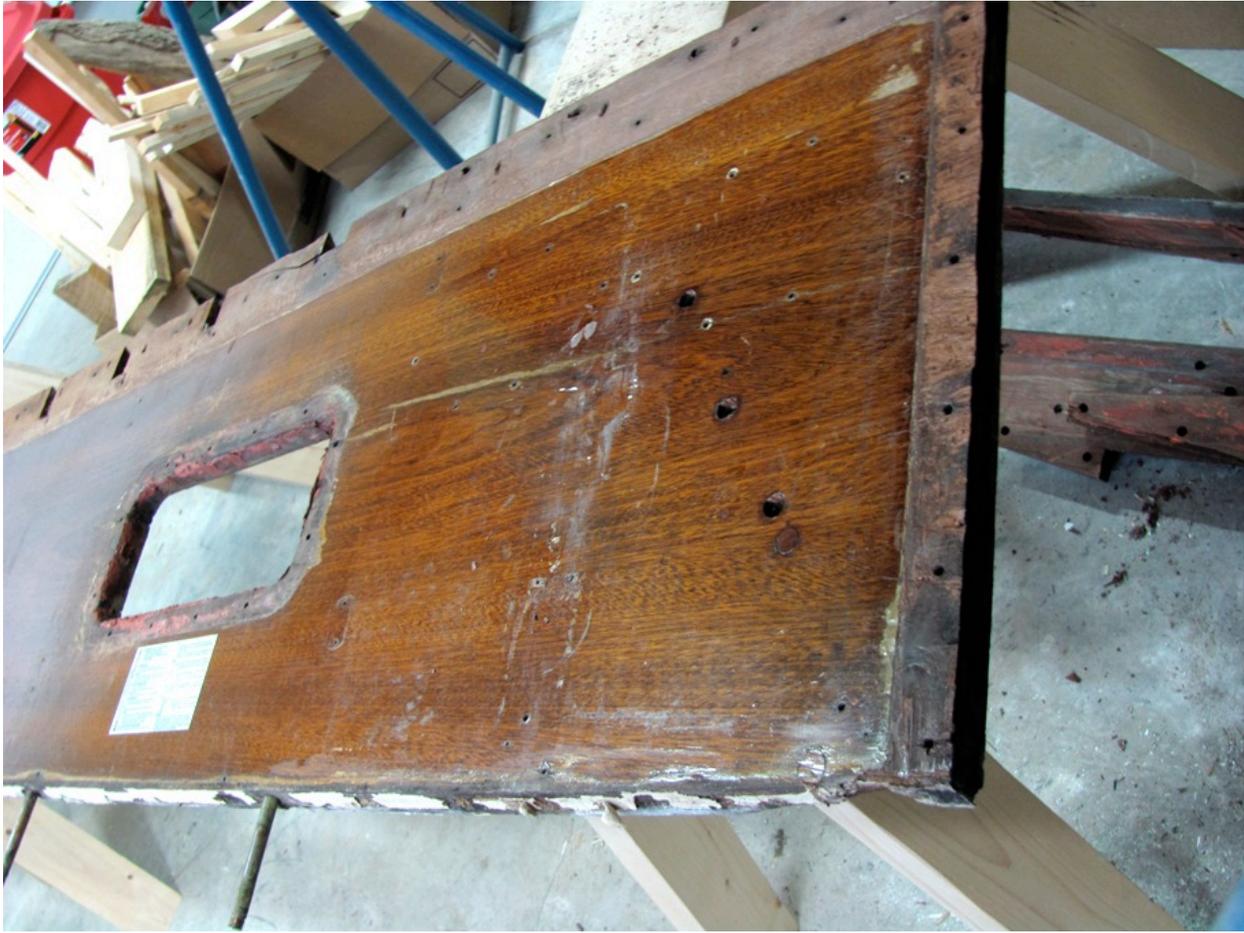
The pic above shows the cabin post removed. This turned out to be a tough job. Evidently, the posts were glued to the sides. The glue on the two front post must have deteriorated, because they came away fairly easily. Not so with this post. I had to hammer a putty knife into the joint to free it. This resulted in some damage to the side, but I don't think it will pose a problem.

The next step is to try to repair the side. Following Bob Smalser's advice, I plan to strip the finish, clean and treat the surface with oxalic acid, fill the cracks with colored epoxy, apply some finish and see what it looks like. If all goes well, I'll do the same to the port side. Otherwise, I'll either replace the side as original or with a panel that has a plywood core and mahogany veneer on both sides.

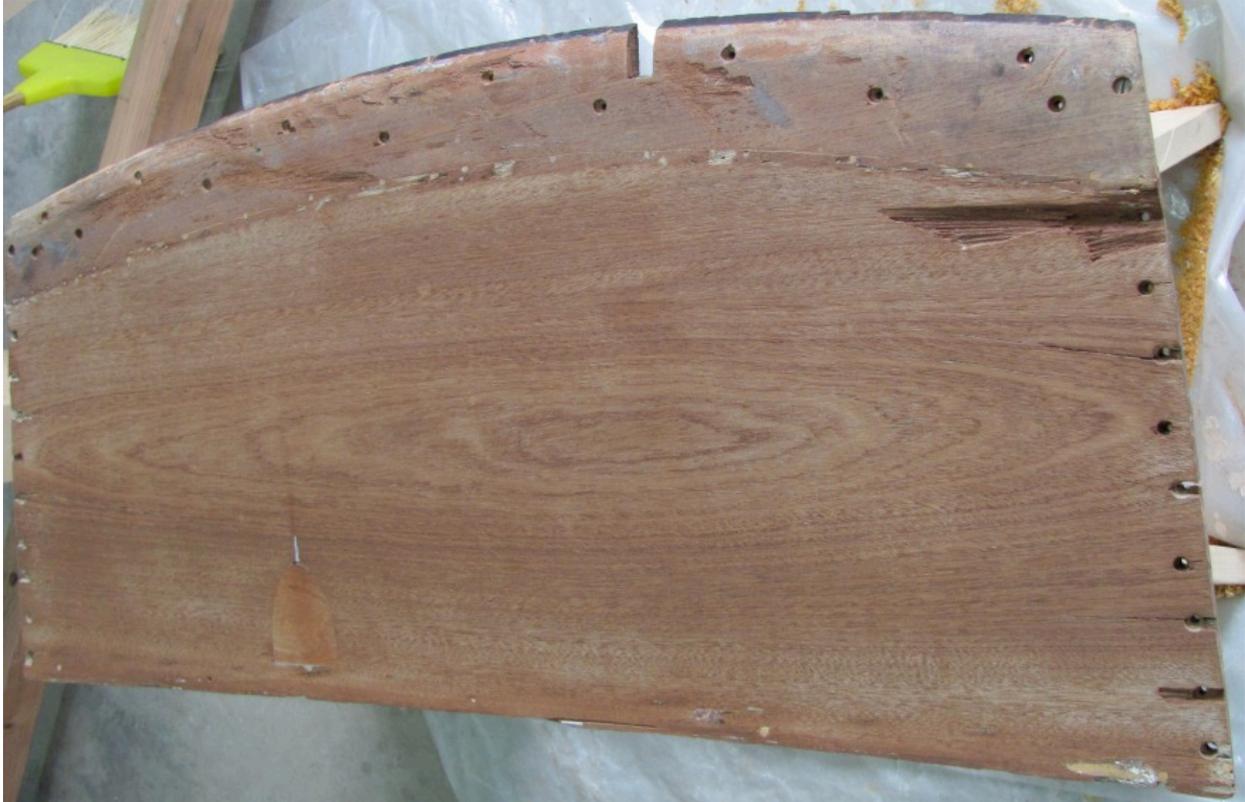
Note that one of the bronze rods is beginning to show through (lower left). This piece has been sanded many times over its life. As you can see in the lower right of the pic, some of the bleached white wood remains. What happens is that most (if not all) of the wood in contact with the bleach turns white. Since H. Mahog has open grain, some of the whitening occurs below the surface. This can be eliminated if you remove enough wood; however, this piece was subjected to severe weathering and thus exhibits numerous very small checks which extend deep into the wood. This cannot be removed by reasonable sanding. Thus, it seems that if bleach is used staining is a must.

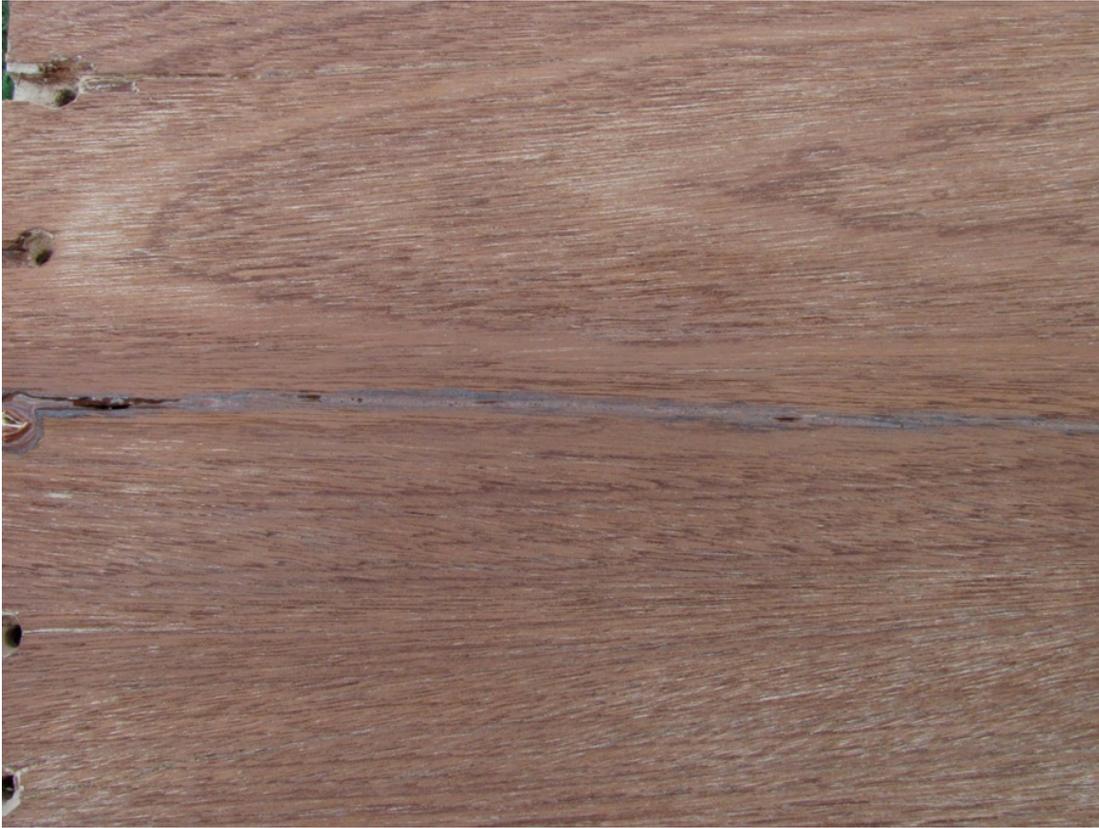
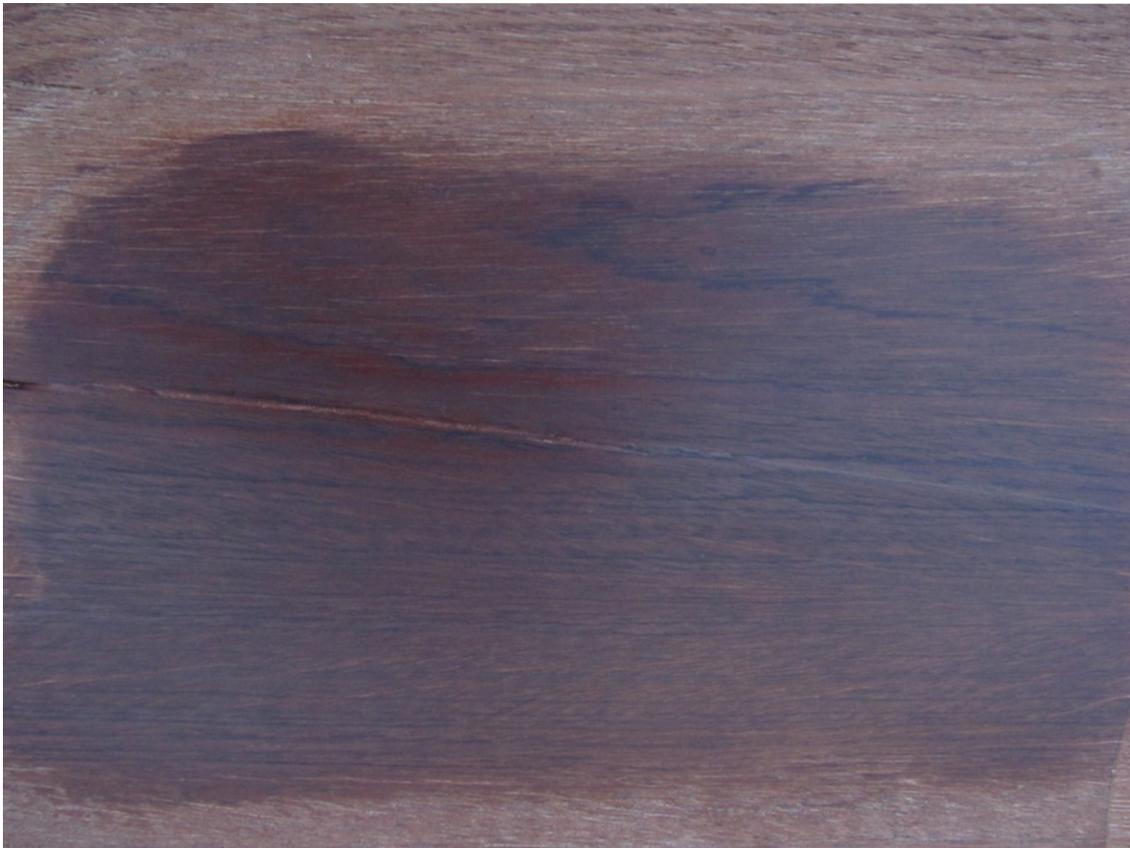
Thus far the best result was the combination of filler, Varathane, and a little General applied to the bare wood. So I decided to try filling one of the larger checks and color match it to my stain. So the theory is to use red and brown dyes to color the epoxy to the same color as the finished wood. So I took my best shot at matching the filler/Varathane/General combo that I liked. First fill the crack with colored epoxy (surrounding wood just bleached and sanded - no stain) - see below.

I started with West System 105/206 (slow hardener) and used a syringe to fill the crack. I taped the back side to limit the leak through. I let it soak in for a few minutes under a heat lamp, thickened the remaining epoxy with Cabosil, and finished the job. When the epoxy reached a partial cure (green state), I removed the excess with a cabinet scraper. Except for a few air

pockets, it worked ok. I could go back and fill these with some more epoxy, but not for this trial run. After the epoxy fully cured, I applied my filler/stain combo.

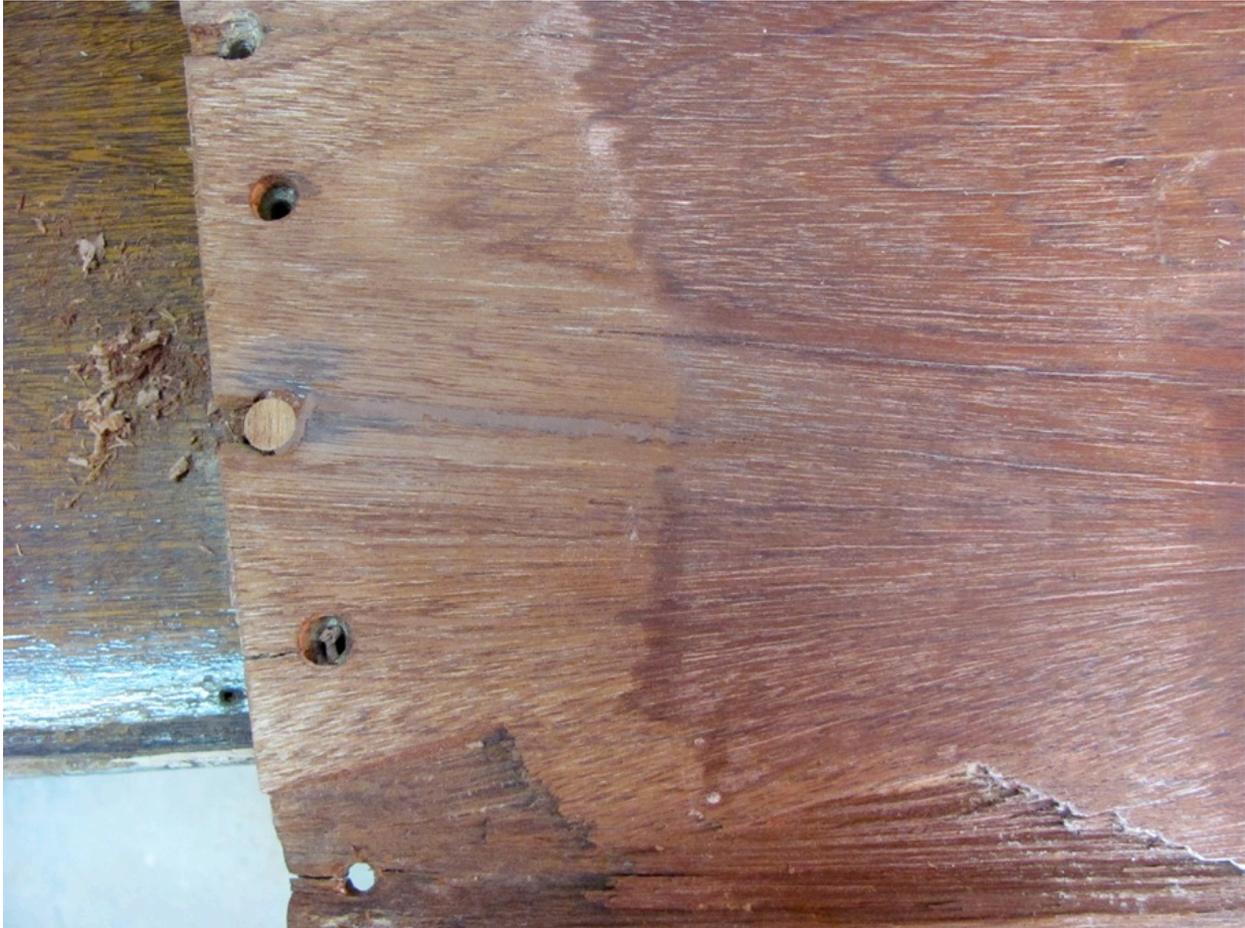
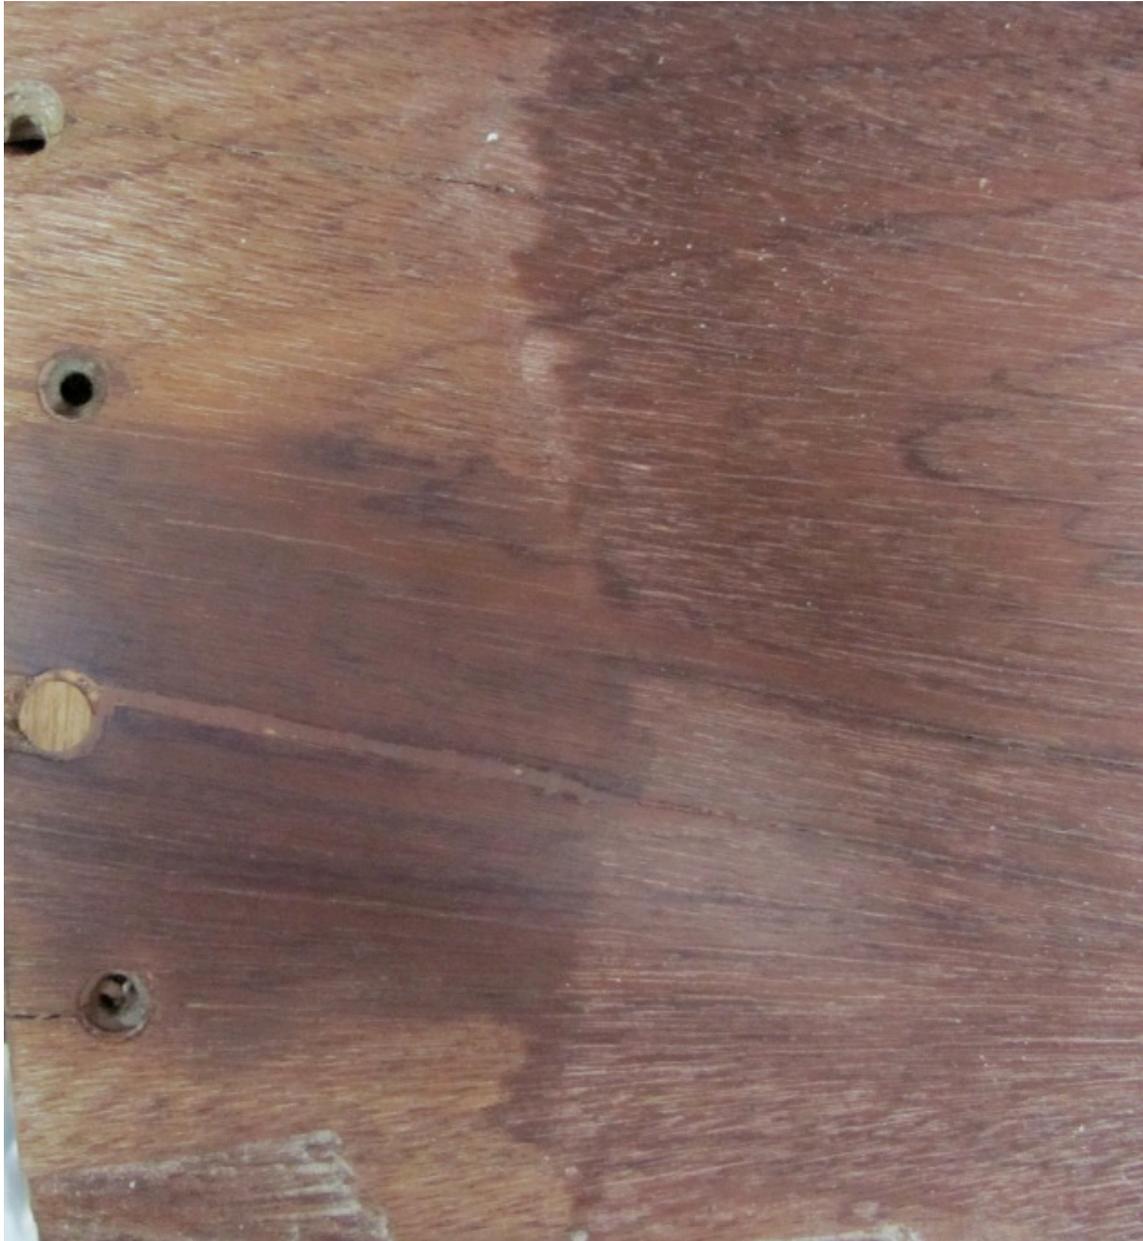
It sure came out darker than I'd hoped. Consequently the color match isn't quite right. So let's try again. This time I tried for a darker/browner epoxy mix. Region to the right was a previous stain sample. The region around the crack was just bleached and sanded. The wood plug seen in the pic was used just to limit the epoxy leakage.

Again the filled crack is lighter than the stain. What I'm beginning to realize is that the darkness of the stain depends a lot on how hard I rub the filler. If I rub too much, however, I drag the filler out of the cracks.

This problem remains unresolved. I'm going to try a couple of things in the future

- Epoxy over the entire surface first and then fill the cracks with filled epoxy colored to match the rest of the wood.
- Just varnish w/o filler.
- No bleaching - just sanding - which might limit the whitening in the cracks.

- A latex based filler which I will color to match the wood. Hopefully this will eliminated the problem of the oil in the filler from staining the wood.
- I bought some black colorant to see if I can make the epoxy crack-filler darker. I think that dark lines would not be as noticable as the lighter ones.
