## Hanging S5

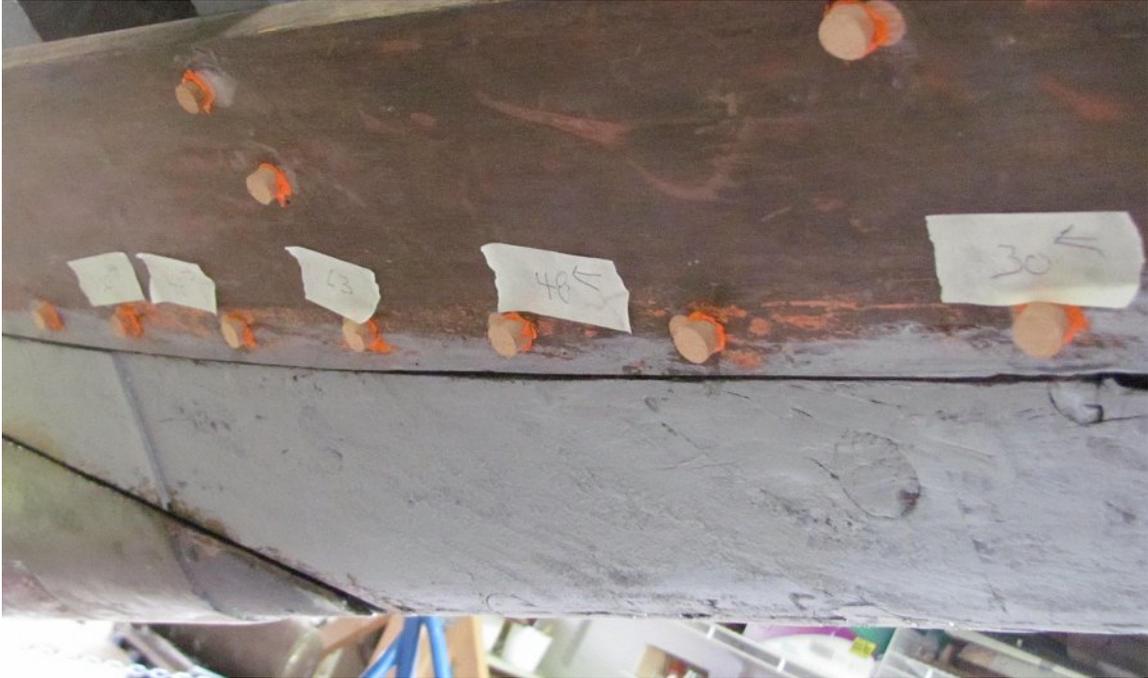
This area is just forward of where the ballast terminates. The region of the seam marked by the pieces of tape is slightly longer than the frame spacing. The gap is about .030” at either end of the region and increases to about .063” at the midpoint. This the largest gap for this plank. Fortunately this region of the seam is backed up by the keel rabbet and so a wider gap is tolerable (caulking cannot be inadvertently driven into the interior of the boat). Note that this is an area where I have not made any modifications, so this gap was probably the same before I removed the plank.

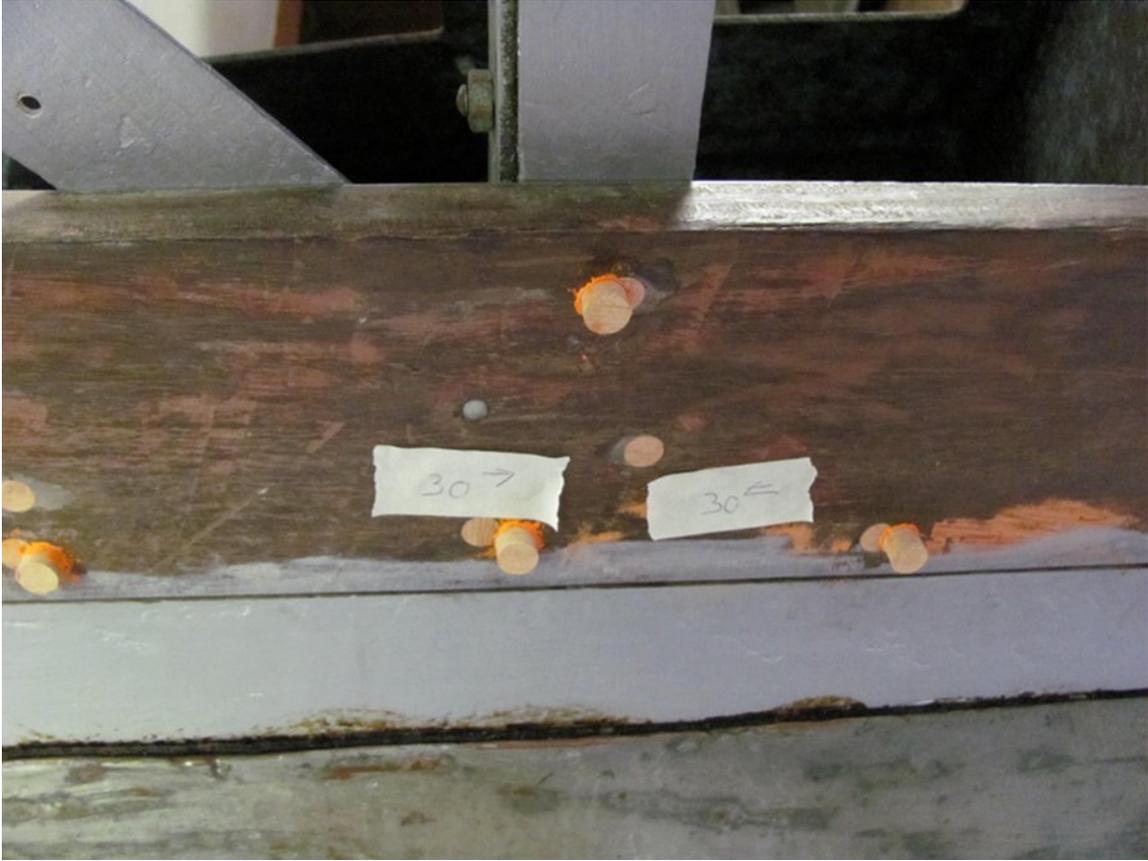
This is a very short region at frame 17 having a maximum gap of .030”.

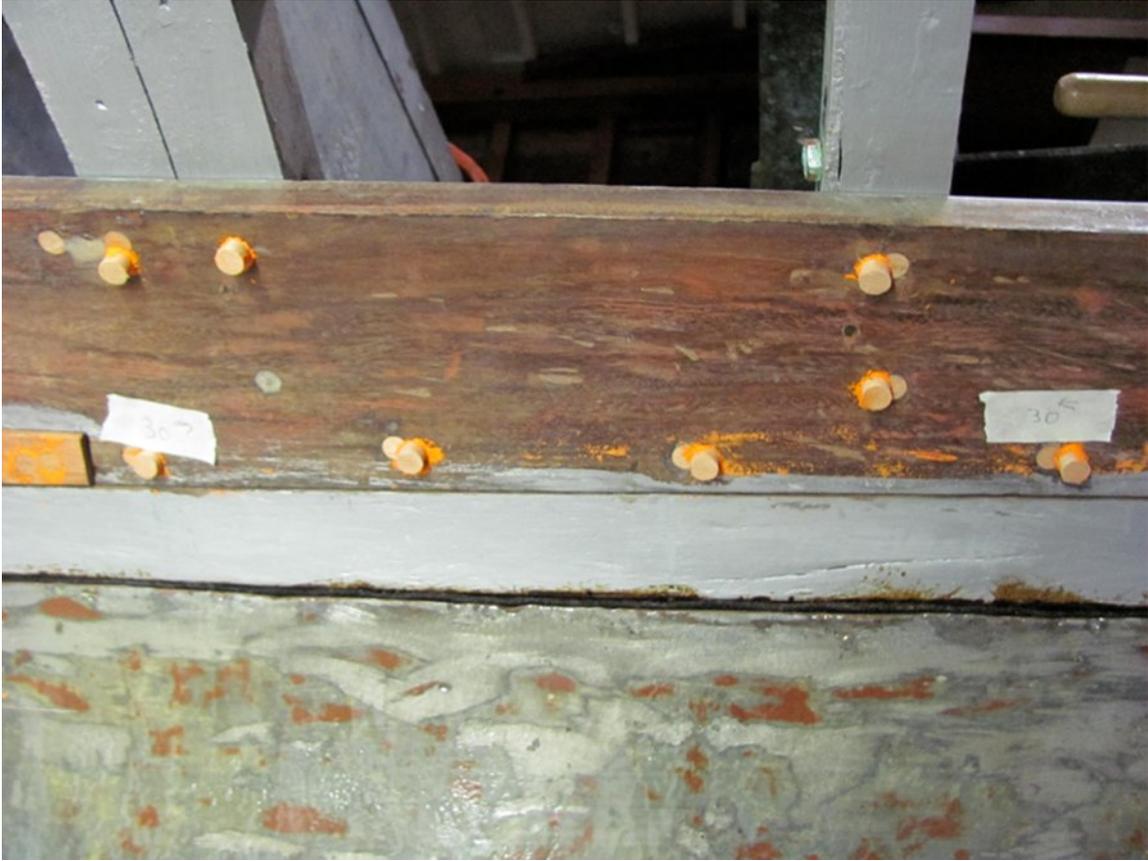
This region is just forward of the notch for the nib end of S4. The length of the region is just over the frame spacing and has a maximum gap of .030".

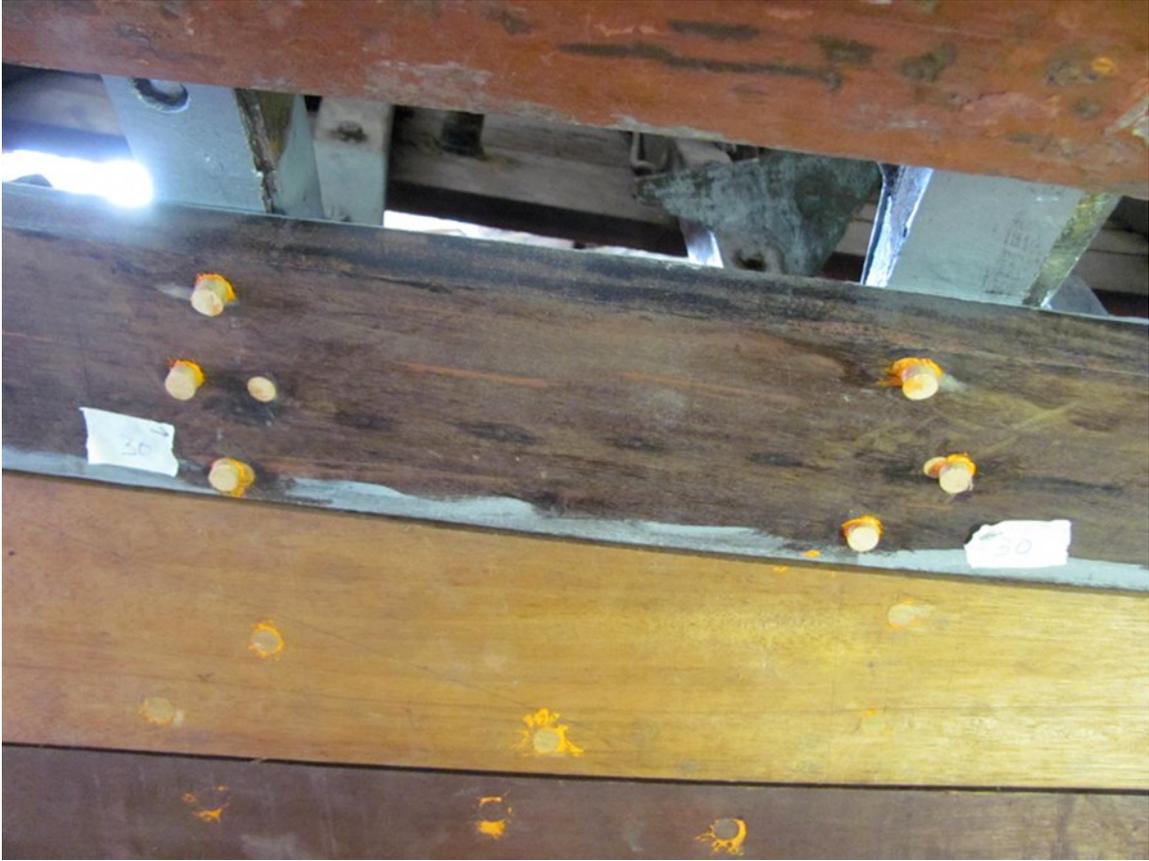
This region is between frames 31 and 32 with a maximum gap of .030”.

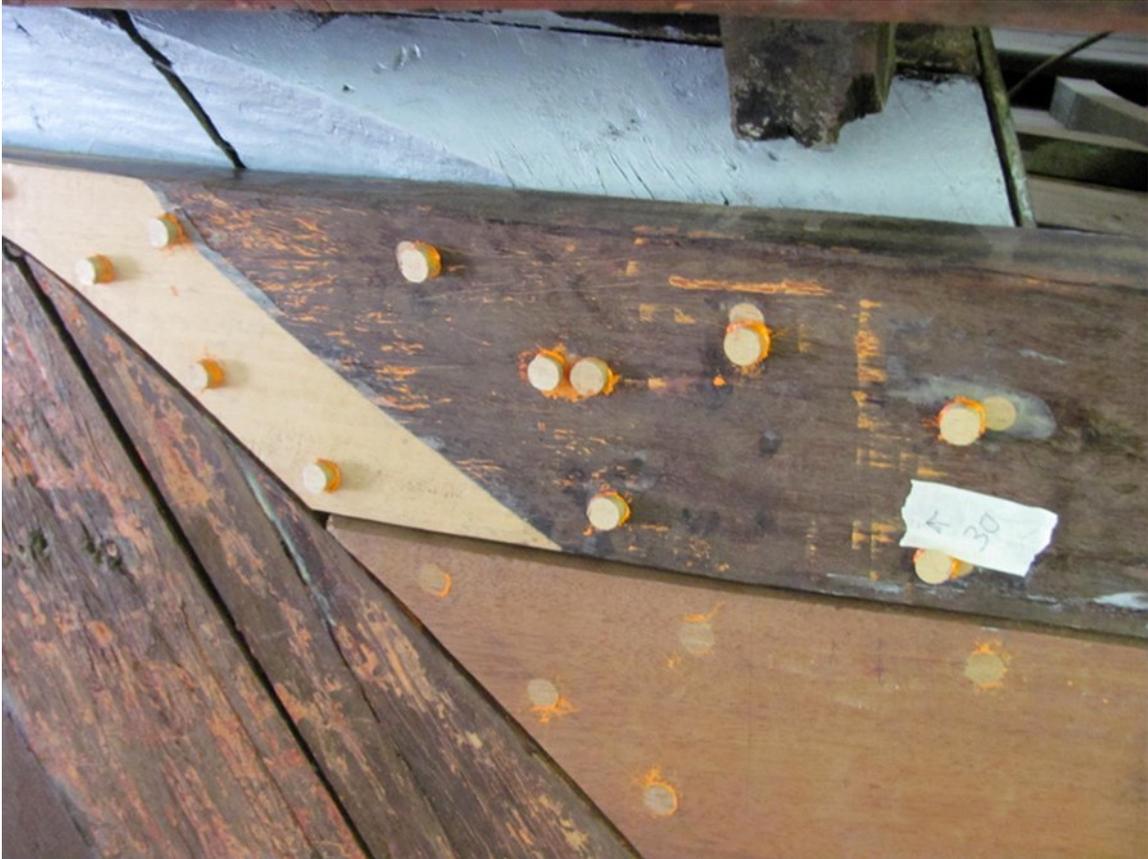
This is the hood end aft having a maximum gap of .030”.

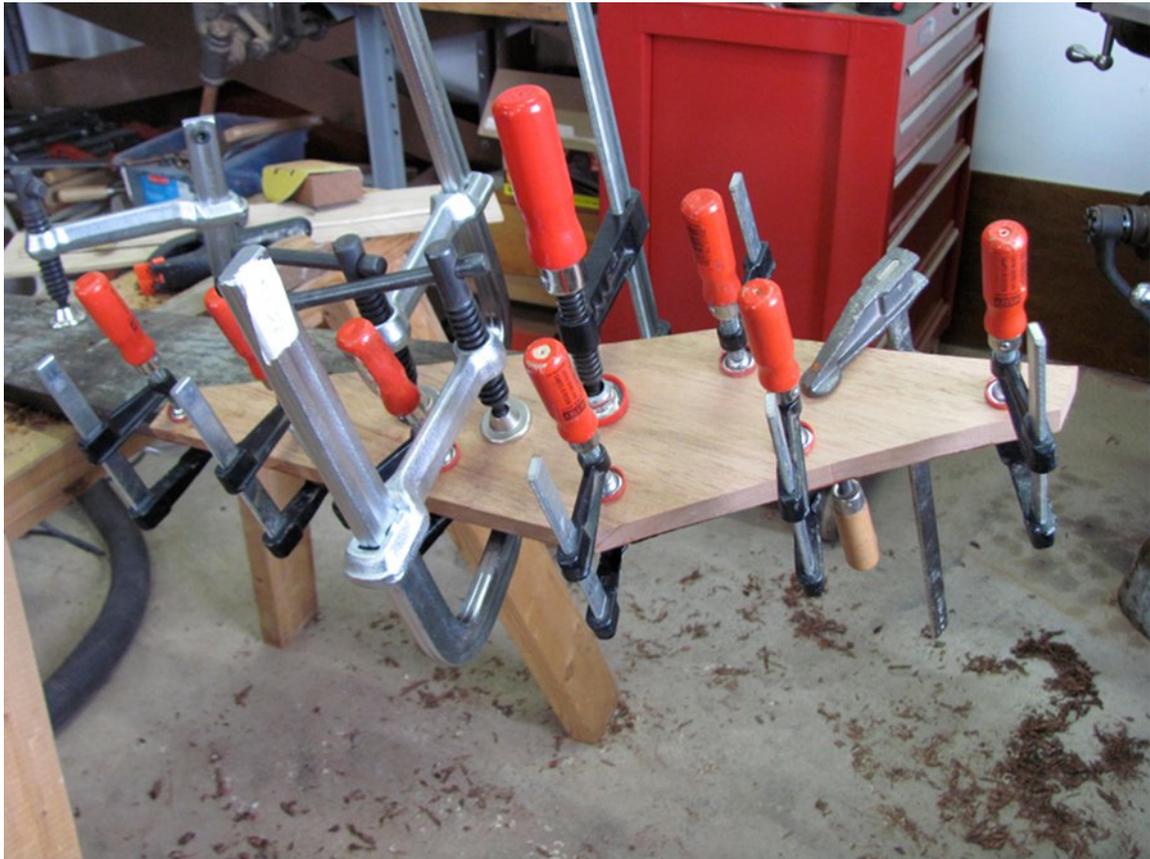
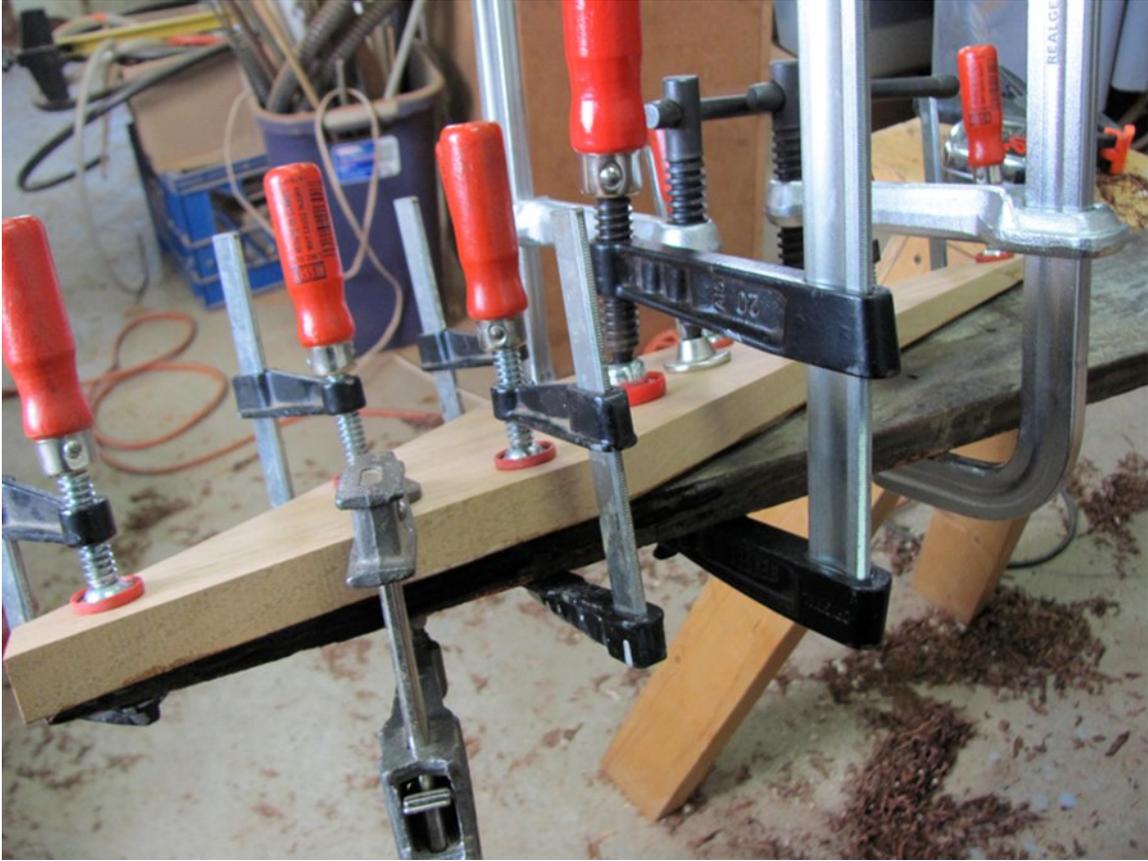
For some reason, the hood end aft did not fit snugly to the rabbet in the stern post. I didn't notice this when I removed S5, so I'm not sure how this occurred. In any case, I spliced in a repair using what is called single finger joint or a cloths-pin splice similar to the repair of P5. Unfortunately, the repair didn't go well.

The problem was that the plank twists a lot and I didn't immediately recognize the impact of this in making the repair. In attempting to plane a flat surface for the splice, the twisting plank caused the splice to extend forever! I finally recognized the problem and had to settle for a surface that was not flat over its entire length. This caused a nasty fitting problem, as you can imagine. After considerable trial and error, I got a good fit. I was more careful in choosing the cutting plane on the bottom half of the splice. The two pics below show the top half of the splice during glue up.

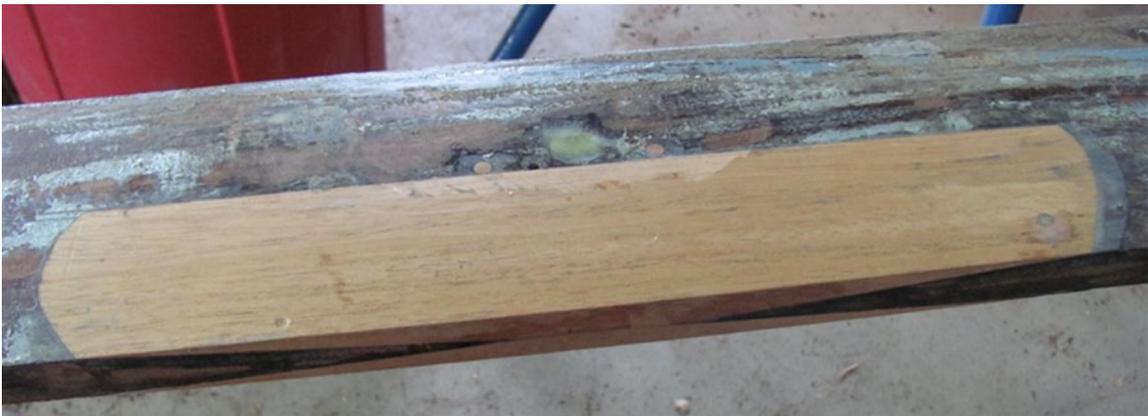
As with P5, there was a semicircular hole in the edge of the plank, which if filled with another cloths-pin splice.

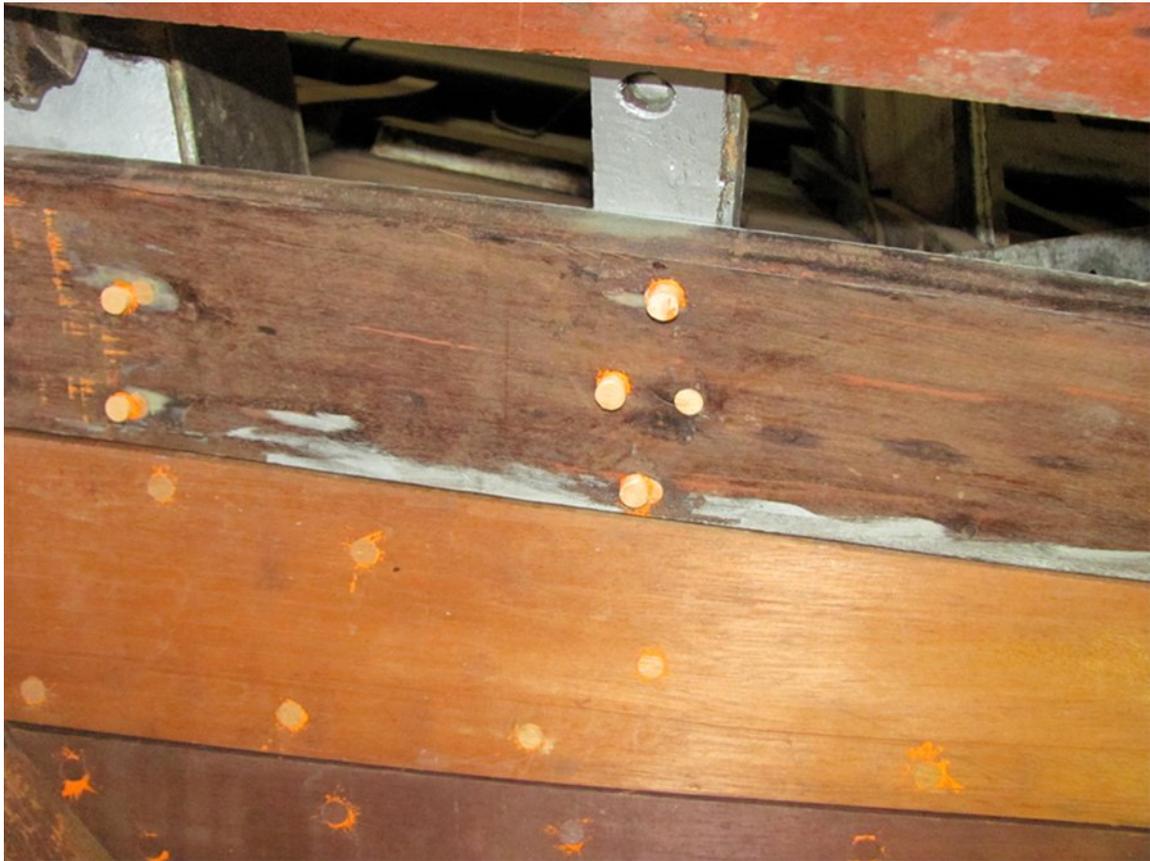
At the center is frame 33 with a diamond bund pattern. Note that the bung on the right plugs an unused hole.

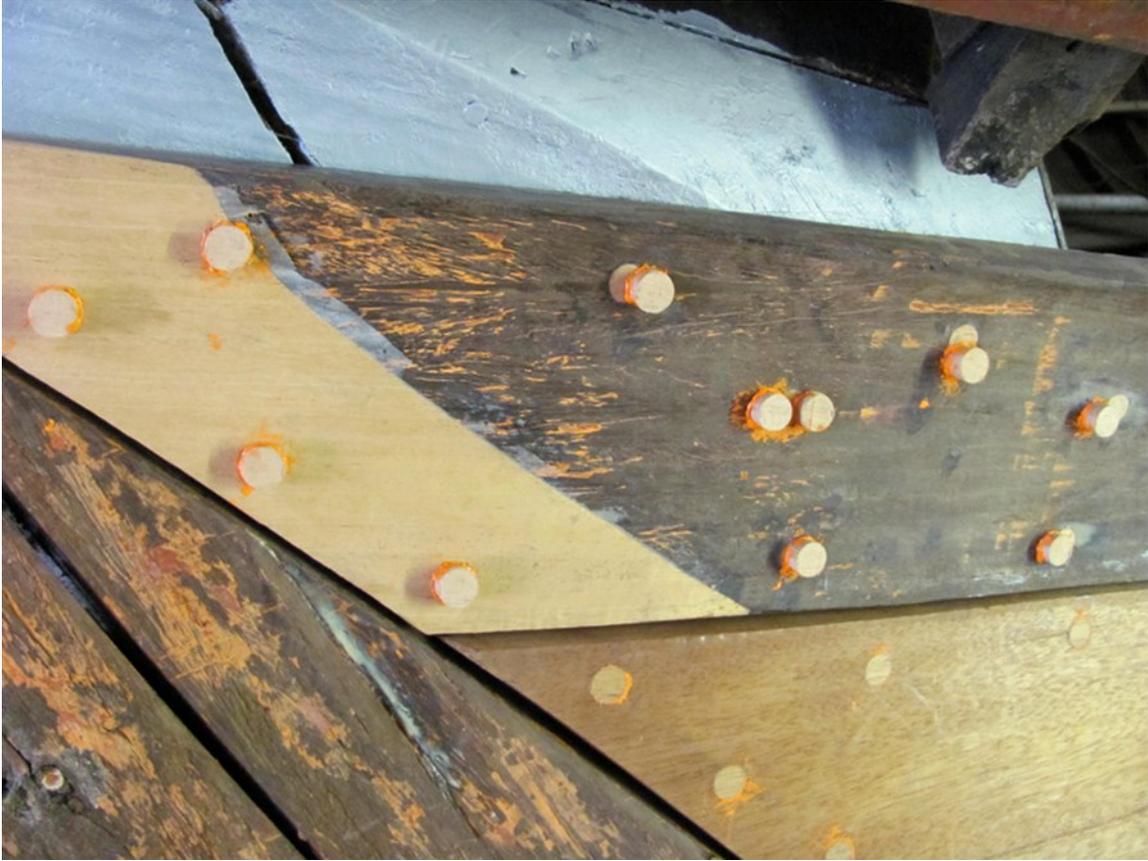
This is the hood end. At the center, we have two bungs close together. The right one of the pair covers an empty hole. The drill hit something in that hole.

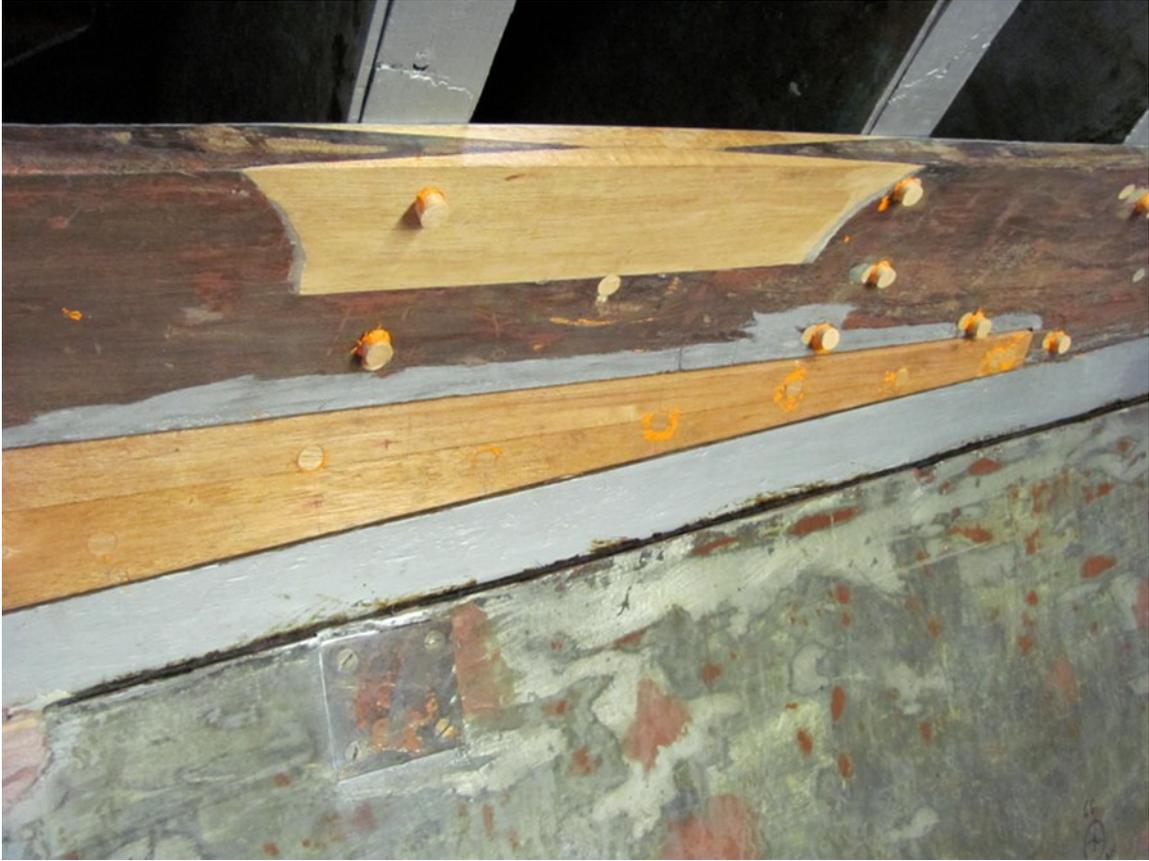
The bung under and near the center of the repair area is a dead hole.

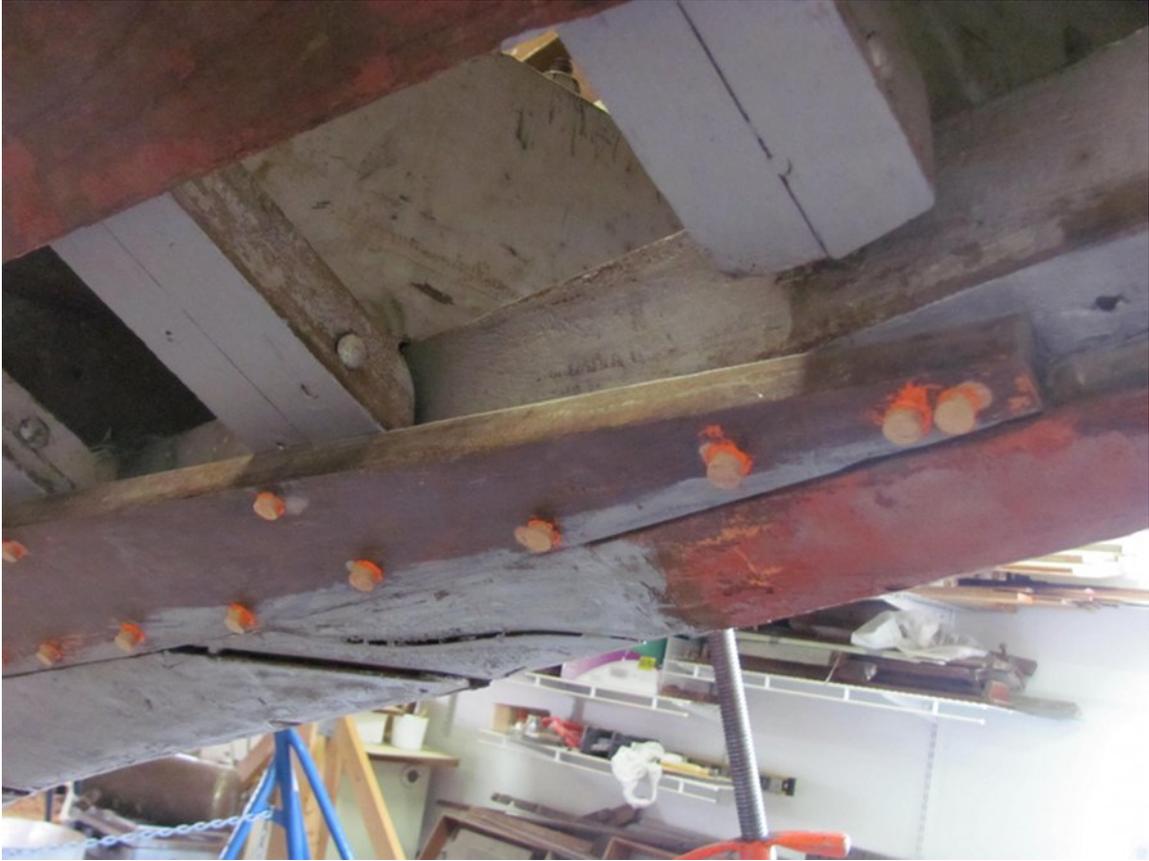
The bung nearest the nib end covers a broken fastener. It would not have to be removed to remove the plank.

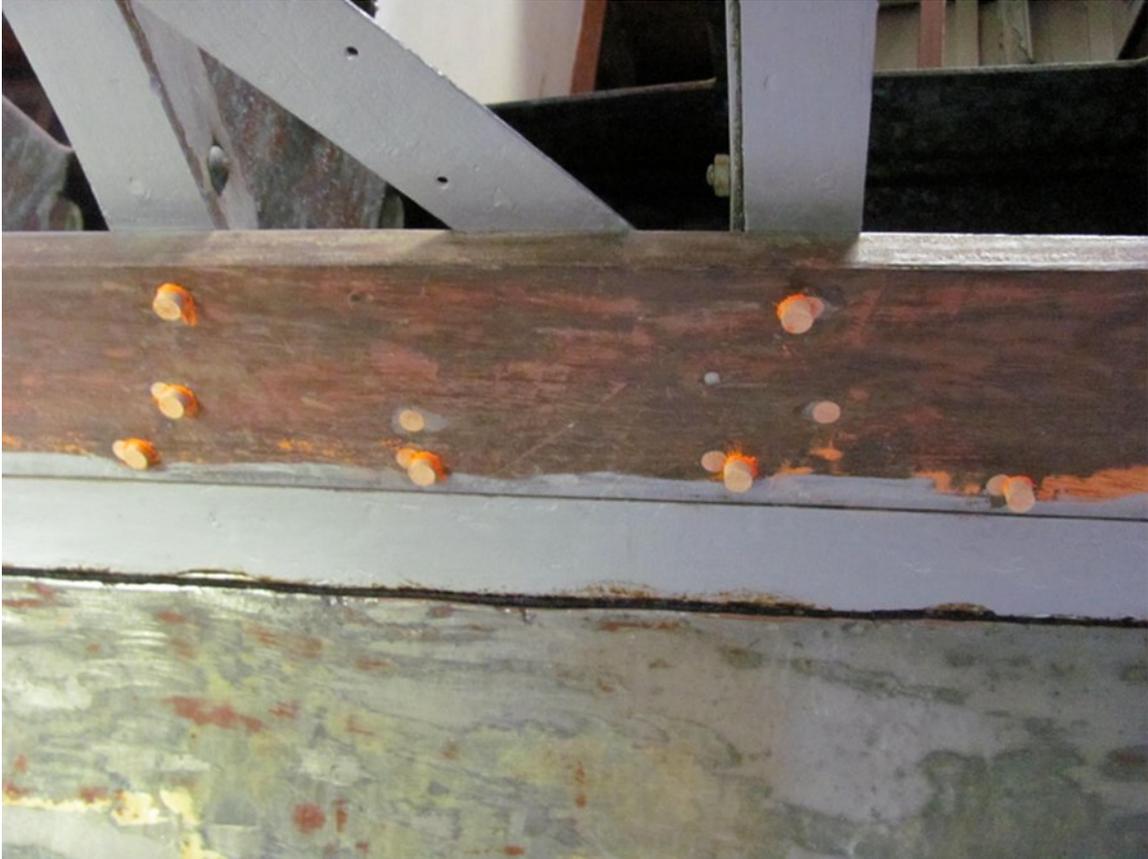
This area is near the forward strap. The two bungs that are isolated and flush with the face of the plank cover dead holes. These were previously occupied by fasteners into the top of the keel plank, but I felt that they were too close to the top of the keel to drill the holes without breaking out.

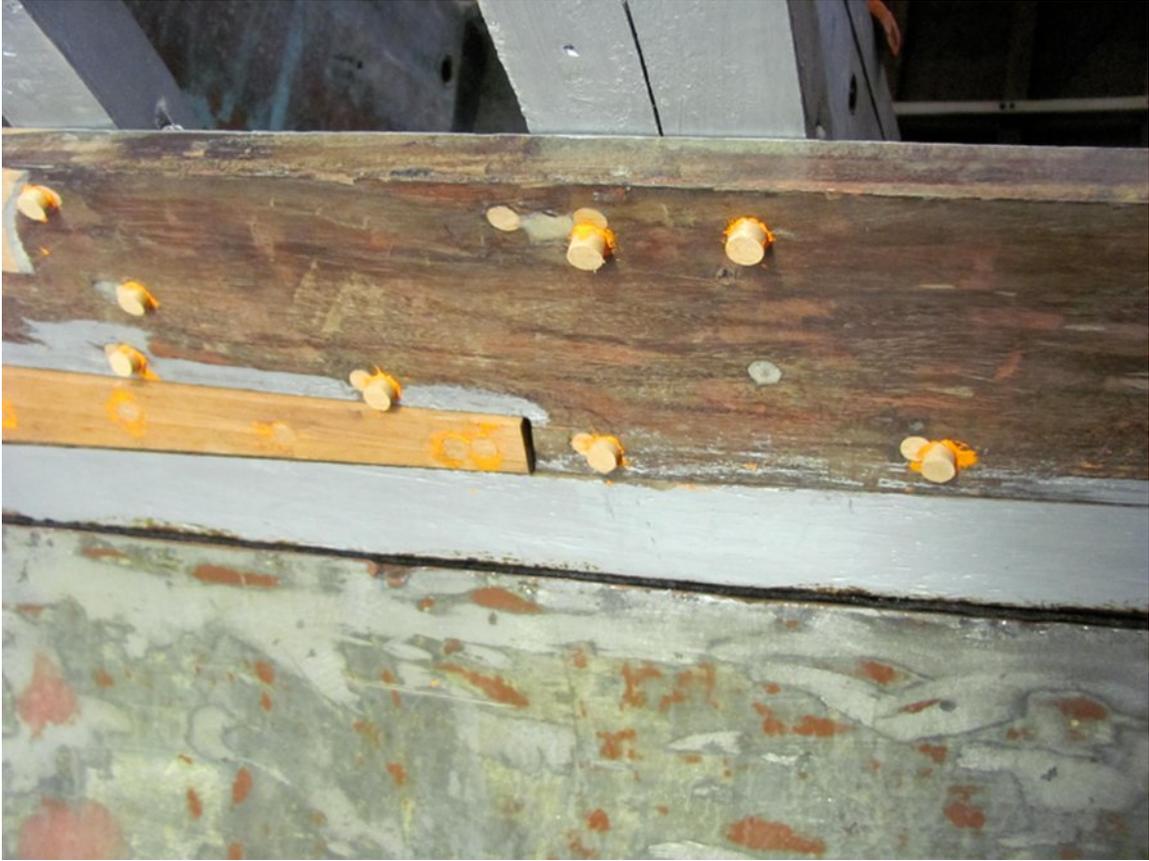
Nib end of S4. The flush bung top center covers a dead hole.
