Hanging Plank P5

Plank number 5 on the port side (P5) is now fastened in place, as shown in the following pics (bungs yet to be trimmed).

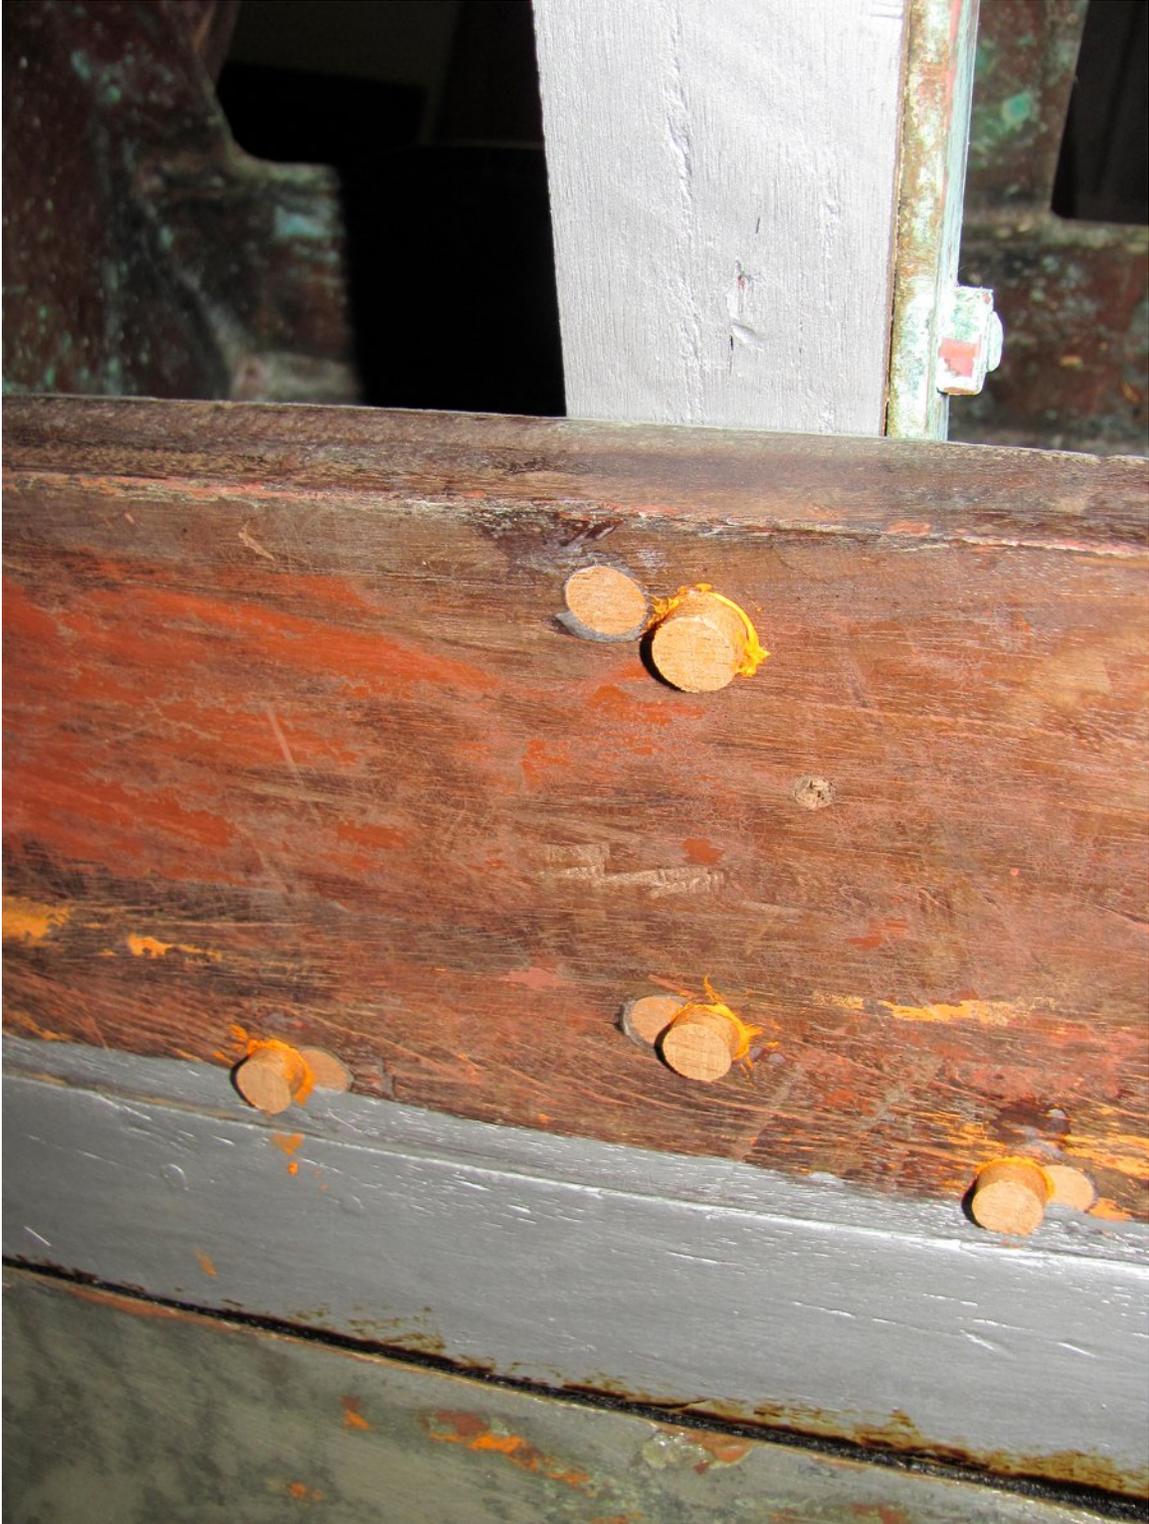
For #12 bronze screws, 7/16" bungs were used. This provides very little clearance for the head of the screw. So if the hole for the screw and the hole for the bung are not concentric, when the screw is extracted the head contacts the side of the hole chipping out a piece of the plank. This can also occur if the old bung is not completely removed.

Unfortunately, this occurred frequently when removing plank P5. Consequently, I decided to plug all of the old screw holes with bungs set in epoxy. In that way I could fill the "chip outs" with epoxy when I inserted the bungs.

The pic below shows an example of the "repair" bungs set in epoxy (trimmed flush) and the new fastener bungs set in red lead (yet to be trimmed). I tried to avoid the old screw holes but overlap the repair bungs so that in the future one could identify the bungs set over a fastener. As you can see at the top of the plank, I didn't always adopt this strategy.

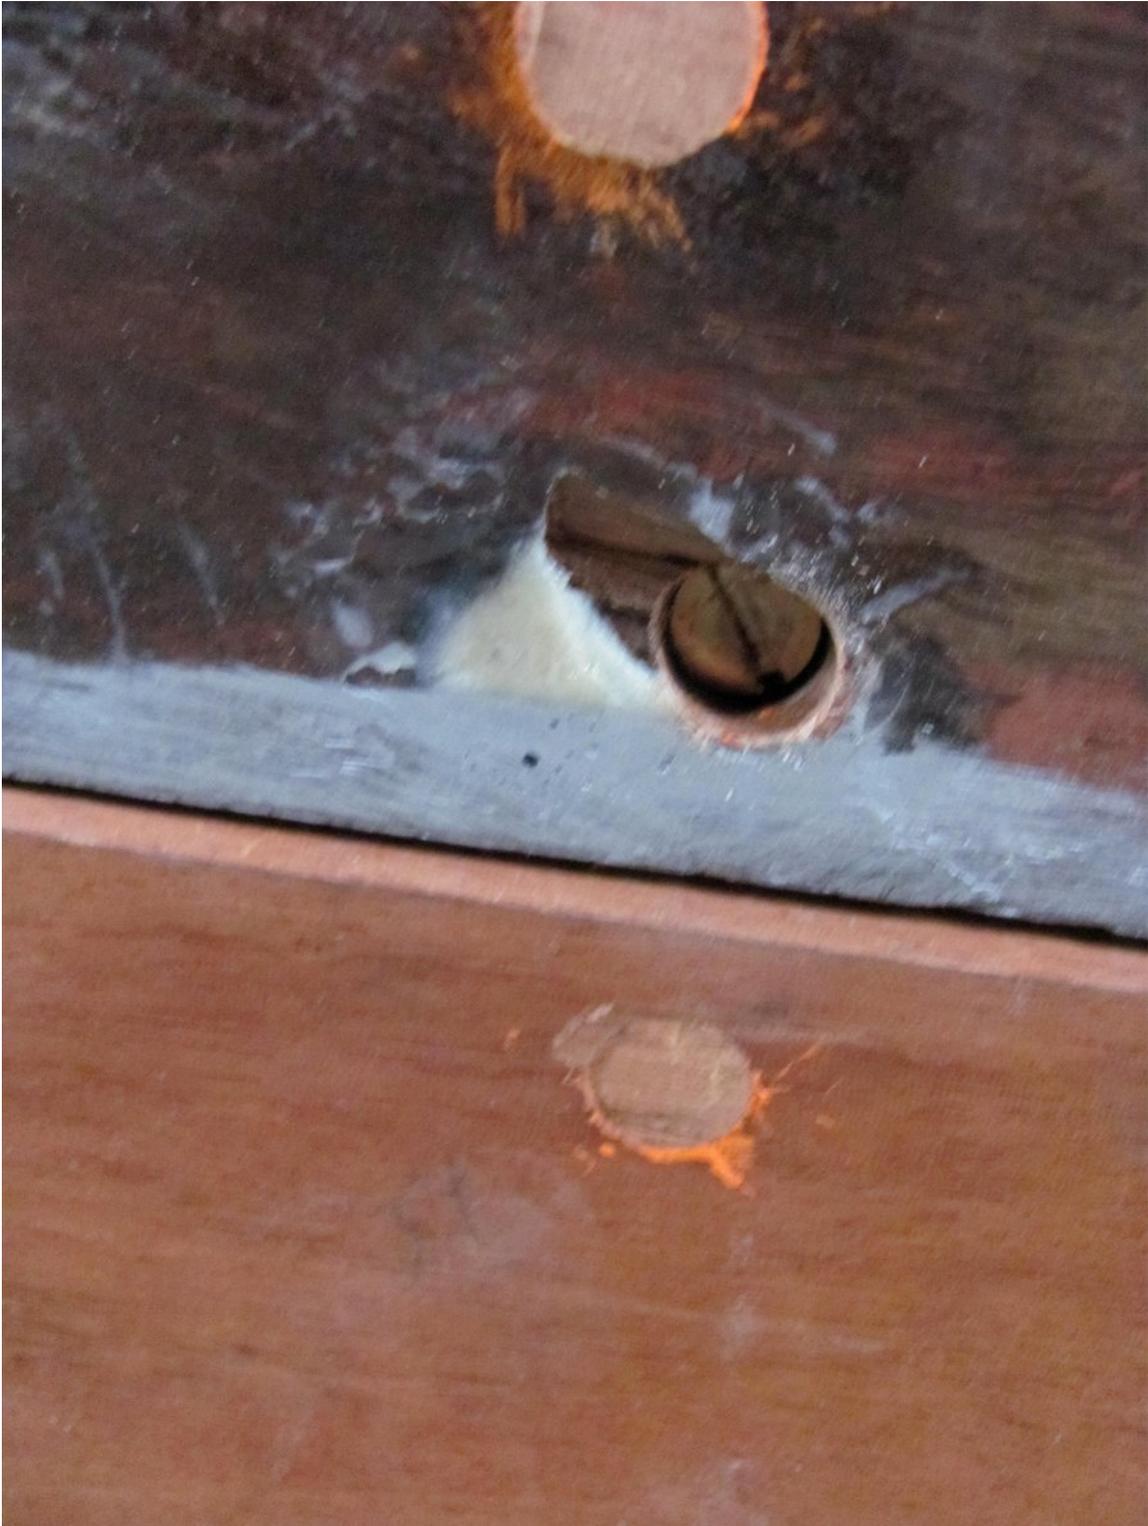
In a couple of cases, I had to remove a screw that I just installed (hole not deep enough; screw would not take up all the way). This typically resulted in the chip out that I just

described (see pic below). I guess I'll have to set these bungs in epoxy so that I can repair the chip out. This will be annoying for whomever might need to remove this fastener in the future, but I don't have a better solution.

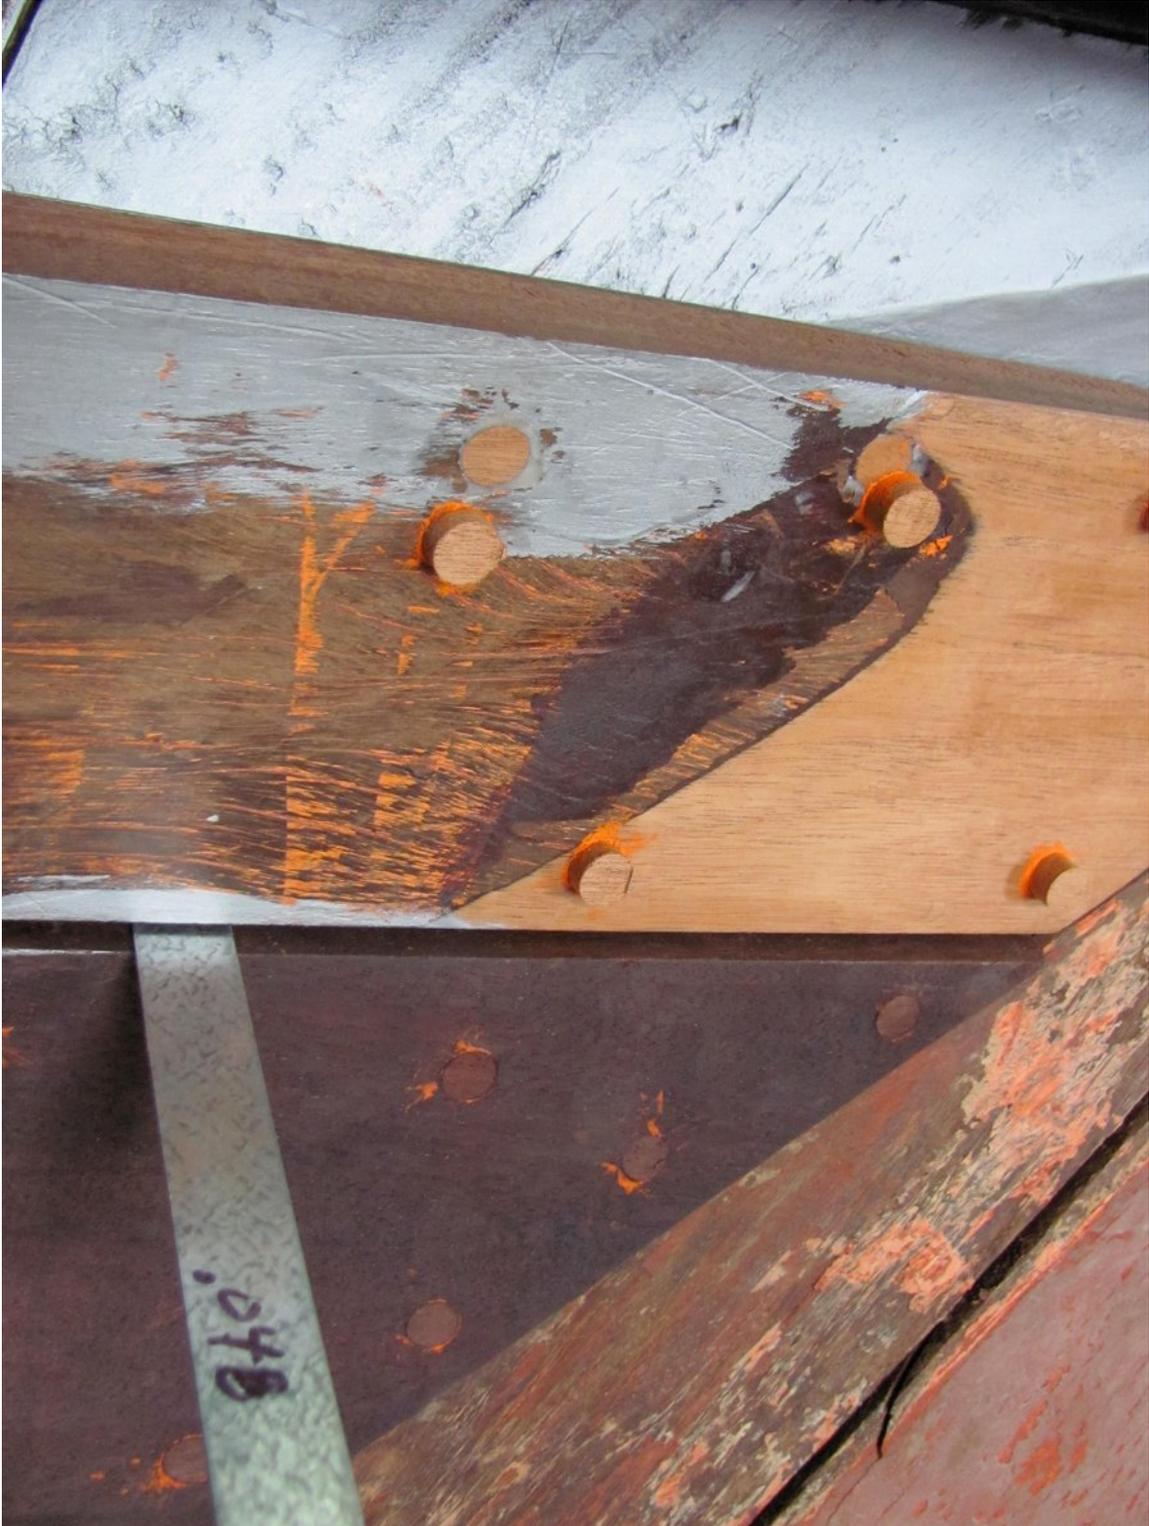
The pic below shows the aft end of the plank. In this area, the gap was slightly greater than .048". In this area, however, the seam is over the backbone. So the caulking will have a backstop and will not be driven through the seam into the boat.

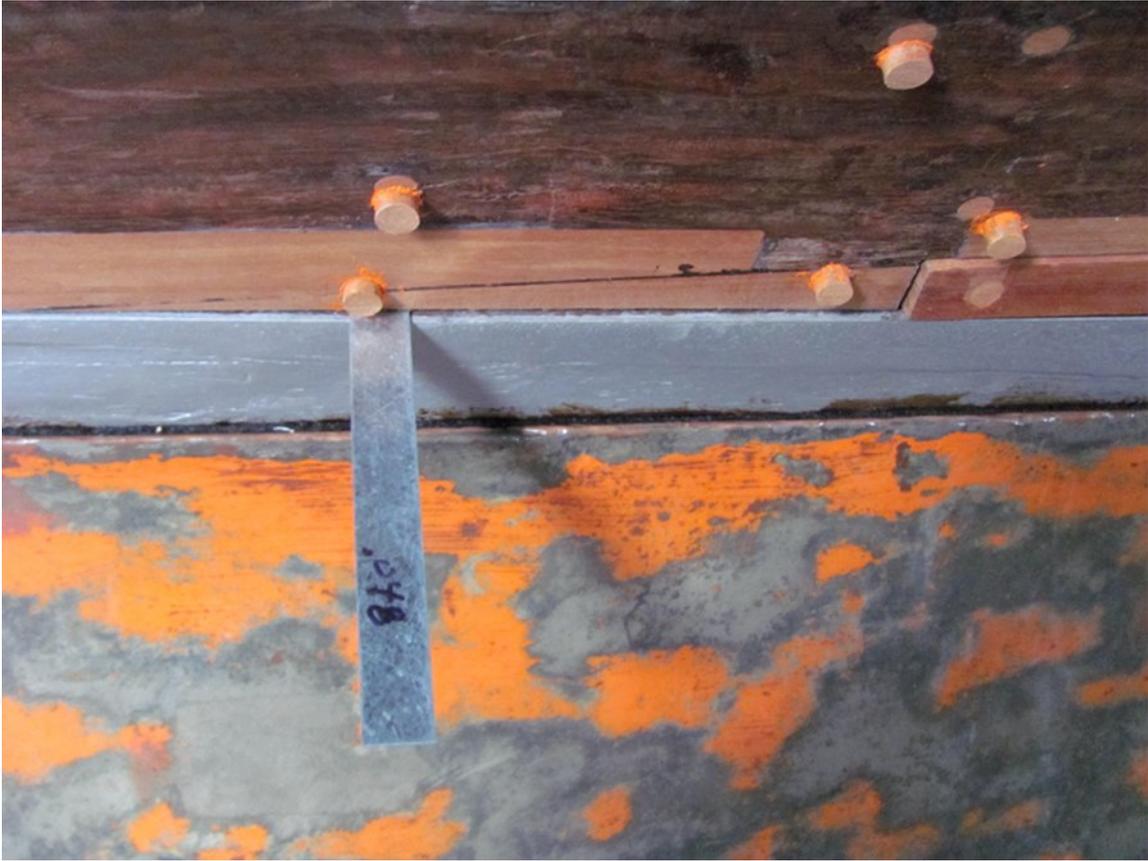
Here is another example just forward of the notch for the nib. This seam has the keel rabbet as a backstop.

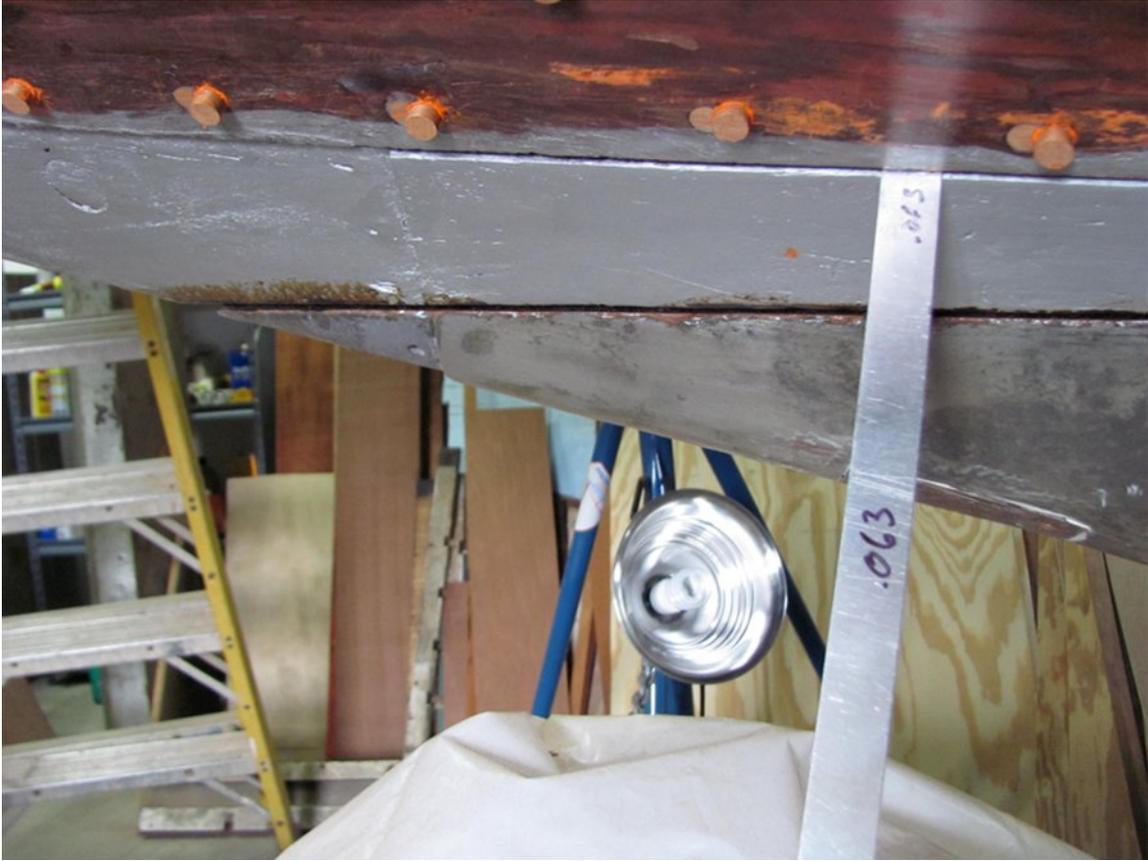
This gap is over .063". This section of P5 interfaces to the keel rabbet and was not modified by me, so any gaps in the seam were original. It would have taken major surgery to eliminate this gap so I chose not to. Fortunately, the keel rabbet acts as an effective backstop for the caulking. It makes you wonder, though, what kept the water out since no caulking was used originally.

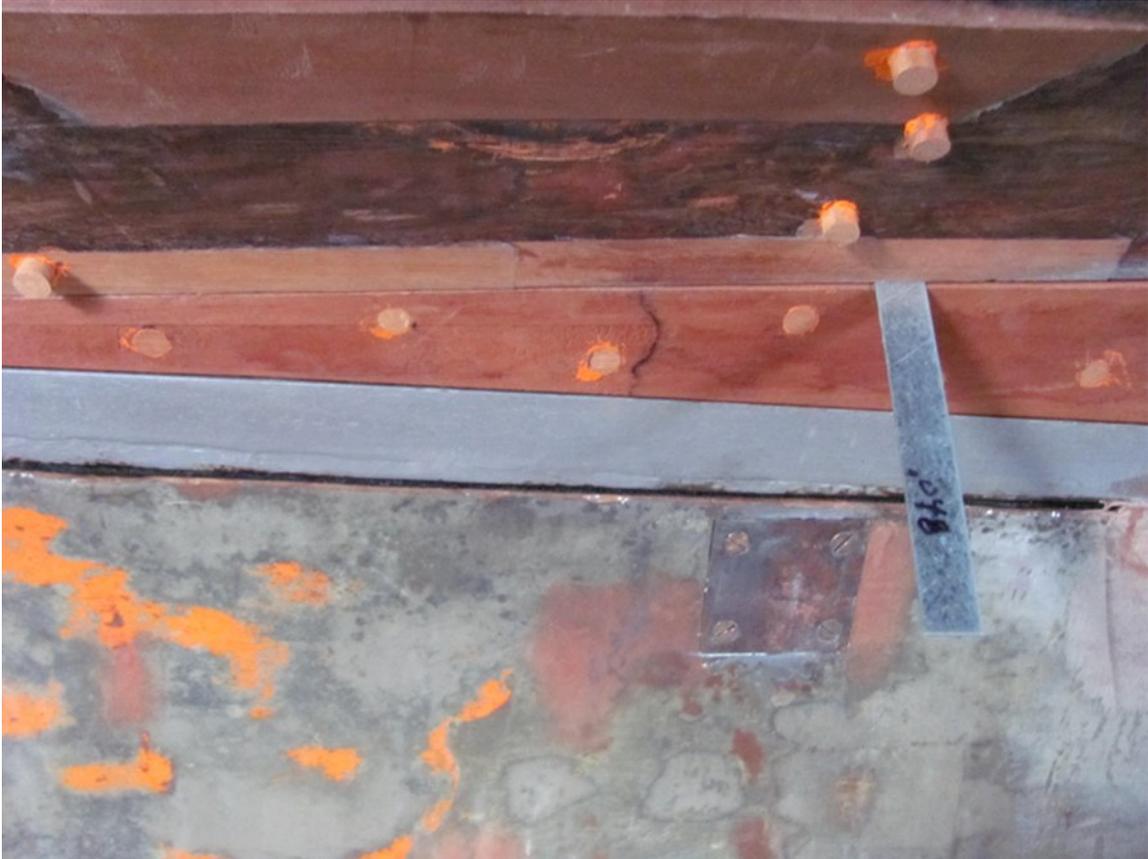
This next pic shows a gap with a .048" gap that is not backed up by the backbone. Fortunately it's a very short section. I'll just have to be careful when caulking this area.

I'm sure that this gap was much smaller at the last trial fit, but the clamping arrangement during trial fits is never perfect. Inevitably, some of the screws pull the plank in a bit tighter than the clamps. This can rotate the plank slightly opening up the seam.
