Keel Repair (11/3/2011)

Keel Rabbet

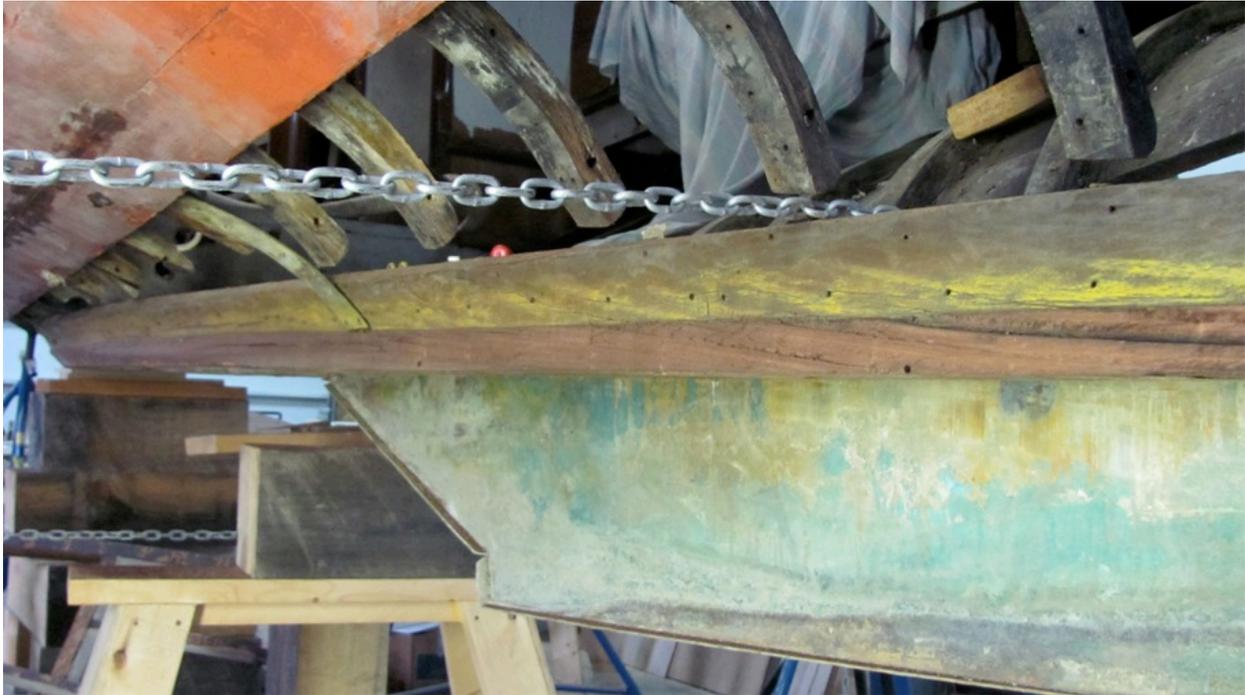
The following pic shows where the previous rabbet was planed away. A power hand plane is a great labor saver for a job like this but you must be careful not to remove too much or in the wrong place. In some places I neglected to keep the power plane perpendicular to the bottom of the keel, which required some adjusting with a hand plane (taking a bit more wood than I would

have liked). I also inadvertently cut some shallow grooves in the back rabbet (painted yellow), which I later filled with epoxy. All in all it worked out ok.

By the way, the yellow paint on the back rabbet was so that I could tell where the rabbet meets the back rabbet (the middle line) after planing.

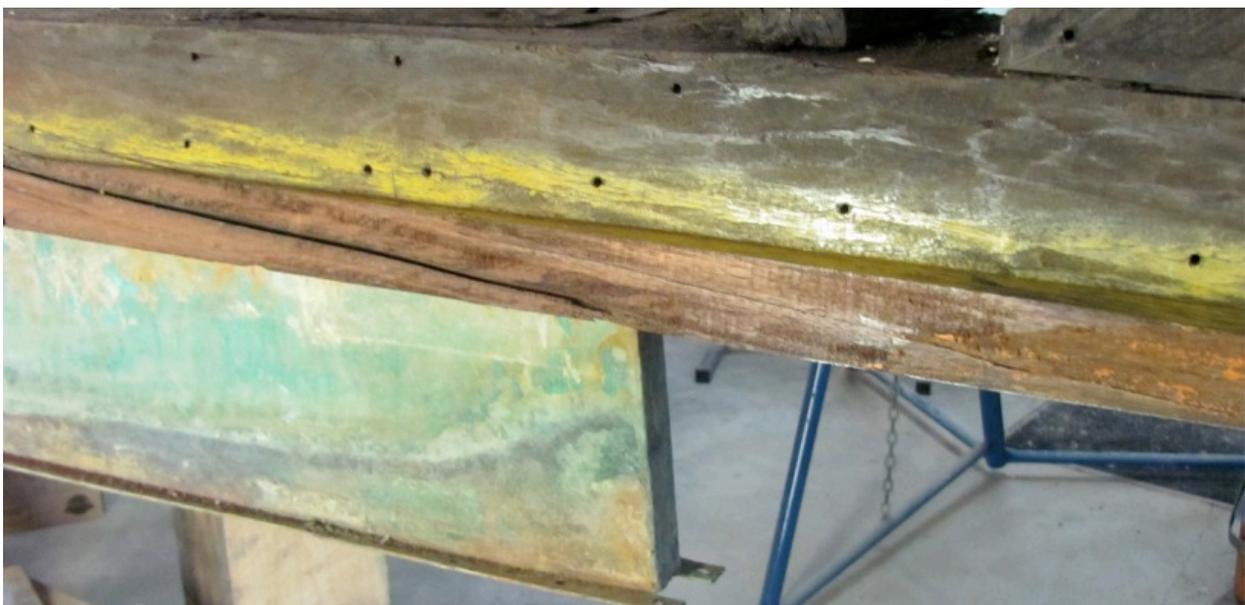
Now with almost an inch of wood removed, you can really see the extent of the checking.

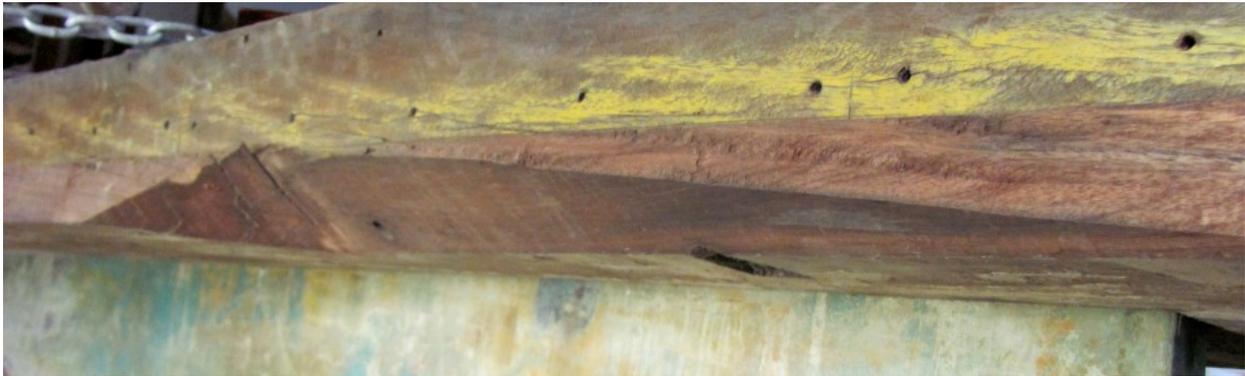
As the following pic shows, I had to remove a fairly large chunk of keel to get down to reasonably good wood. Note the rather odd shape of the repair - sort of a scarf at an angle. It might not look like it in the picture, but those surfaces have been planed flat with no noticeable twist. A lot of hand planing to get this right! I would use the longest plane possible to keep the surfaces flat but a regular plane can't reach where the two surfaces meet. So I had to use a bullnose plane to clean up that section. (I subsequently learned that a large chisel, called a slick, is the better tool for this job. When I face this problem again, I'll get one.)

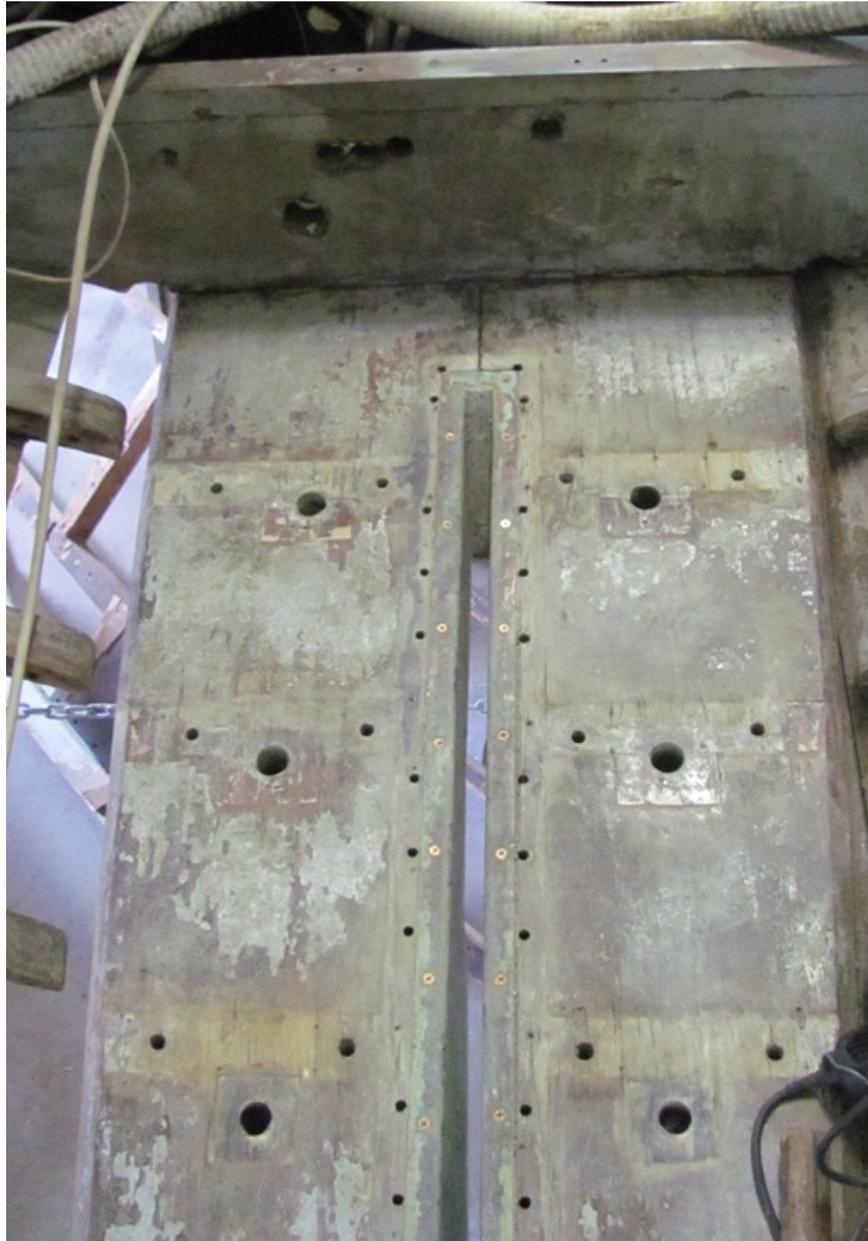
The keel had one other problem that needed attention - a check along the centerline. The pic below shows the top of the keel plank with the centerboard trunk removed.

At the top of the picture, you can just see a check along the centerline of the keel that starts at the floor and travels aft to the slot for the centerboard. This next pic provides a closeup of the check.

It's possible that this check could swell shut after the boat is launched, but I'm considering installing a stopwater just in case. Looking at the first pic above, I would install the stopwater just in front of the liner so that the centerboard trunk flange would rest on top of the stopwater. In that way, any water that travels from the centerboard slot forward would encounter the stopwater, travelling upward it would stop at the flange of the trunk.

As for the keel check, the best advice appears to be to use refined (so that it won't go rancid) tallow to fill the gap. This will stop any leaks and will extrude out if the crack swells shut. I found a source for the tallow on line.

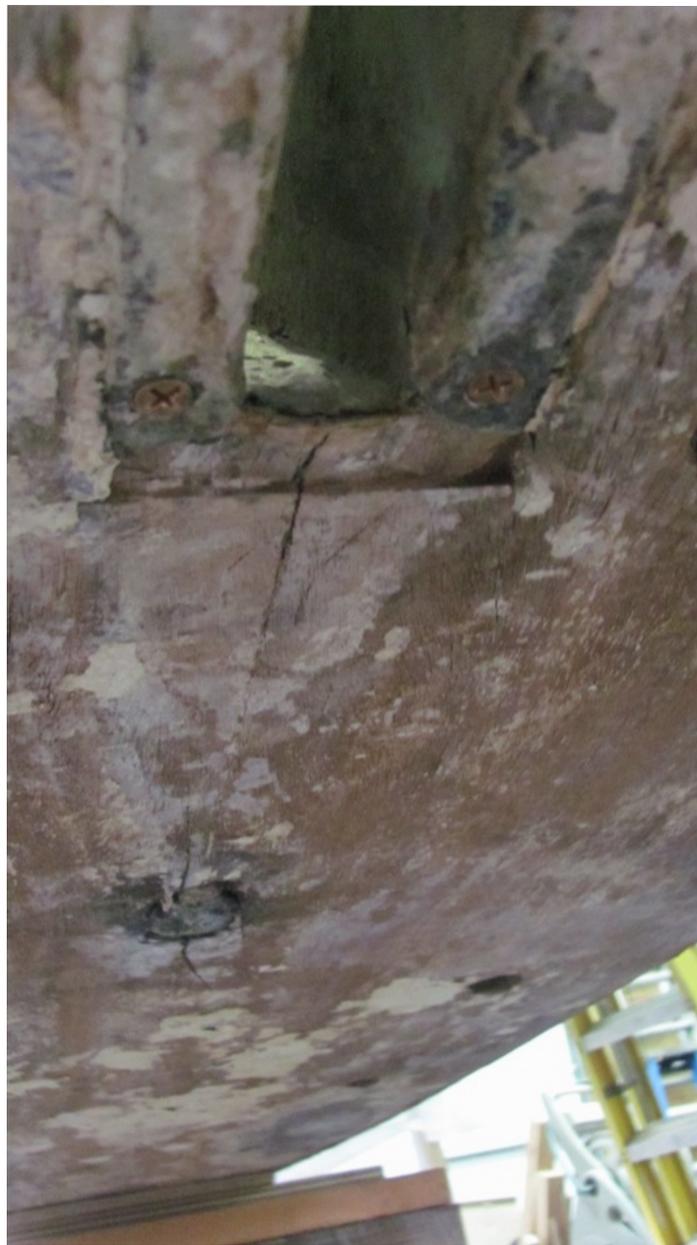
The centerboard slot contains a copper liner that cannot easily be removed, and this liner obstructs one's view of the check. So you can't really tell whether or not the check extends to the CB slot. The following pic shows the bottom of the keel at the forward end of the centerboard slot. Again it's not clear if the check extends to the slot.

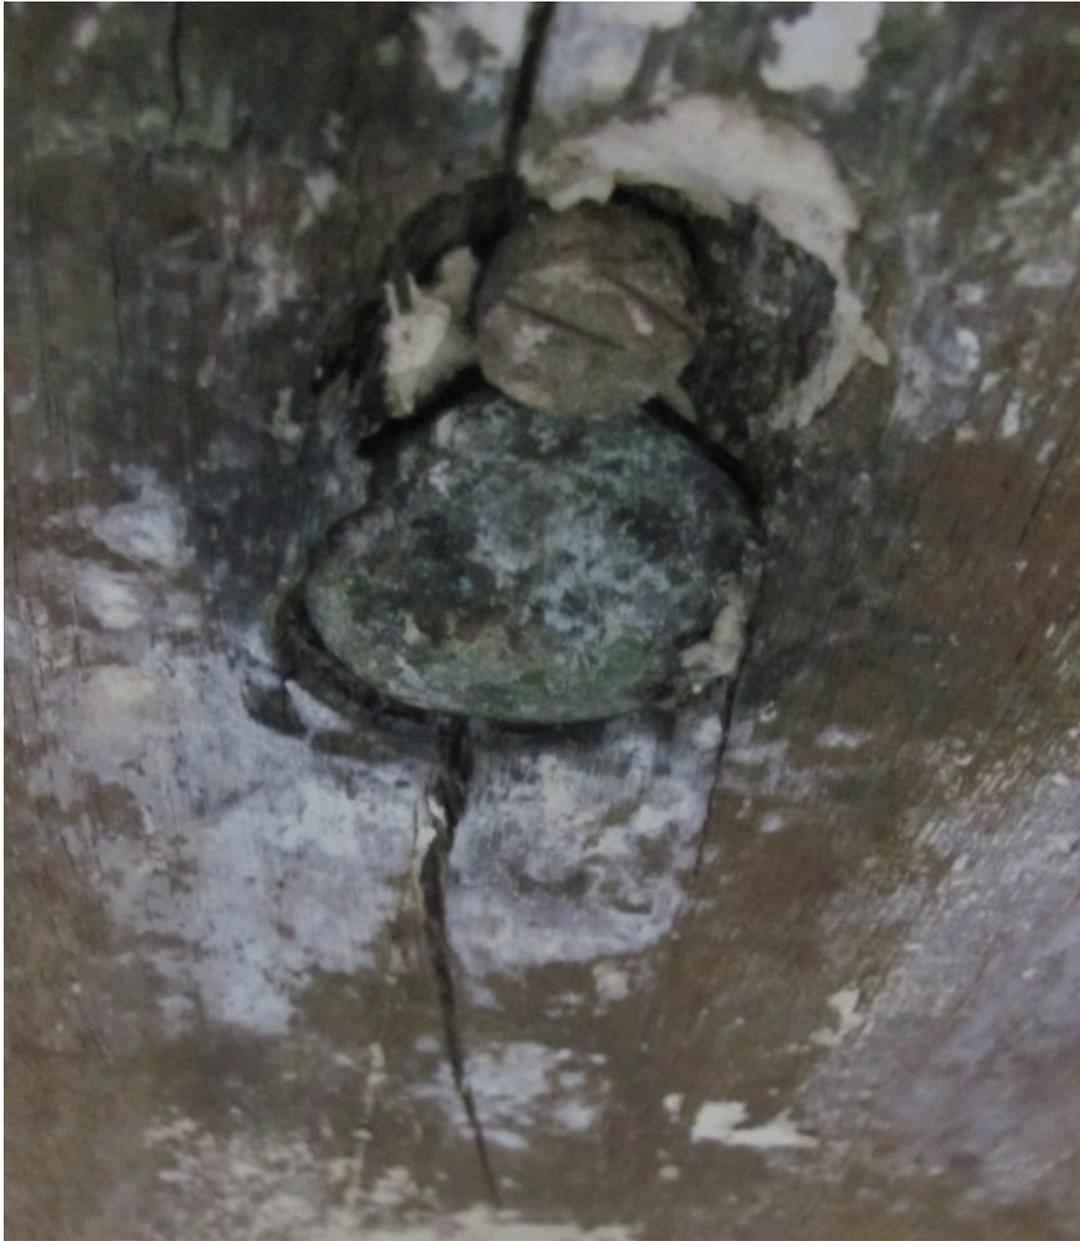
On a related note, take a closer look at the first and second pics above. Note that the check extends forward to the floor. Observe that a stopwater has been inserted there. A view of the bottom of the keel (below) shows that the stopwater runs adjacent to the bolt that secures the floor to the keel. In fact, there are three bolts securing the floor and all three have similar stopwaters. Why was this done?

I believe that the "stopwater" question has been resolved with the help of advice from the Woodenboat Forum. Since there are "stopwaters" in the same relative position in all three floor bolts, it seems likely that the original bolt holes were drill incorrectly and that these "stopwaters" were used to plug the holes.

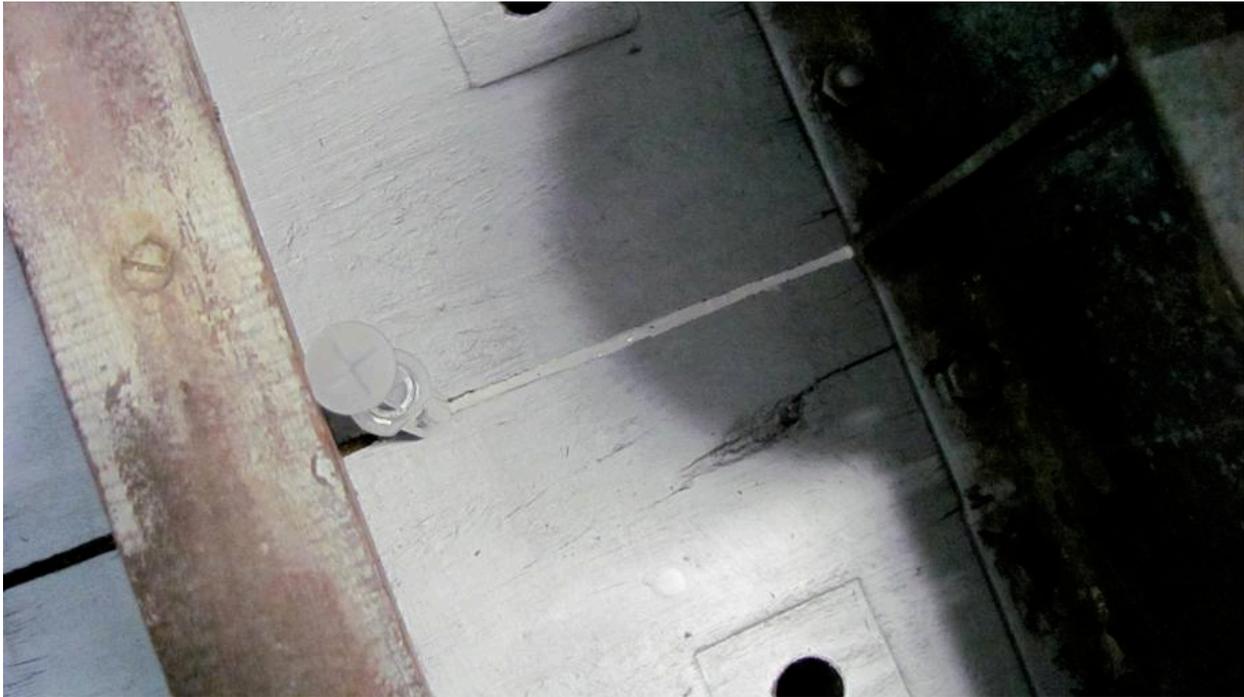
- 3M5200 is not solvent resistant, so using it in the bilge is questionable (I didn't realize this until after I'd finished).
- The check passes under a wood floor and one of the floor's bolts pass directly through the check under the floor. Ideally, I should have removed the floor to make a proper repair, but this would have been a major undertaking. Instead, I attempted to inject sealant into the check on both sides of the floor. Whether or not this will be effective remains to be seen. I shudder to think of how difficult it might be to stop a leak in this area after the boat is finished!

I then filled this check with 3M5200.

- Since the trench is wider than the check, if the check closes up there will still be room for some sealant – the excess will simply extrude upwards.
- The making of the trench should provide fresh wood for the sealant to bond to.
- This process should provide some protection against a possible future leak.
