More Stopwaters

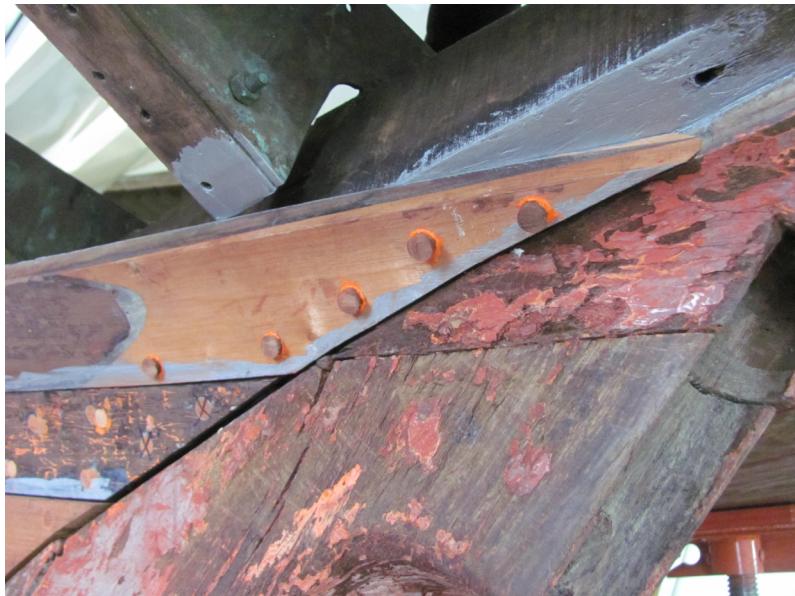
The aft stopwater was broken, and I was able to extract most of the stopwater from the starboard side. I tried unsuccessfully to remove the remaining 2" piece by driving it out from the port side, but it wouldn't budge. Alas, I should have dealt with this before I installed the seventh plank on the port side (P7).

The pic below shows the stopwater on the port side (at the intersection of the rudder post, horn timber, and stern rabbet). Only half of the stopwater is visible. The other half is covered by P7.

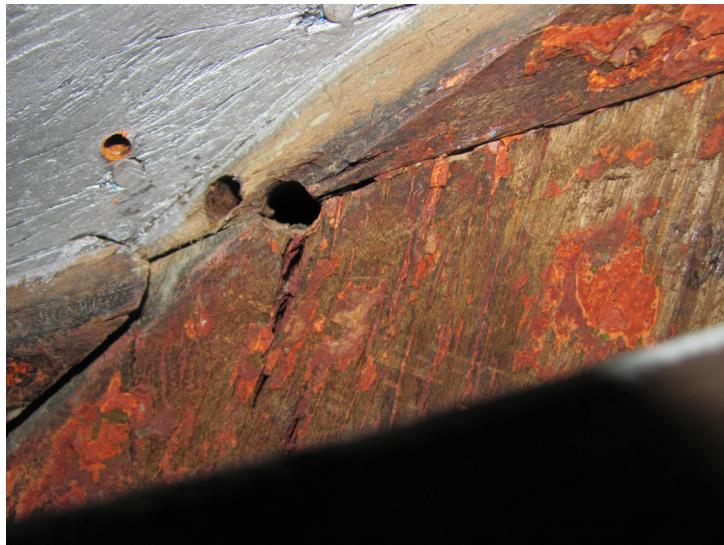
Unable to remove the broken piece, I decided to drill it out from starboard. I reasoned that since 6" of the 8" hole was clear, I should be able to run a long 3/8" diameter drill through to the port side. This turned out to be a big mistake. Instead of removing the broken piece, the drill exited through the plank! To see what went wrong, I removed about 10 screws from P7 so that I could spring the plank away from the stern rabbet. I could immediately see that my drill wandered off about 1". Using a drift, I was able to drive the broken piece of stopwater from the port side through to exit on the starboard side. With the hole clear, I could see what happened. Evidently the builder started the hole on the starboard side and after drilling about 6" he switch to the port side. The two holes met but not in a straight line. So they were able to drive a stopwater through because it would deflect enough, but maybe that's why this stop water broke? In any case, when I tried to clean out the broken piece by drilling

through from the starboard side, of course my drill followed the old hole straight on through the face of the plank. The pic below shows the two holes on the port side. The hole to the right is the original stopwater hole. The one to the left is where the drill exited.

So now to do it right ... First I had to plug the old holes. I made some long (1.25") 3/8" diameter Amendoin bungs. I epoxied one bung into the hole where the drill exited on the port side and 5 more into the hole on the starboard side. The one plug on the port side filled the bad hole completely and the other 5 almost completely filled the original hole. This left me with a shallow hole on each side (properly located).
