Spars (2010)

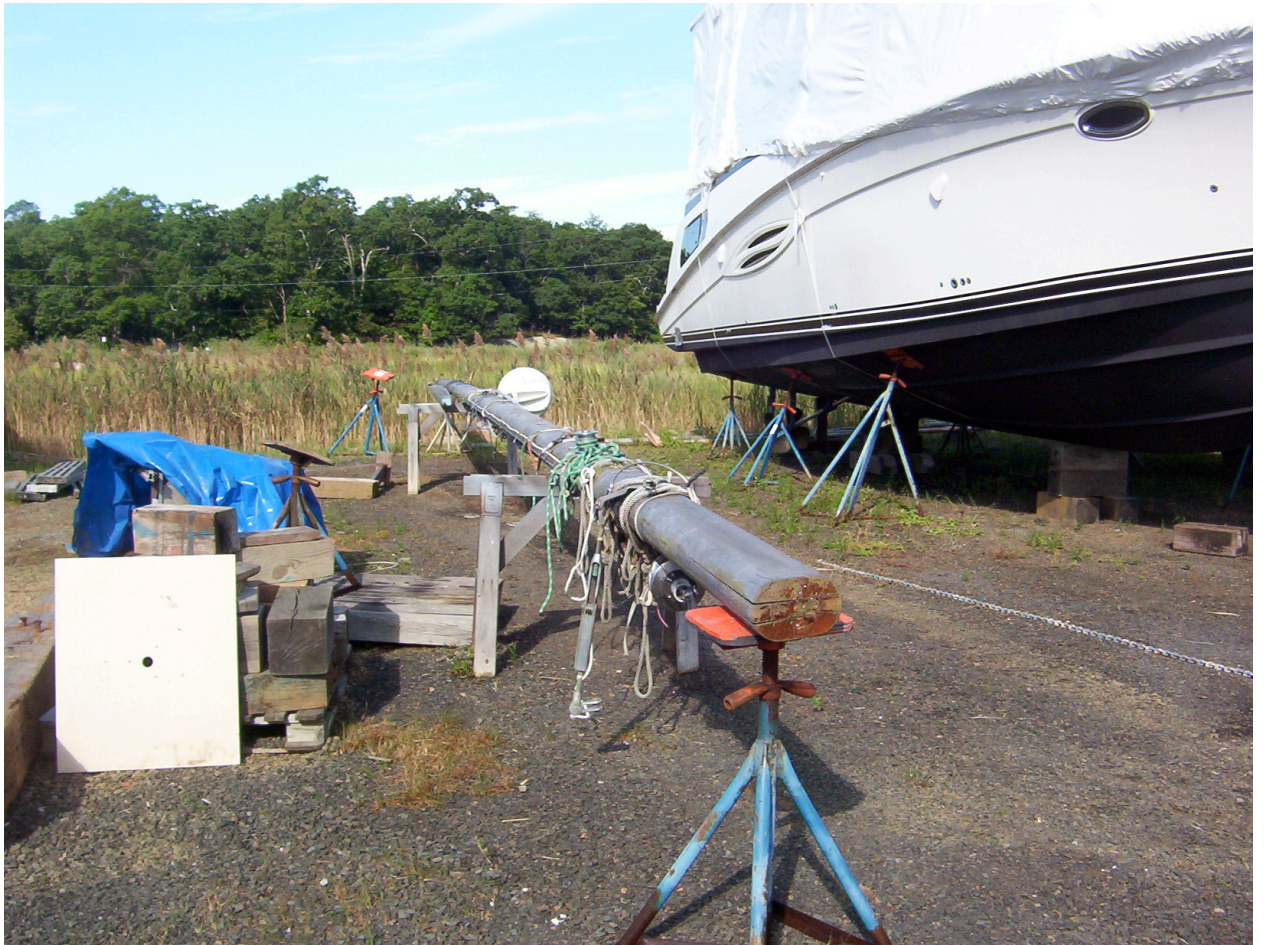
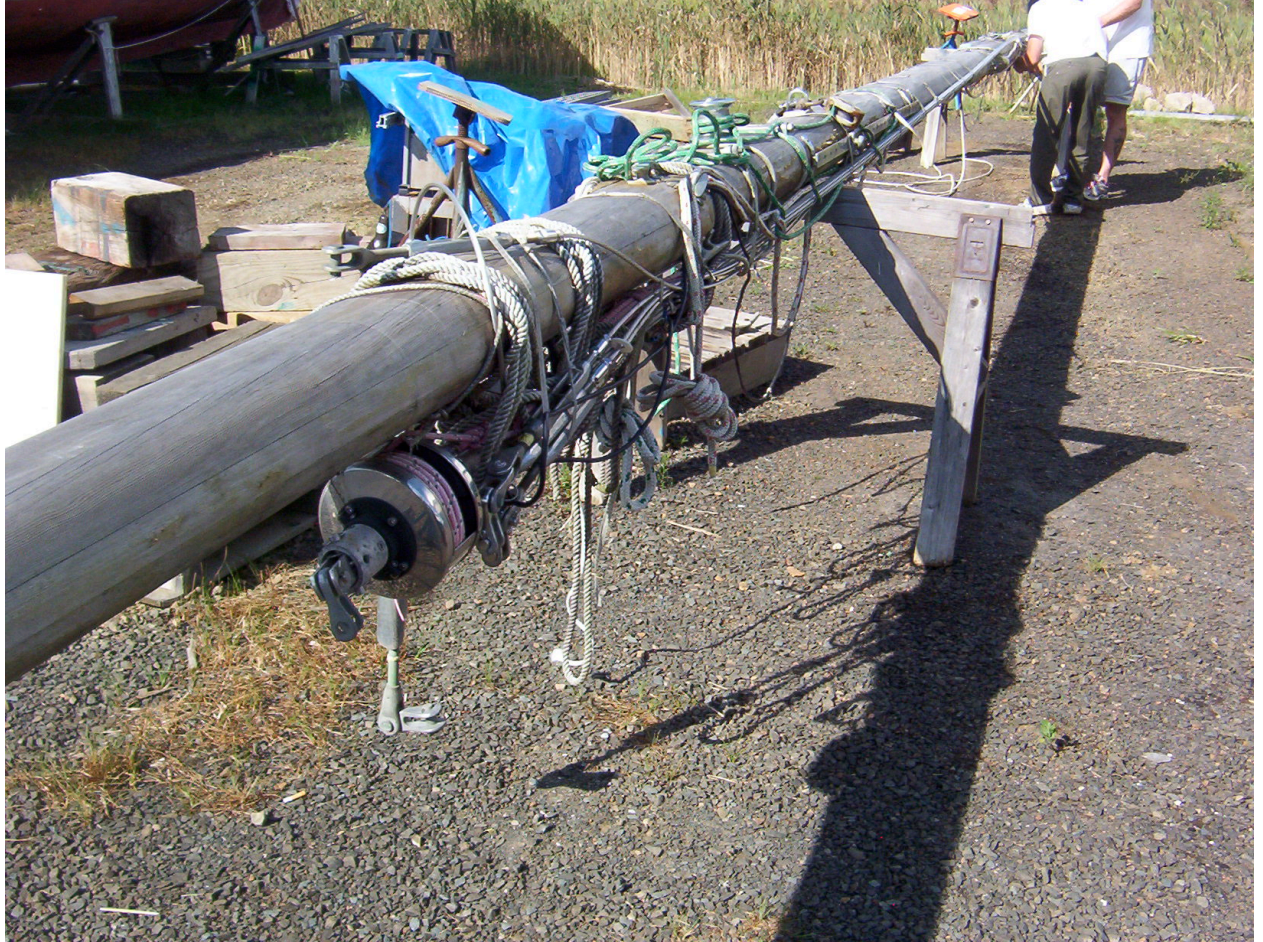
The spars are made of Sitka spruce. When we took delivery of the boat, I knew that both masts needed a lot of work. It was clear that many of the glue joints were failing due to the long exposure to the sun (with no finish). Once in the garage and subjected to closer inspection, I found that both masts were infested with carpenter bees. So after measuring and photographing the location of all the fittings, I remove the fittings and cut the masts into pieces for disposal. Very sad day ... The plan is to either build new masts in spruce or replace with aluminum.
