Installing New Deadwood and Ballast 11/22/2012

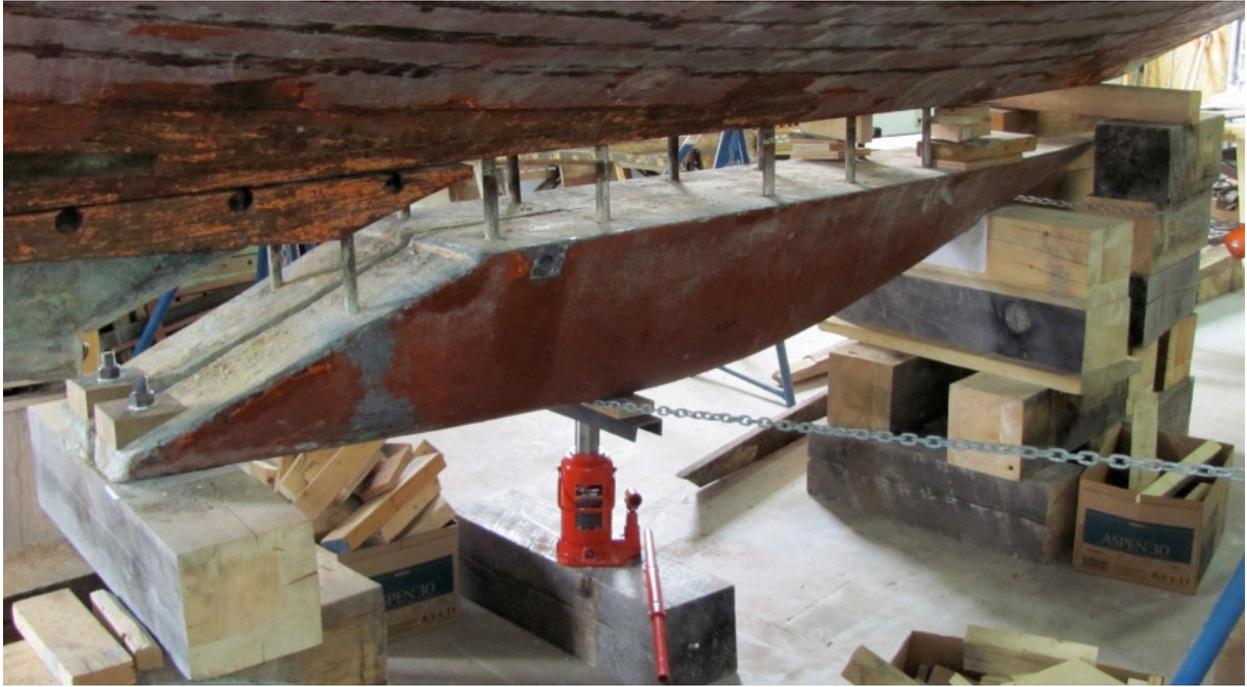
To install the deadwood after the ballast meant that I had to remove the two keel bolts that penetrate the deadwood. As the pic below shows, there are actually 4 keel bolts that penetrate the deadwood (where the ballast is sloped); however, the 2 longer aft-most bolts go completely through the ballast and were removed when the ballast was removed from the boat. What you're seeing in the picture are sections of all-thread that are used to temporarily hold the blocking in place.

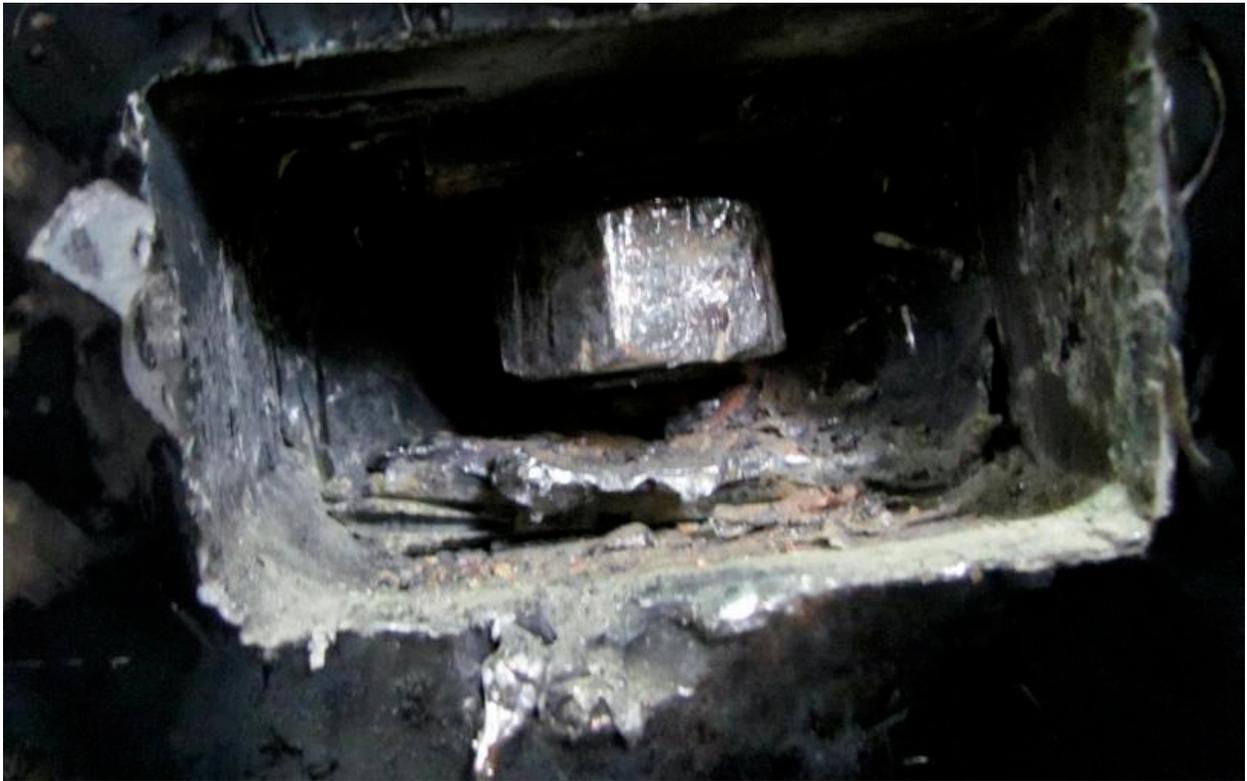
The two shorter bolts (the ones still in the sloped section of the ballast in the pic above) do not pass completely through the ballast. Instead pockets called galleries are cast into the side of the ballast to provide access to nuts at the end of the bolts. One of these galleries is shown below.

These galleries are plugged with lead blocks, made of softer lead than the ballast proper (no antimony), so they can be melted away with an oxy-acetylene torch. As you can see in the pic, I got a little carried away with the torch and melted a bit of the keel. Oh well that's what filler is for!

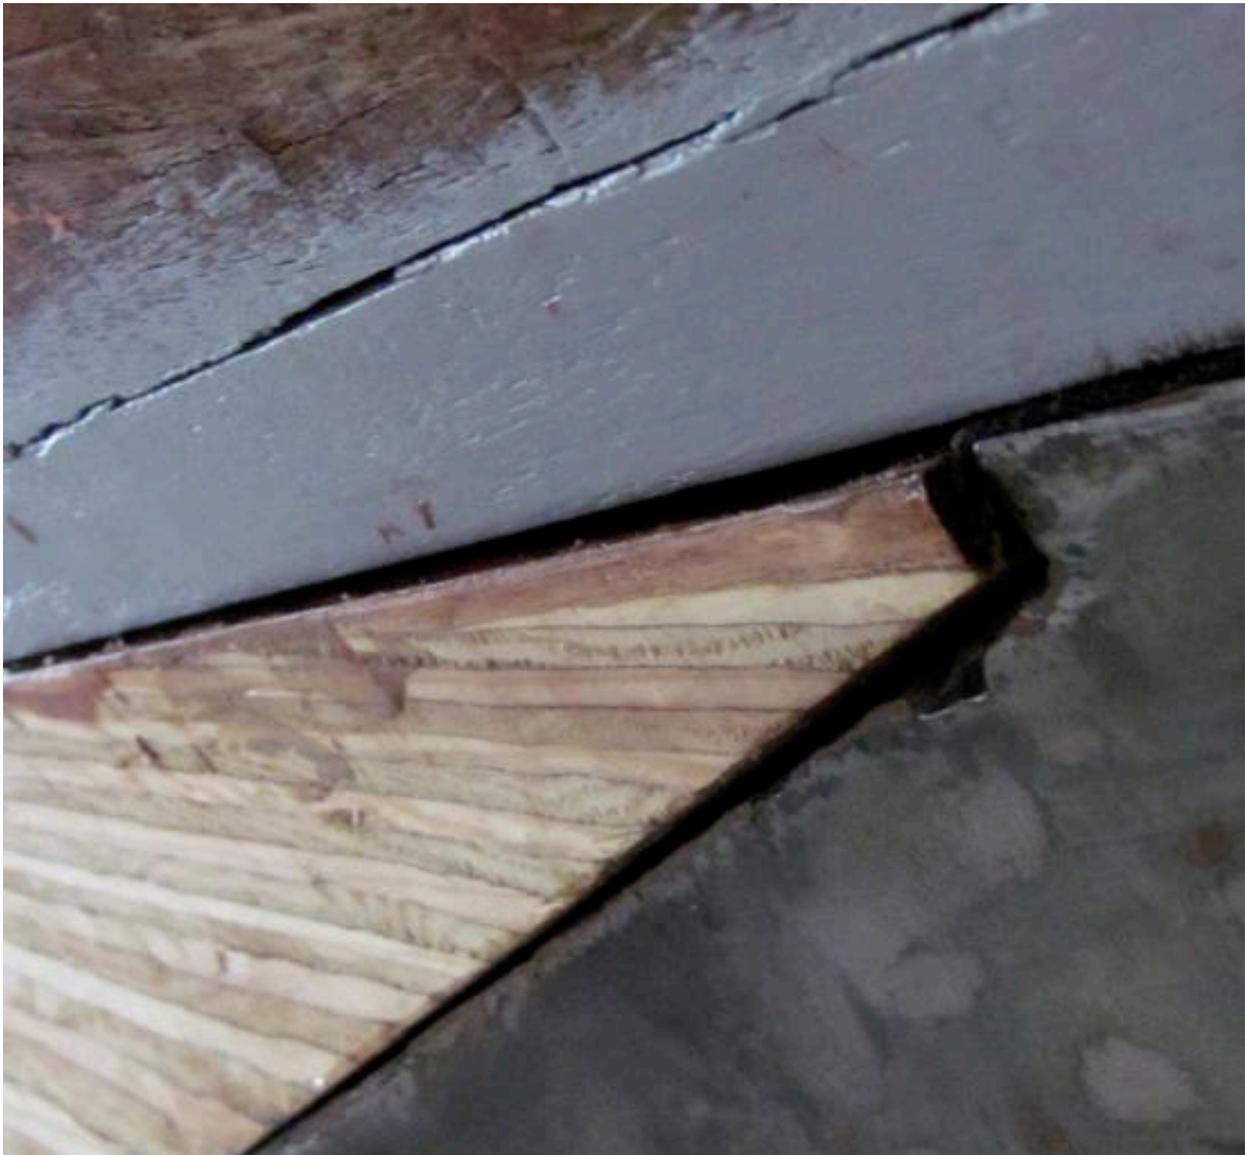
- Although the template idea for adjusting the fit of the deadwood was a good one, I was careless with my measurements. Specifically, the ballast was about 1/8" too far aft and I neglected to account for the thickness of the felt. These errors combined to produce about 1/16 – 1/8" gap between the deadwood and ballast.

The same pic reveals another problem with the fit. At the top of the deadwood forward, the deadwood does not make contact with the keel plank. I'm not sure what happened here, since the

rest of the deadwood lies tight against the keel. Maybe I planed too much from that corner. Whatever the problem, it's systematic since the other half of the deadwood has a similar problem.

Of course these mistakes can be fixed, but it is none the less very disheartening. I have very high expectations and try very hard to do things correctly; however, my lack of experience means that every step is a learning process and thus errors are inevitable.

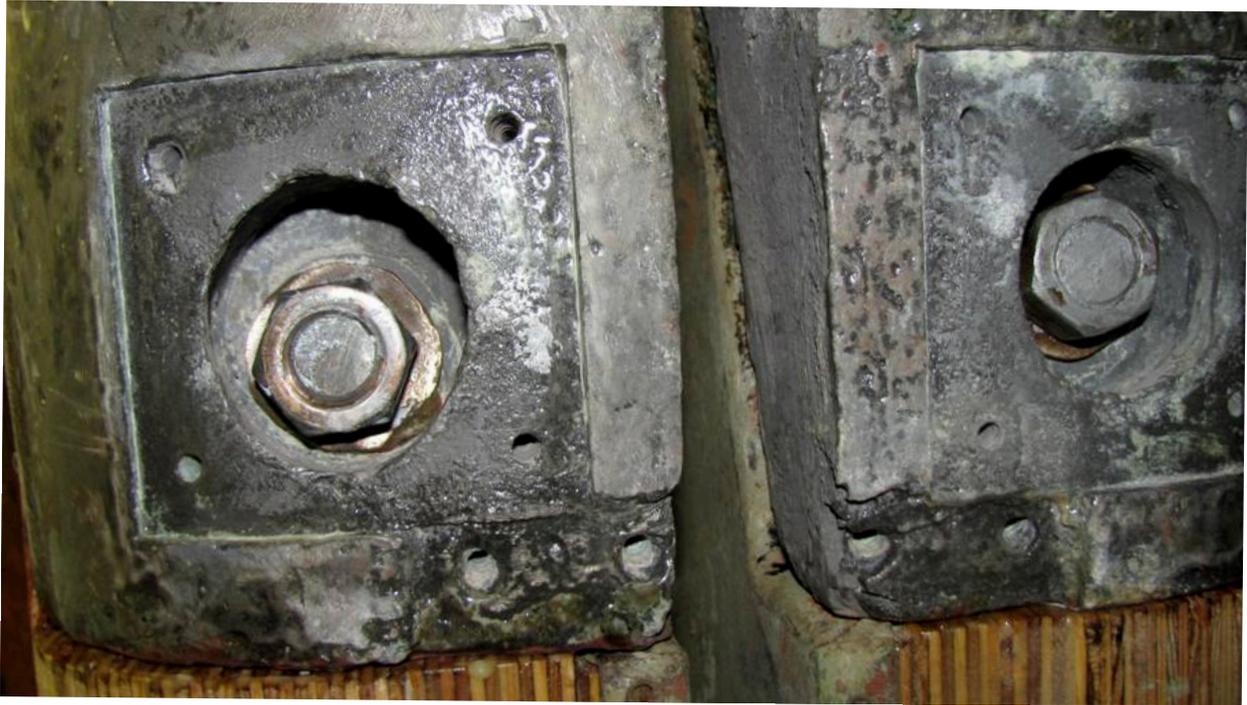
One other problem associated with drilling for the deadwood bolts, is shown in the pic below.

The pic shows the aft end of the ballast, where two deadwood bolts connect to the ballast. For whatever reason the bolt holes in the deadwood did not line up precisely with the holes in the ballast. (Since these were the longest holes in the deadwood, I suspect that the drill lead off some.) The misalignment was not much, but upon chasing the holes with the drill bit, some lead was removed, resulting in the nuts not in the center of there pockets. The shift wasn't much, but enough so that for the nut to the left in the picture, you can't get a socket on the nut (the right one is ok). This could be a nuisance if one ever needs to remove this bolt!

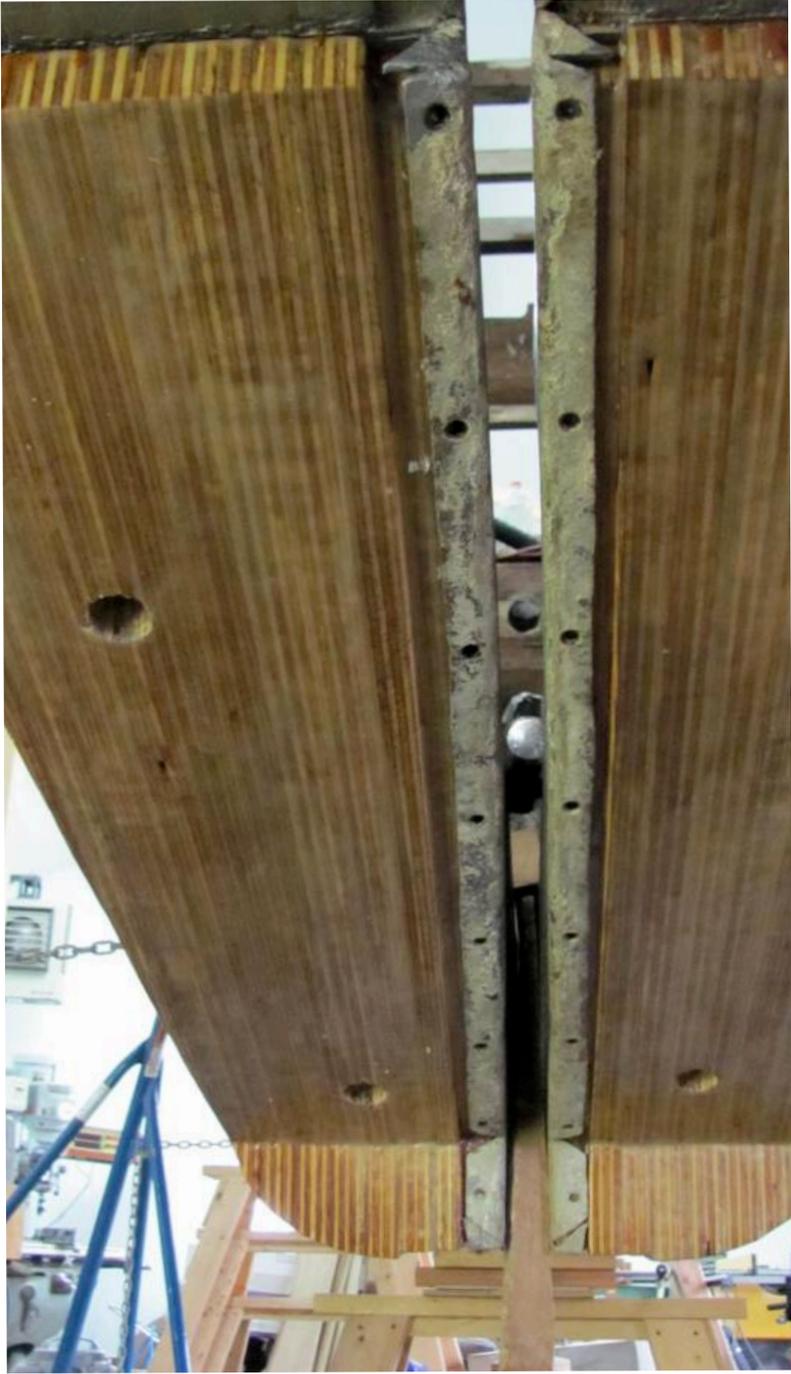
In the pic below, notice that the left half (starboard side of the boat) of the deadwood does not fit the centerboard liner as well as the right half. This caused the deadwood to shift outboard slightly. I suspect that the problem might be due to the keel plank swelling. This would reduce the space between bottom of the keel plank and the flange of the centerboard liner. If I had noticed this earlier, I could have trimmed the deadwood a bit where it mates to the liner. I'll just have to live with it now, however.
