**Engine  
(Final Assembly)  
(2010)**

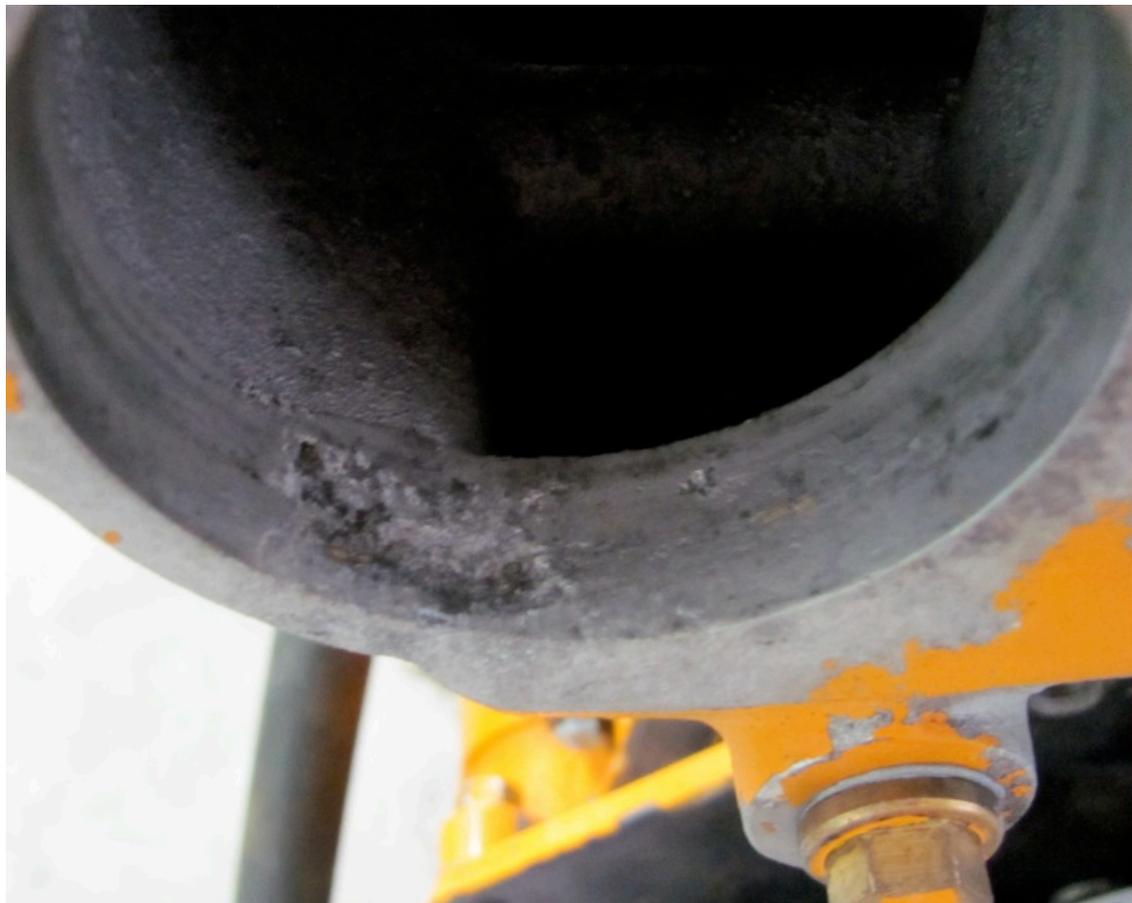
While the end caps were in place, I did pressure test the raw water side of the heat exchanger. Using some hose and fittings from the local hardware store, I attached a pressure gage to one of the end cap hose fittings and the air compressor to the other hose fitting. I filled the tube bundle with water and applied about 7 psi – no leaks. I realized then that this test was not sufficient. It's possible that the O-ring can seal the tube bundle from the coolant side; the pitting at the rear end of the exchanger would probably not allow the O-ring to seal the coolant from the outside.

So I decided to fill the pits with epoxy. I decided to use some G-flex with Cabosil from West System, thinking that the added flexibility of the G-flex would better tolerate the expansion of the aluminum. I machined a wooden plug just a few thousandths smaller in diameter than the heat exchanger housing. I removed the exchanger from the engine. I mixed a batch of epoxy/Cab to peanut butter consistency and troweled into the pits, and then inserted the plug with some wax paper as a release. The next day, I removed the plug and cleaned up the squeeze out. Worked well.

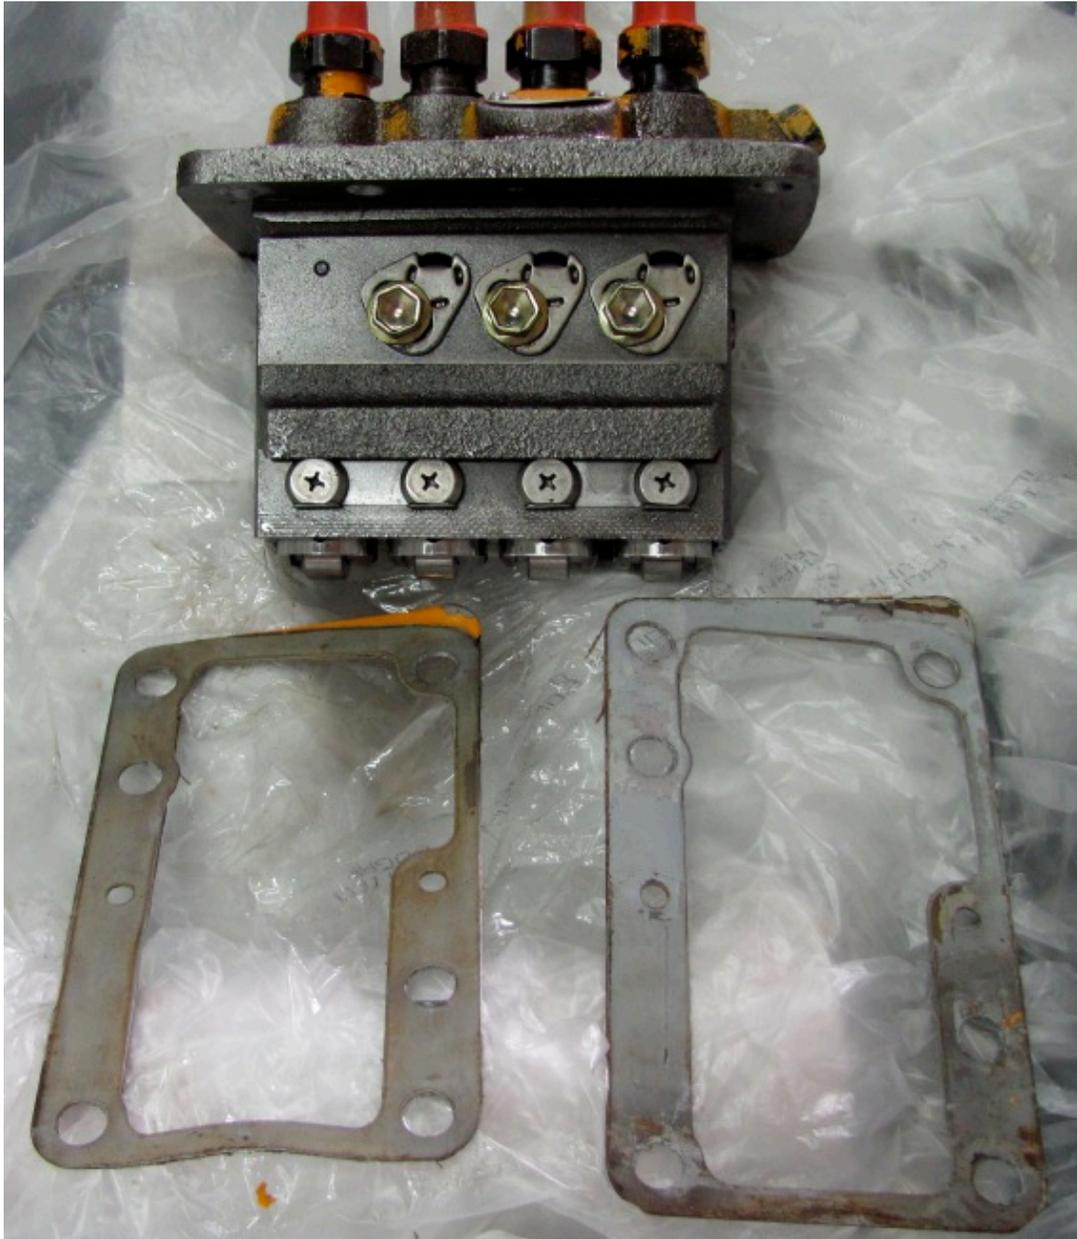
I have yet to understand why the injection timing isn't to spec. The timing is controlled by the thickness of the shims under the injection pump, so one possibility is that the thickness of the shims is incorrect - but these are the original shims (shims and pump shown in the pic below).

So maybe something is wedged between the shims? But I checked and the height of the fuel pump above the housing is the same as the thickness of the shims. So it appears that the injection

timing was set to 12 deg instead of 17 deg from the factory. Michael, from Stauffer, suggests that maybe Vetus specified this timing for their engines. I asked John Miller from Vetus about this – will check and get back to me (10/28/2010: I just learned today that John is no longer employed by Vetus). I could also ask Mitsubishi if this particular serial number was configured differently. Michael also said that he doubts that the difference in timing would prevent the engine from starting.

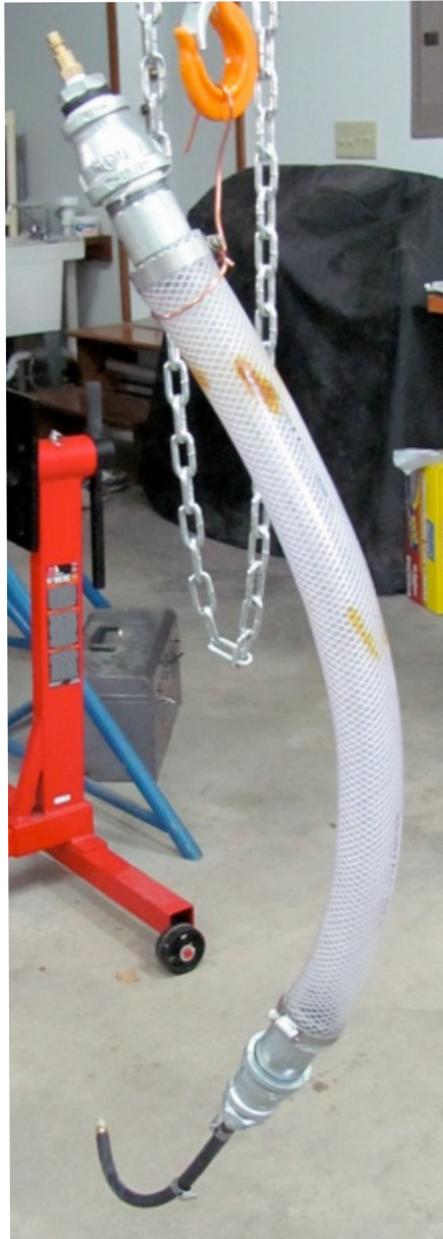
Pulled the crank and took it to DL Automotive for evaluation. They suggested that in the future, I pre-pressurize the oil gallery before starting the engine. A small oil tank connected to the oil pressure sensor port, apply air pressure – should do it. Leave the valve cover off and check the flow out of the rocker arms.

Upon reflection it appears that the problem was due to two connecting rod bearing having insufficient clearance and lack of oil (soon enough). The assembly lube was just not enough. This offered enough resistance to prevent the starter motor from turning the engine over fast enough to fire the fuel – hence the black smoke. So I'm waiting on DL. If they can clean up the crank without having to regrind it, that will be great. In either case, I'll need to order new bearings and some gaskets. Maybe new shims, if I decide to change the timing.

I built a device for pre-pressurizing the oil galleries.

A 2 ft section of clear PVC tubing (about 1.5" diam.) and pipe fittings to reduce it to 1/8" pipe fitting at one end and air hose at the other. The idea is to attach the device to the block in place of the oil pressure switch, fill the pipe with oil, and apply air pressure to pump the oil into the block.

DL says to use 50 psi and wait for oil to emerge from rockers. Oil pan and timing gear cover can be in place.

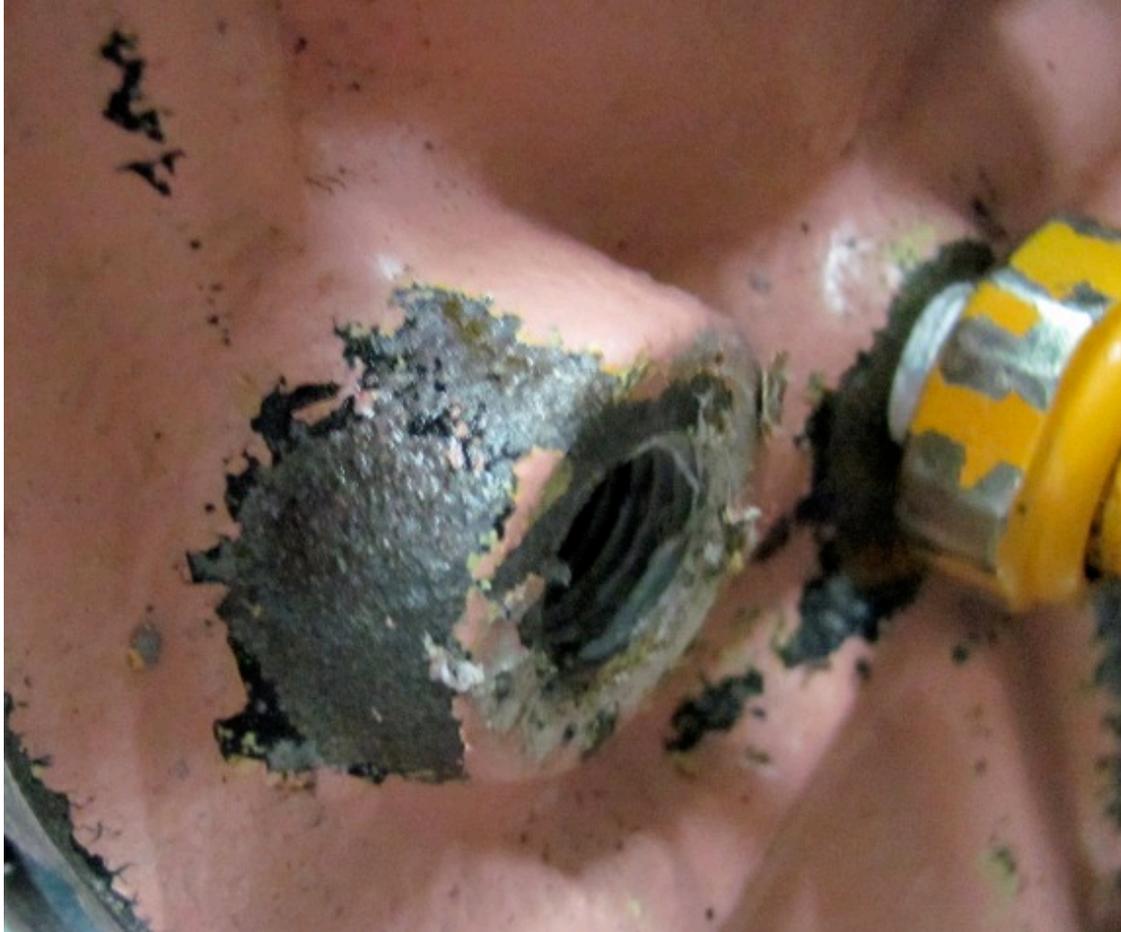
While working on the block, I noticed a hairline crack where the coolant drain plug enters the block. Oh boy! Will it leak? I tried to apply Loctite to the crack, but I doubt that this will help. My research on the web indicates that crack repairs in cast iron are problematic. Need to check with Carson and DL.

I talked to Carson about the cracked block. He said it will leak. Fortunately, the extent of the crack is limited to a small boss extending out from the block. You can barely see the crack at the top of the boss in the pic below.

Hence, I put the block on the mill and removed most of the boss (until the crack disappeared) and then re-tapped the hole. Plenty of metal left for threads, so it should work fine.
