S9

This is a commentary on the hanging of the ninth plank on the starboard side S9, which is the first of the outer double planks on the starboard side.

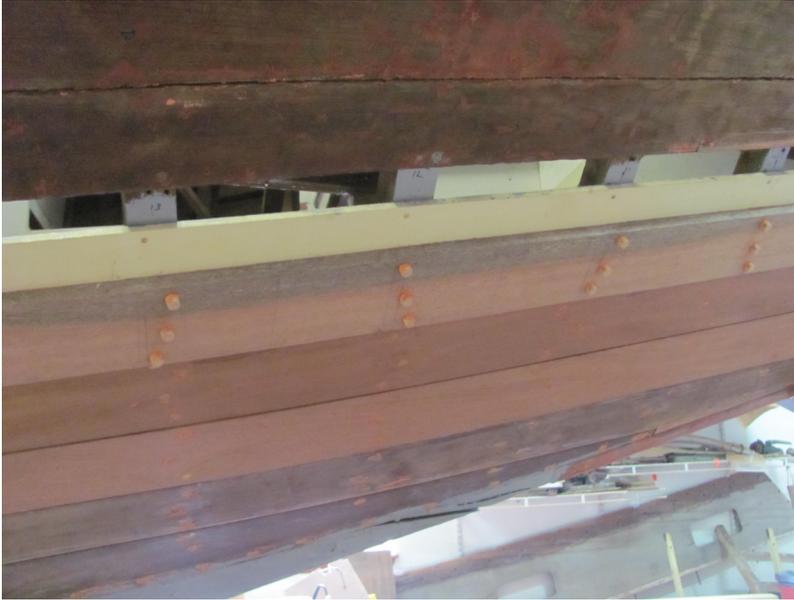
- Spiled for top and bottom edges of S9
- Removed the spiling batten, selected an offcut of Wana from plank P9, and reverse spiled for the S9 section from the hood end forward to frame 23. Draw a rough cut line ½" outside the spiling points and cut out the plank. This offcut was just barely wide enough near the middle. And now I see the consequences of getting the last bit out of my stock – the plank has a significant chunk of sap wood. Ideally I should probably make a new plank, but the rate this project is going I can't afford it. The sap wood is the greenish part in the pic below.

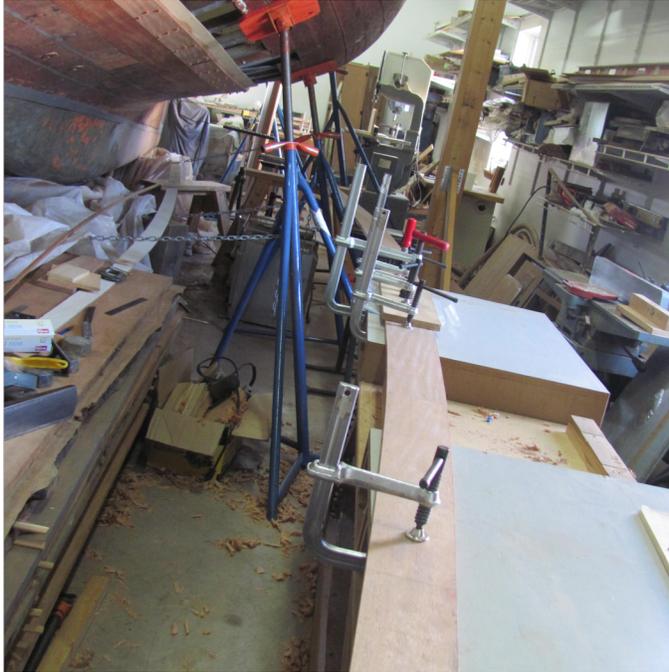
Scarf joint being glued up on the bench.

- After cutting the sections to length for a 6" scarf joint, I glued up the joint with resorcinol.

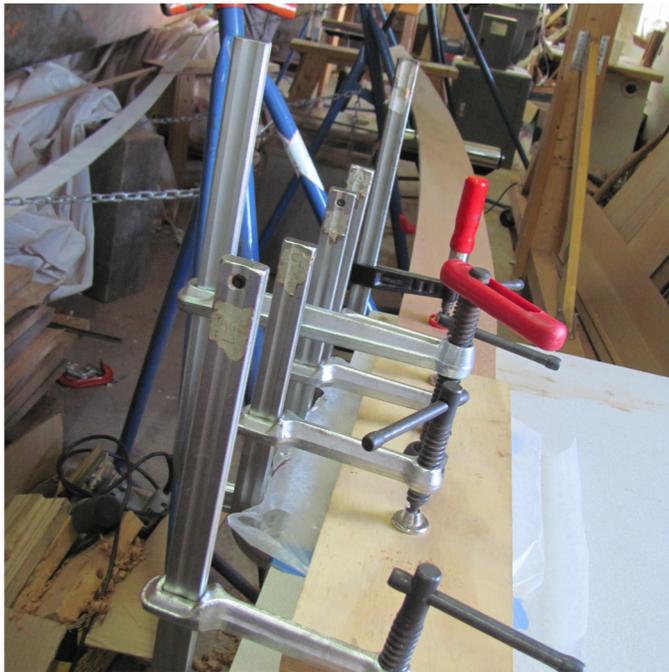
Close up shows blue tape used for reference marks. The tape in the foreground marks the center of the scarf. The saw horse in the distance provides another reference. The other reference mark is at the near end of the bench (not visible in the pics above).

With a 3+ frame overlap, it's easy to align the sections (one on top of the other) so that the bottom edges match for (almost) the full length of the overlap. The problem is that when you cut the planks for the scarfs, you lose all that overlap. When that happens, achieving proper alignment is difficult. Consequently, before cutting the sections to length, I aligned the sections on the bench (one on top of the other) and made reference marks on the bench, several feet from the scarf. With these additional reference marks, I could easily align the two sections even after cutting to length.

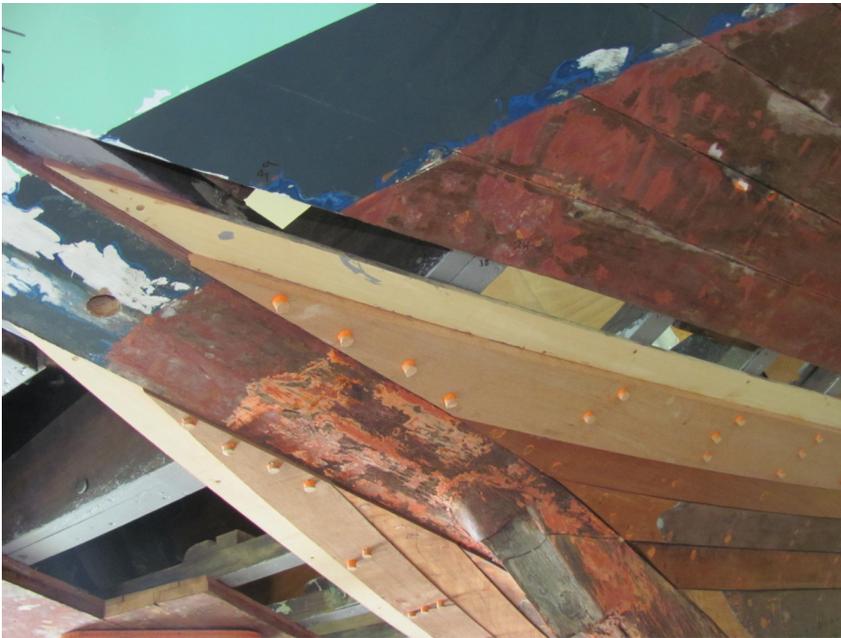
Hood end aft.

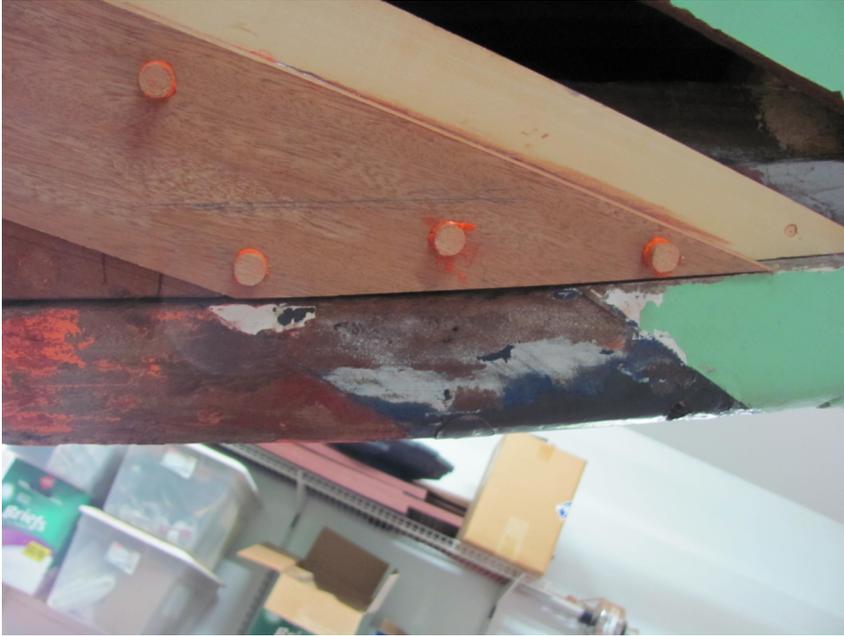
Hood end forward.

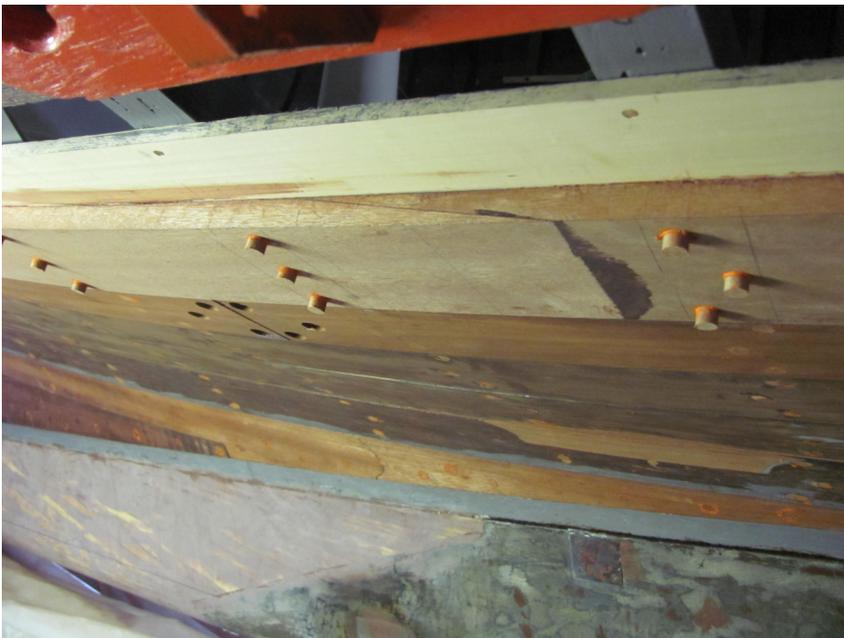
Scarf joint.

- After cleaning up the glue squeeze out, I found that the joint was near perfect. The top edge, of course, needed work.
- Using a fairing batten, I redefined the top edge so that the transition from one section to the other was as smooth as possible. The new curve, which differs from the original by 2 ft on either side of the scarf, is somewhat flatter than the original, but otherwise is fair.
