Centerboard Removal (3/29/2011)

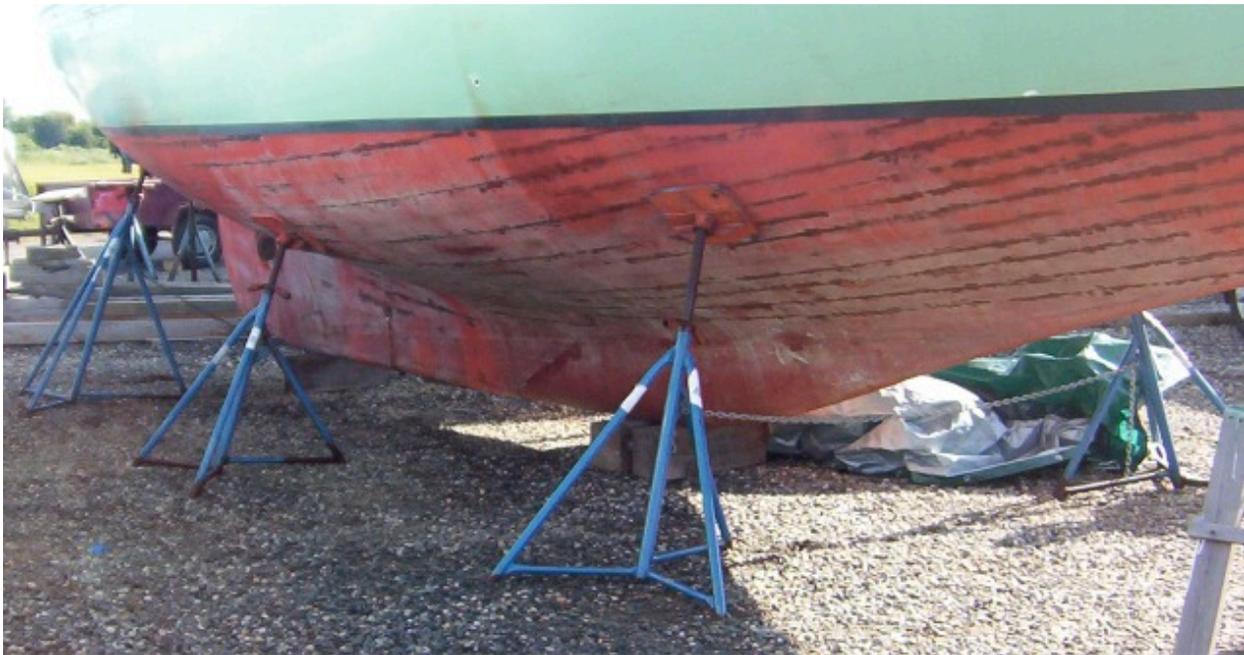
I've determined that proper inspection and repair of the keel and deadwood requires that I remove the centerboard. This turns out to be a substantial undertaking. First, I must raise the boat high enough so that the board can be removed from below. On delivery, the boat was set on blocks 16" off the floor. Since the board is 28" deep, I will need an additional 16" of blocking. Next, I must remove the pin acting as the centerboard pivot. Then, finally, lower the board to the floor where a cradle will be waiting to hold it (the board weighs about 500 lbs). Raising a 9 ton boat without a proper hoist is a scary proposition. A boat with a lead ballast keel, such as this one, has much of its weight concentrated in the lead keel. So wood timbers are used to support the weight and a series of screw jacks called poppets are used to balance the boat.

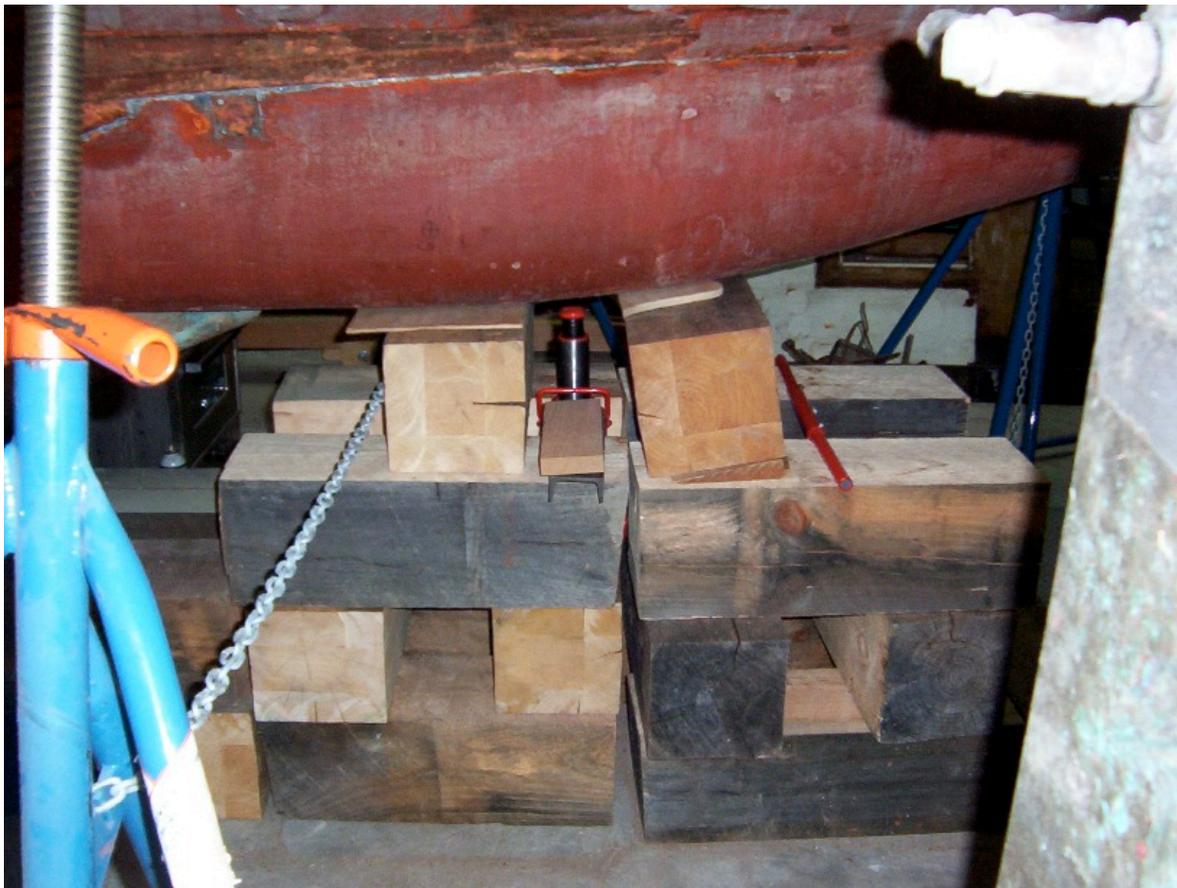
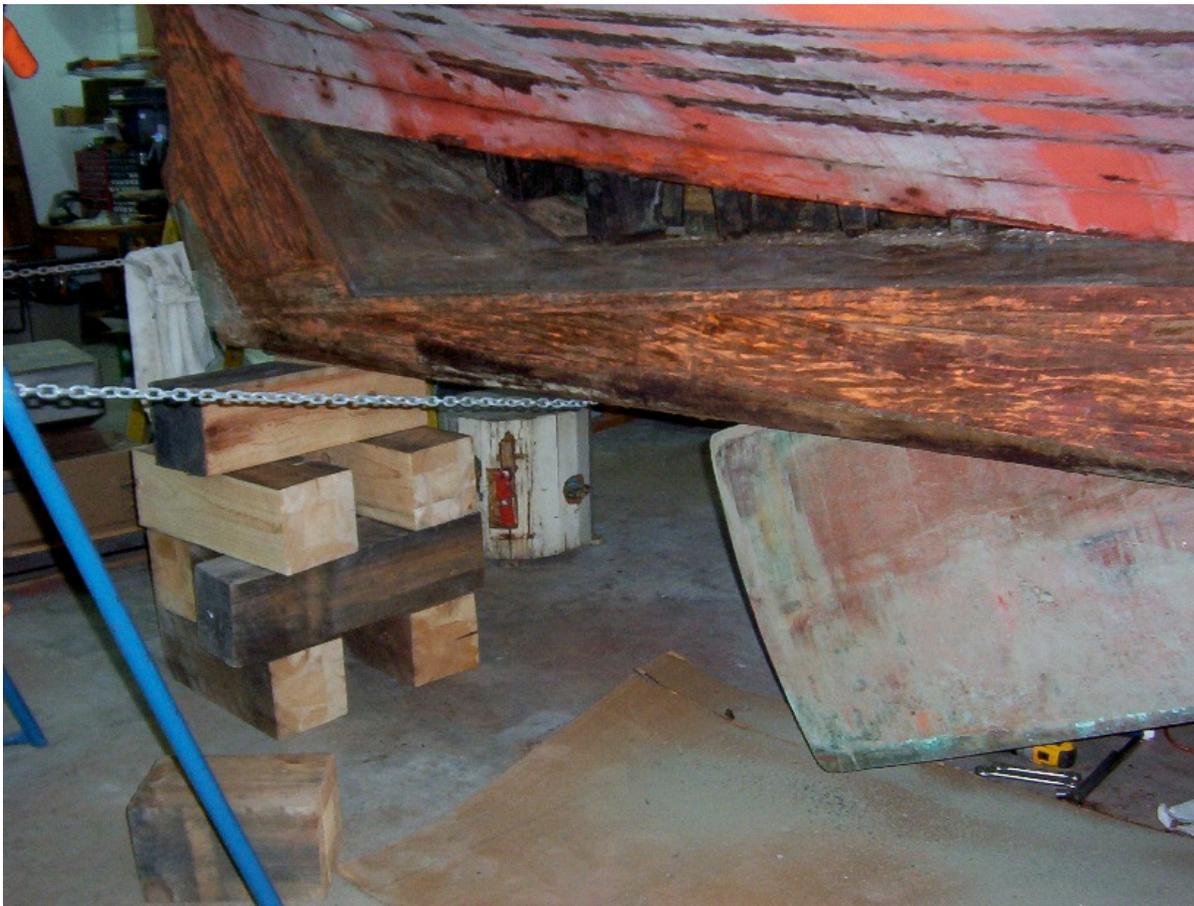
- After completing the lift, I was faced with a dilemma - all this blocking was in the way of the centerboard slot. So I had to reposition the blocking, which took some finagling. The final arrangement is shown below with the centerboard partially lowered.

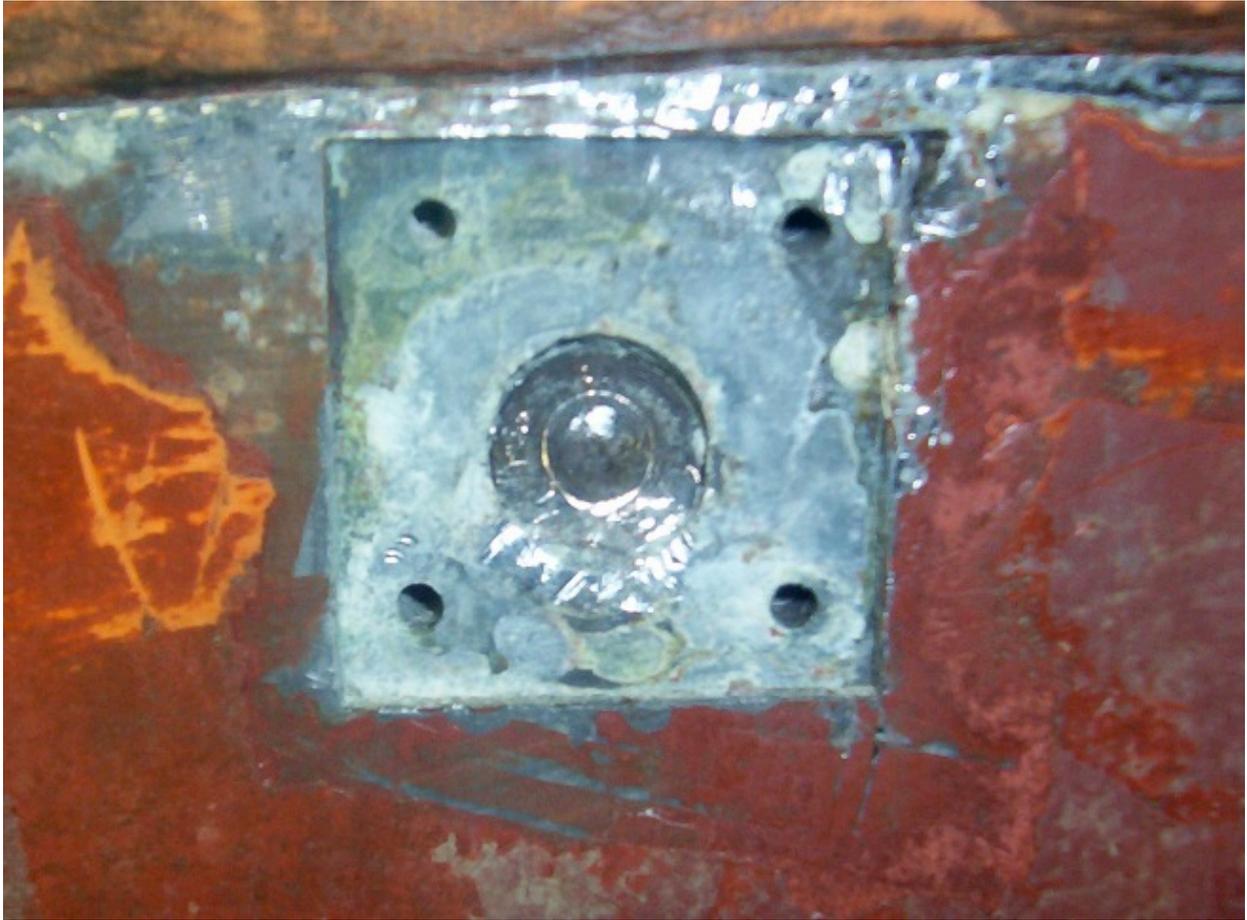
The starboard end of the pin is dimpled in the center where presumably it was hammered in place, so the plan is to pull from that end. Here is a picture of it.

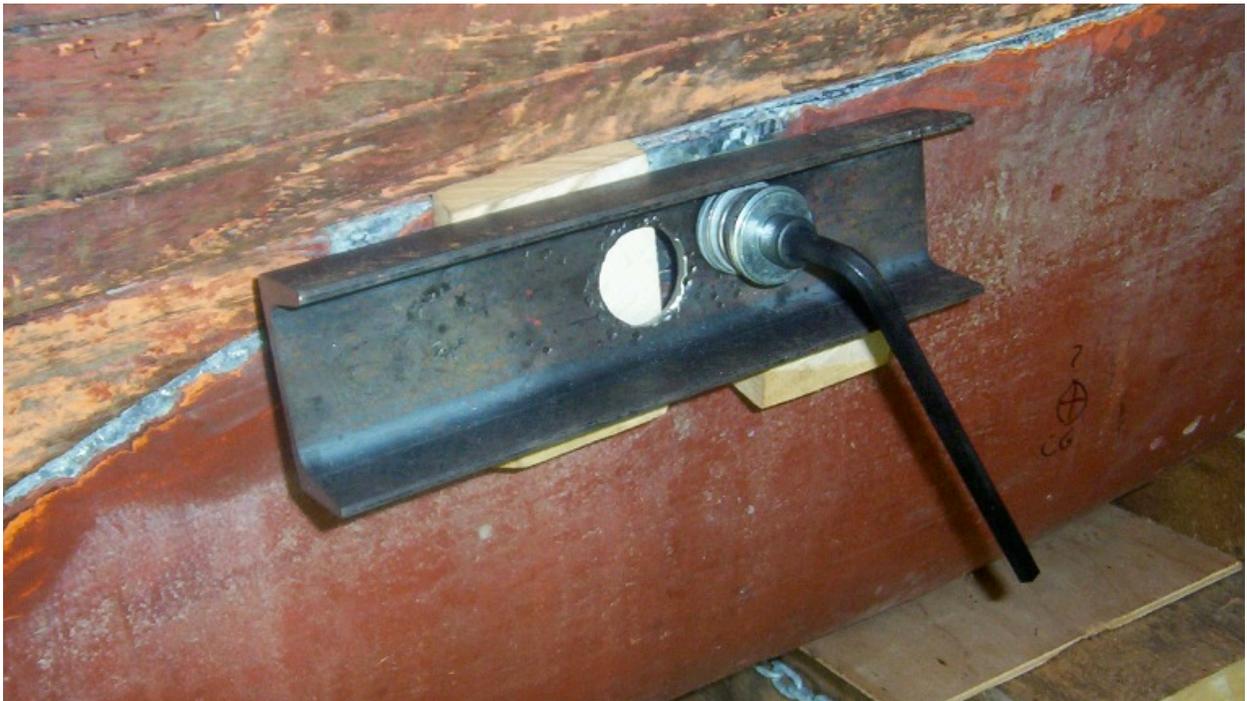
I marked the center of the pin and used a center drill to start a hole. I followed this with a 1/4" hole 2" deep to act as a pilot hole for a 1/2" - 20 tap drill. Of course, the goal is to drill these holes down the centerline of the pin. Good luck with that! The only reference that I had was the end of the pin on the other side of the boat. I did my best to transfer this location to the starboard side, but it was very rough. After tapping the hole, I installed the my make-shift puller.

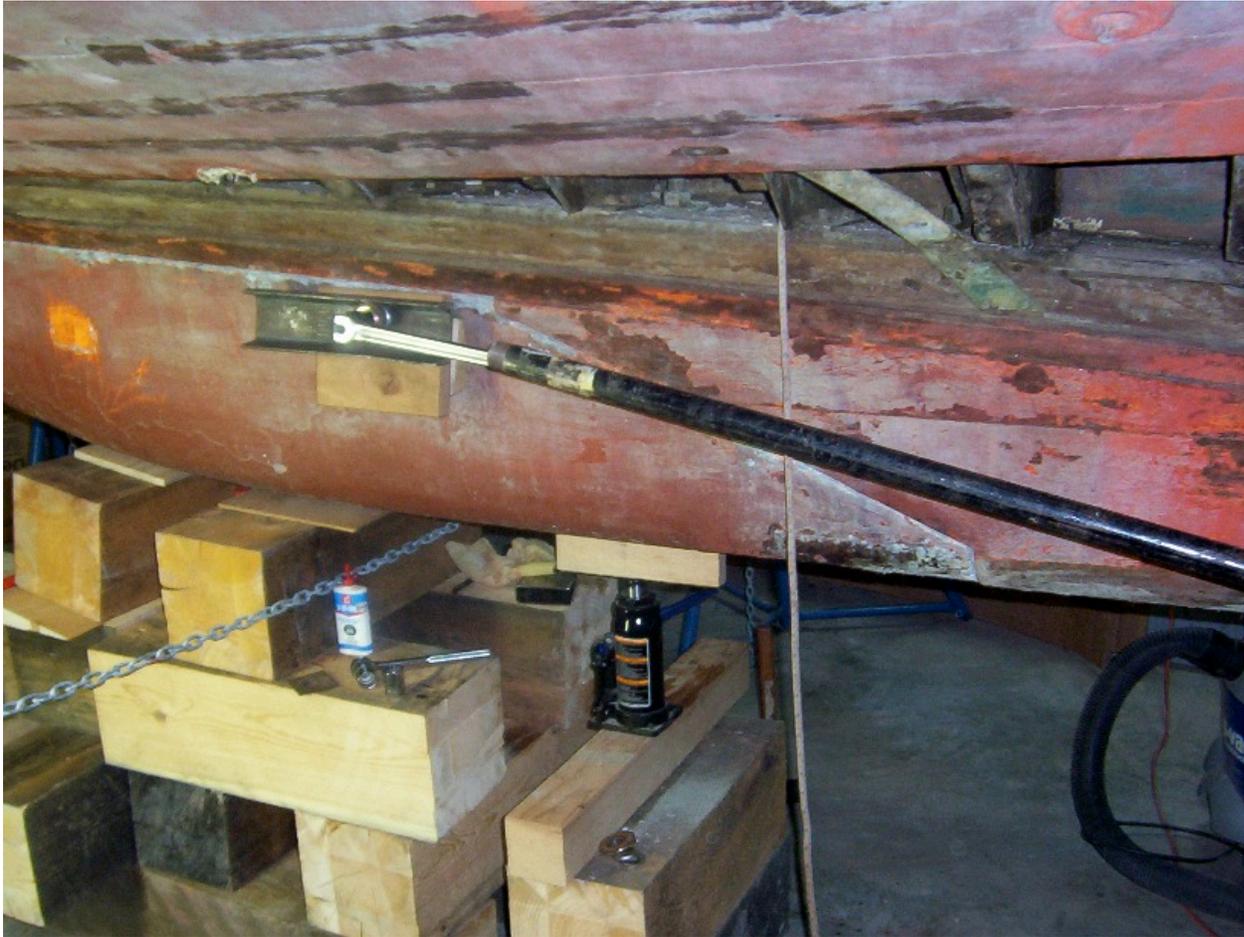
I estimate that it took about 20-30 ft-lbs of torque to move the pin. I was surprised/elated. I expected much more. Well, my elation was short lived. What I removed was just a 2" long plug covering the end of the real pin! Well, maybe this isn't so bad after all? Maybe both ends have a plug the the actual pin is a slip fit. So I moved to the other side, drilled, tapped, and started pulling.

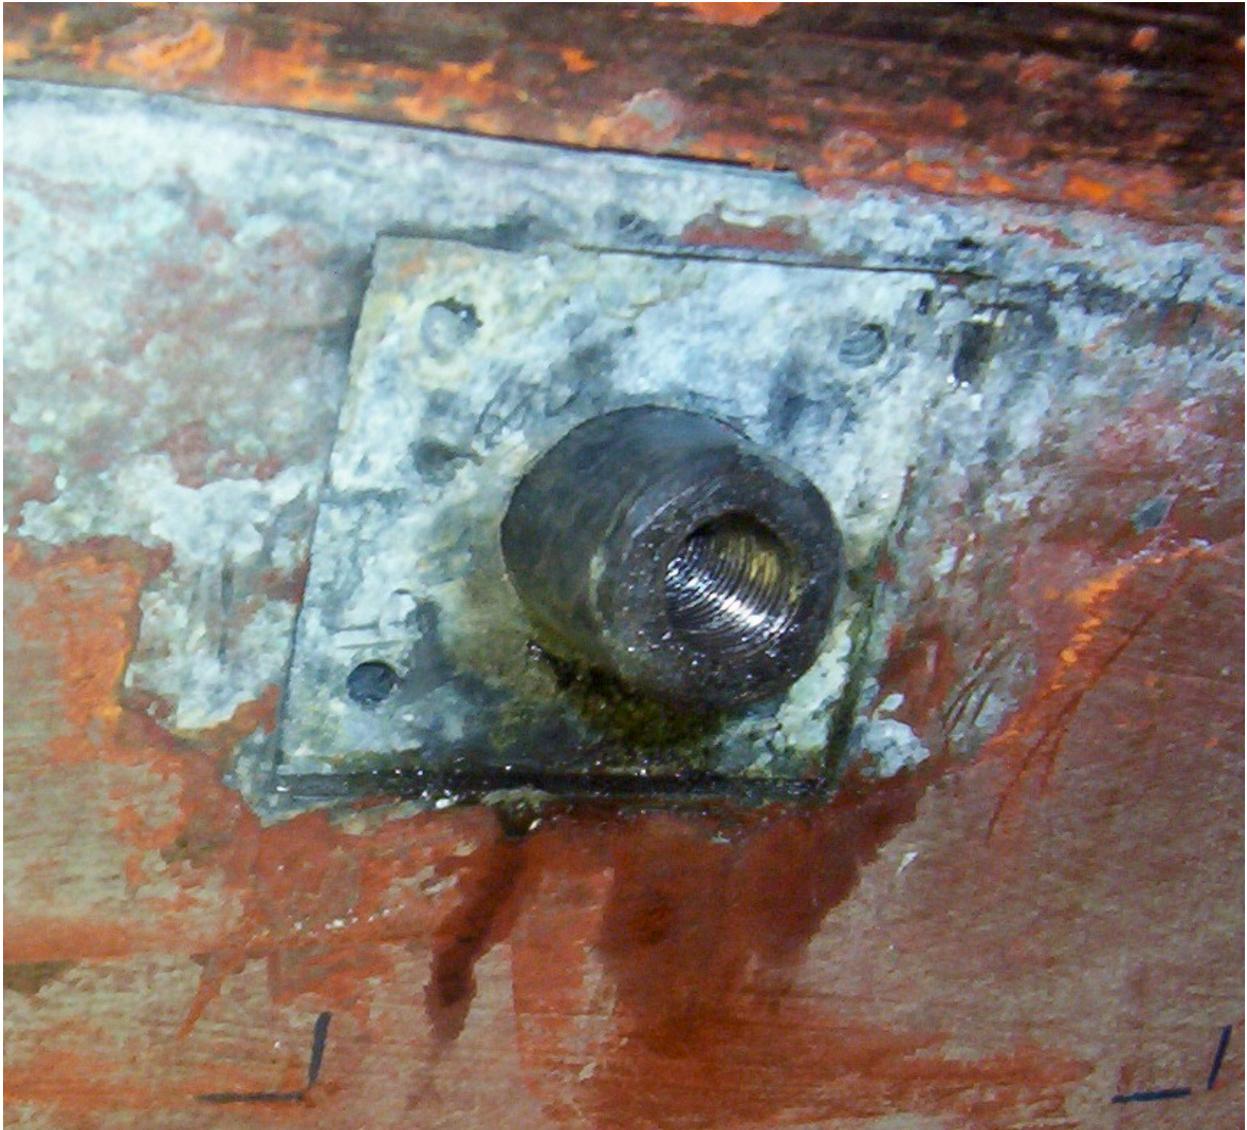
Unfortunately, 30 ft-lbs did nothing! Now I'm wondering how much torque that this system will take before I either strip the threads or shear the pin. I'm using a grade 8 9/16" bolt, so the bolt itself is not likely to be the first thing to fail. I've tapped deep enough so that almost 1.5" of threads are engage, so I don't think the treads will strip. After some rough calculations, I estimate that I can apply almost 300 ft-lbs of torque. So I put a 3 ft pipe on a 1/2" drive breaker bar and lean into it. At about 200-250 ft-lbs (estimated) and pin starts to move! After a couple of evenings, I've moved it about 1". It's going to be a long process.

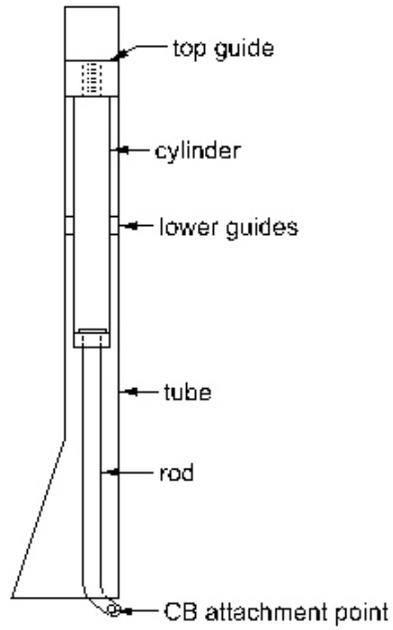
With the centerboard pivot pin removed, removing the centerboard involves lowering the board below the bottom of the keel and detaching the lifting mechanism (or vice versa). To clarify the problem, it's helpful to understand how the centerboard lifting mechanism works. Refer to the drawing below.

The lifting mechanism is housed in a bronze tube that is bolted to the top of the centerboard trunk (not shown). Inside this tube is a hollow bronze cylinder that moves up and down inside the tube. A top guide and a set of lower guides keep the cylinder centered in the tube. The top guide is treaded to accept a long threaded rod and provides the lifting force. Attached to the bottom of the cylinder is a solid bronze rod that connects to the centerboard with a pin at the attachment point. This rod is not rigidly attached to the cylinder. Rather, the rod is inserted into a hole in the bottom of the cylinder. The end of the rod is equipped with a large washer that prevents the rod from exiting the cylinder. In case of a grounding, the centerboard is free to move upward, the rod moving up inside the cylinder, without damaging the lifting mechanism.

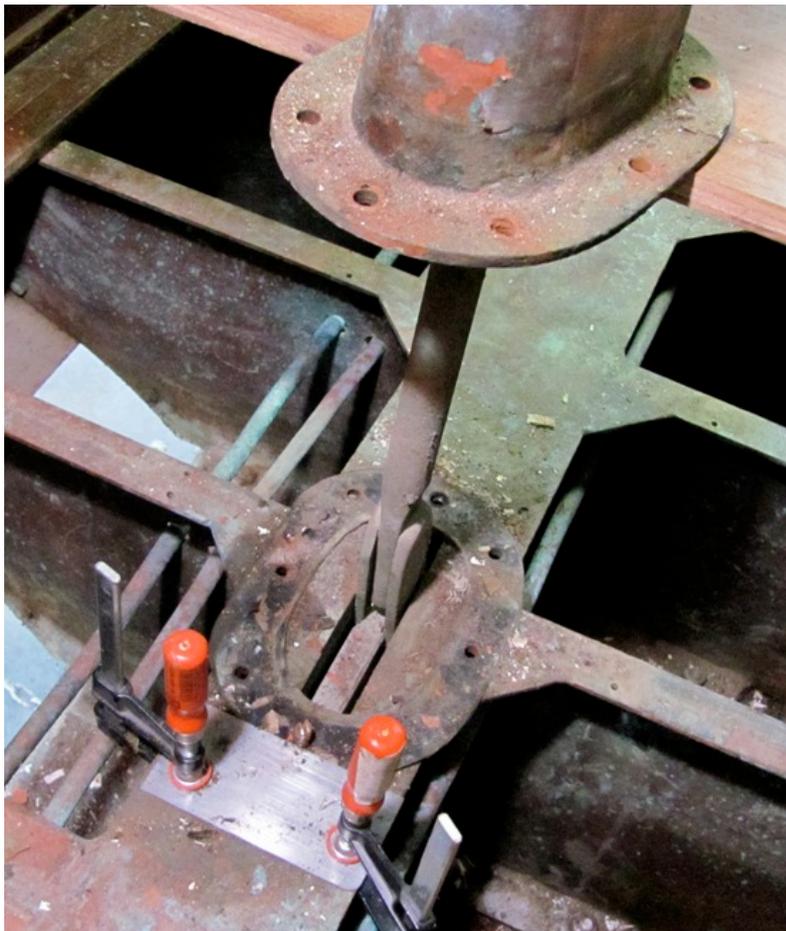
A picture of the bottom of the tube and the top of the centerboard trunk is shown below. As you can see from this pic, the solid rod of the lifting mechanism is attached to the top edge of the

centerboard, but access to this attachment point is inaccessible due to the presence of the centerboard trunk.

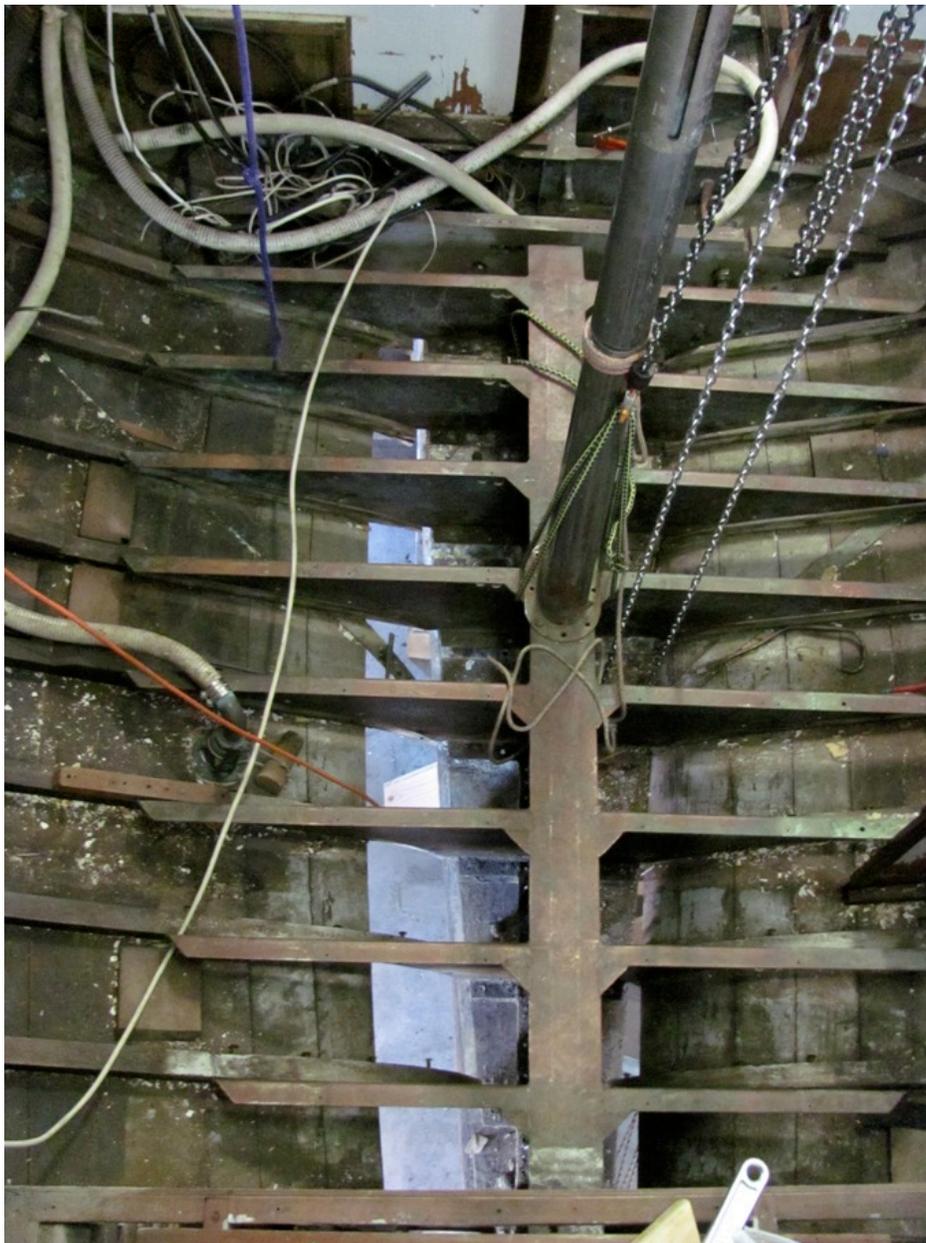
Next, I tried lowering the board below the keel using the existing lifting mechanism. Unfortunately, this exceeded the normal travel of the lifting mechanism. Once I reached the lower limit, the board would not move any further. At the time, I thought that the rod was binding in the centerboard slot. Ultimately, I think it was the board itself that was binding, due to the considerable amount of dirt accumulated in the trunk over the years.

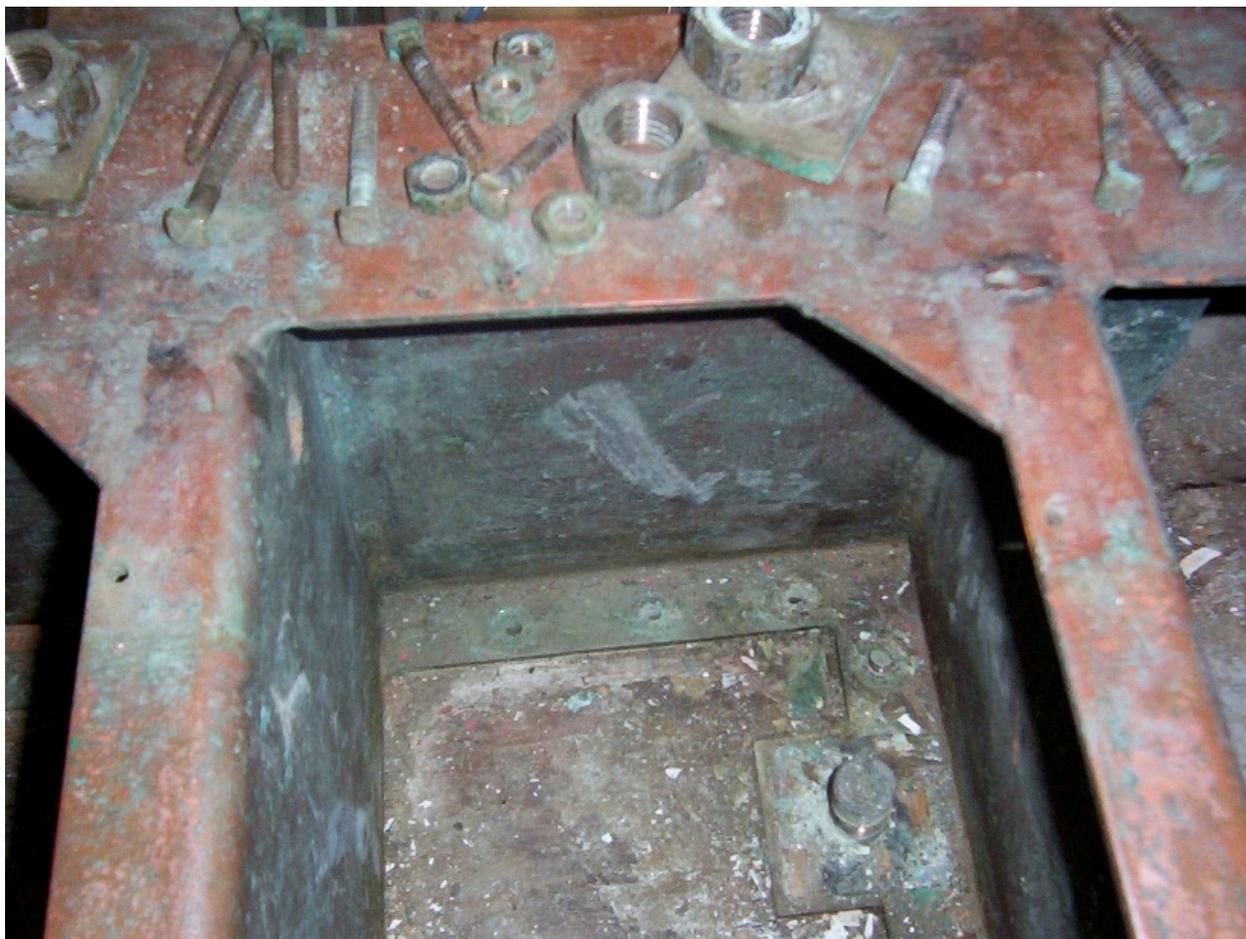
Once the carriage bolts were free, it was time to remove the fasteners holding the trunk to the keel. Below is a example of a typical bay between two floors. Three lag bolts fasten the trunk to the keel and two threaded rods come up through the keel at the base of the floor. In addition, some bays have a ballast keel bolt (with washer and nut) that clamps to the floor.

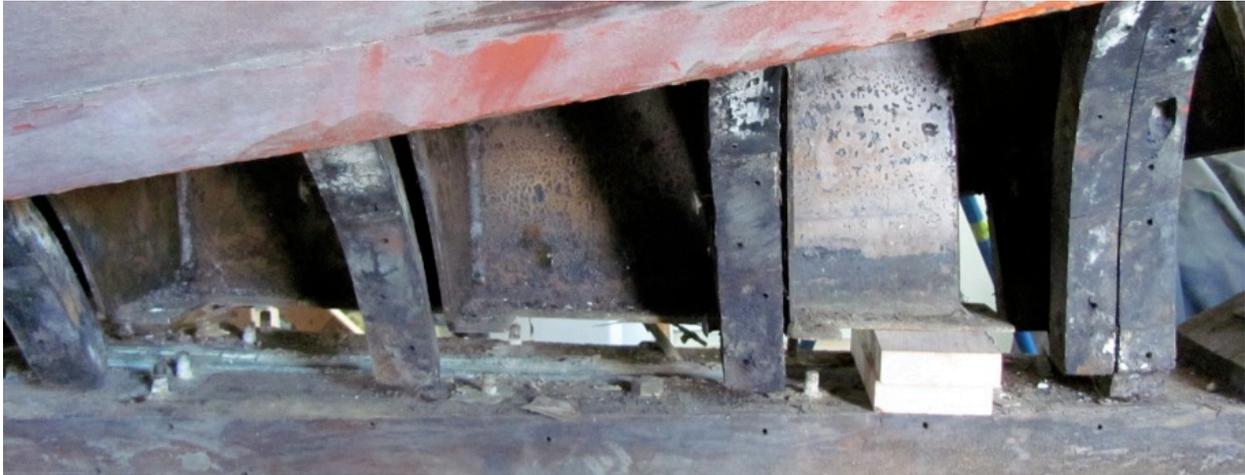
Even with all the bolts removed, I was not able to lift the trunk with a chain hoist; however, after some work with a putty knife and careful prying at one end, I was able to break it loose. It appears that thin canvas in white lead paste was used as a sealer. After that, the chain hoist did the rest. I raised the trunk just enough to access the centerboard-lift attachment point and put some wood blocks under it.

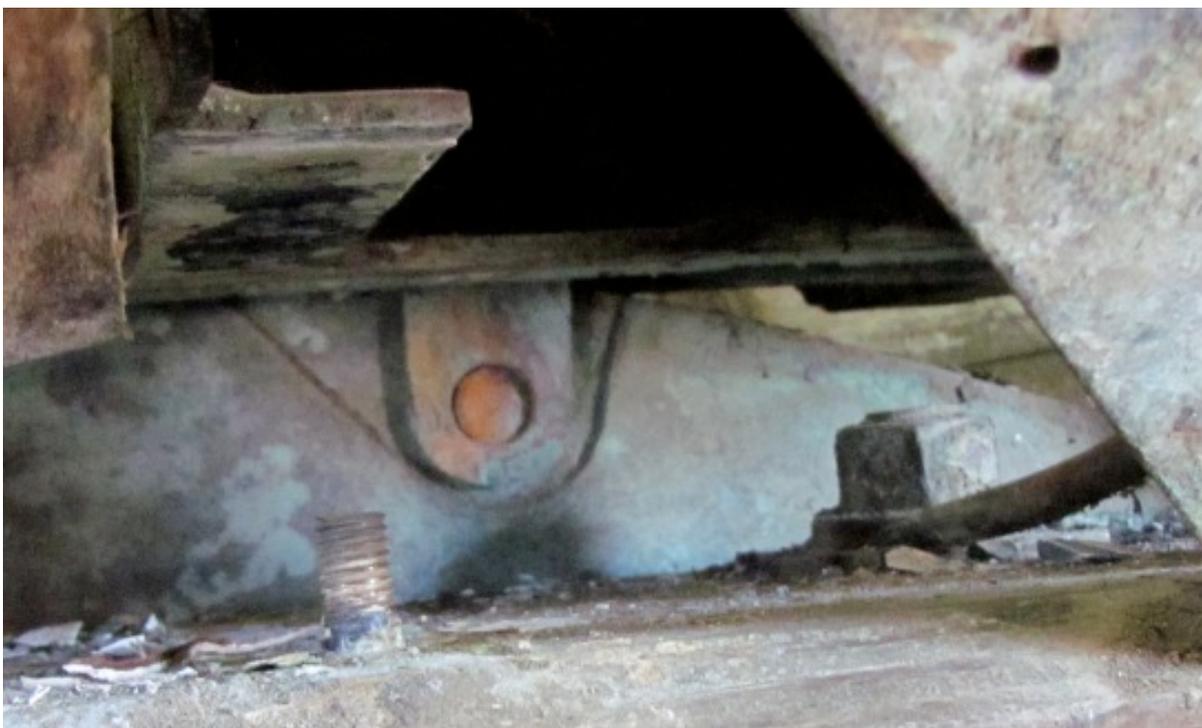
This pic shows the attachment point. The pin you see is just a slip fit kept in place by the sides of the centerboard trunk. I was able to push it out with a long drift. Of course the centerboard was supported below with blocking before I removed the pin! Afterwards, I used a bottle jack and a series of different height blocking to slowly lower the board. One would think that the board, weighing about 500 pounds, would slide down easily, but it actually took some prying downward (pry bar between the centerboard and the bottom of the trunk) to get the board to move. Once the pivot hole was exposed below, I was able to insert a shaft and pry downwards on it to finally free the board from the trunk.

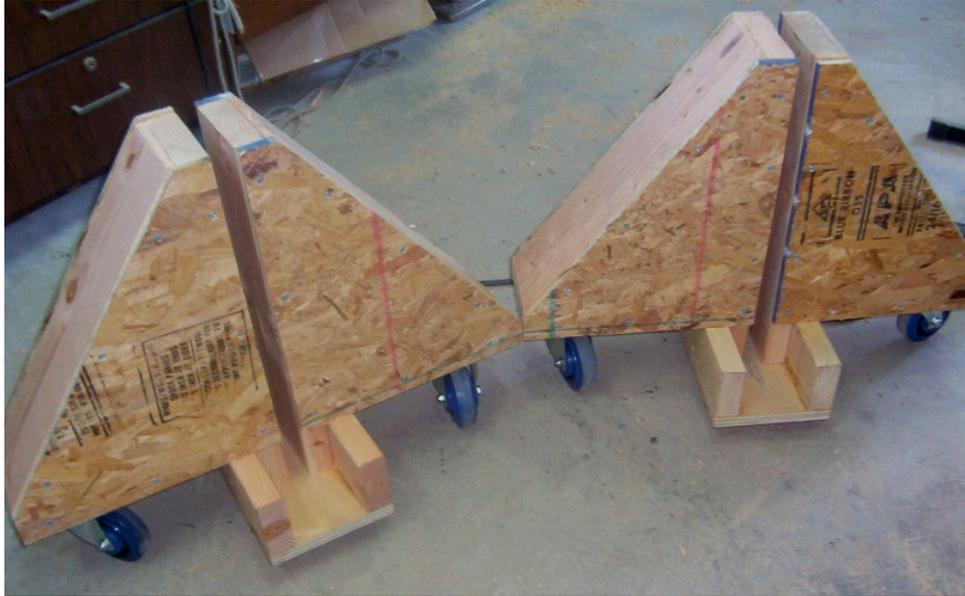
I built a pair of dollies to hold the centerboard.

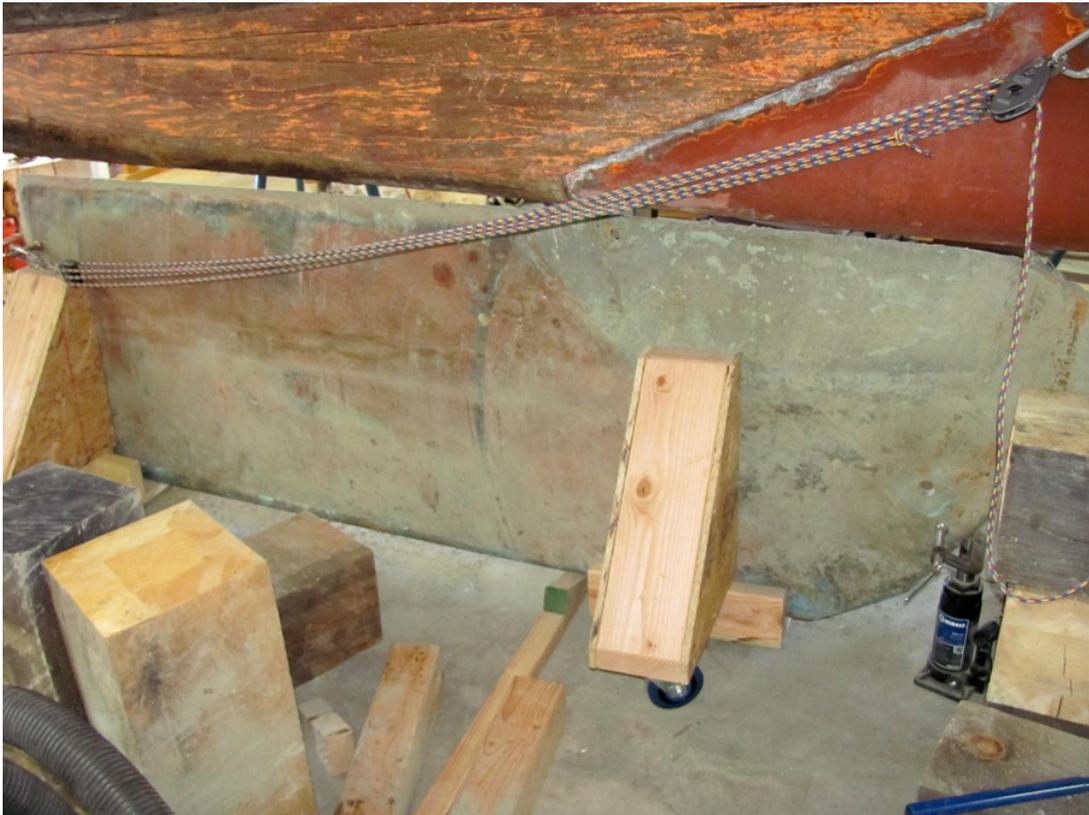
This pic shows the dollies at work. Note also the block and tackle arrangement. This was to keep the centerboard from sliding aft out of control while lowering the board. Also note the bottle jack/C-clamp arrangement at the front of the board, which allowed me to lower the board close to the ground.

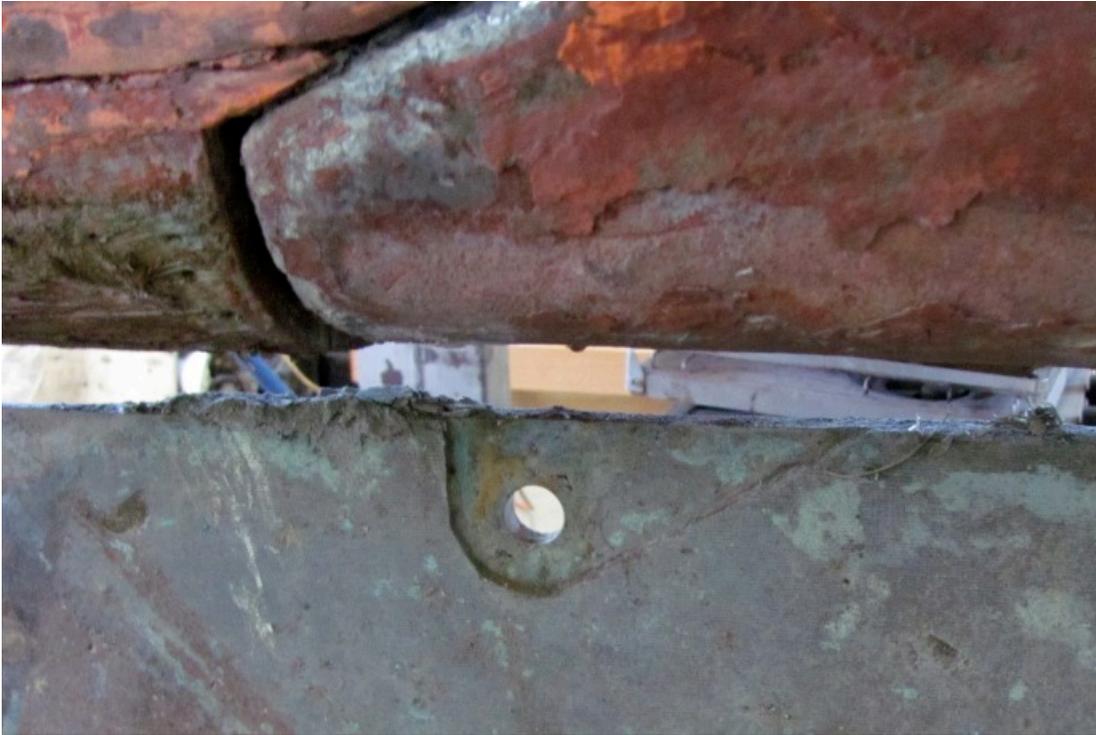
This pic shows the attachment point with the rod/pin removed.

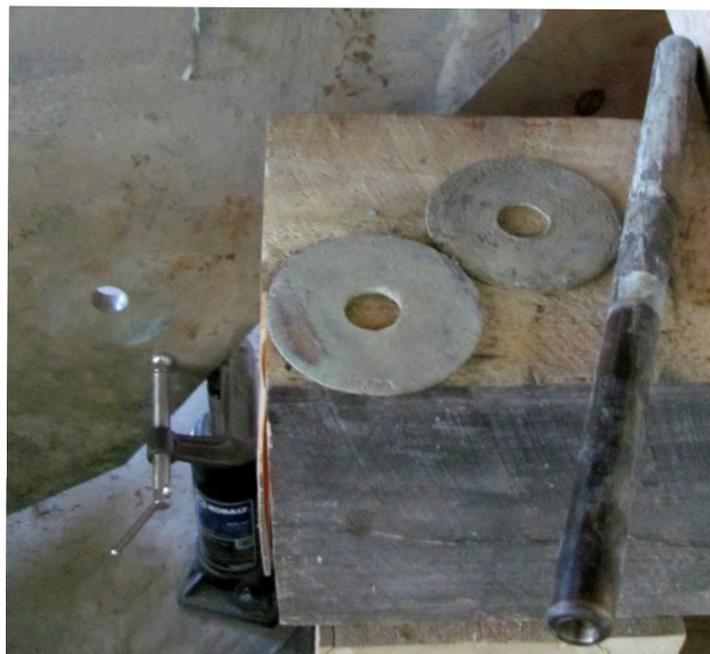
To prevent raising/lowering the centerboard from wearing away the ballast keel, two large bronze washers were inserted at the pivot point. The following pic shows these washers and the pivot pin.

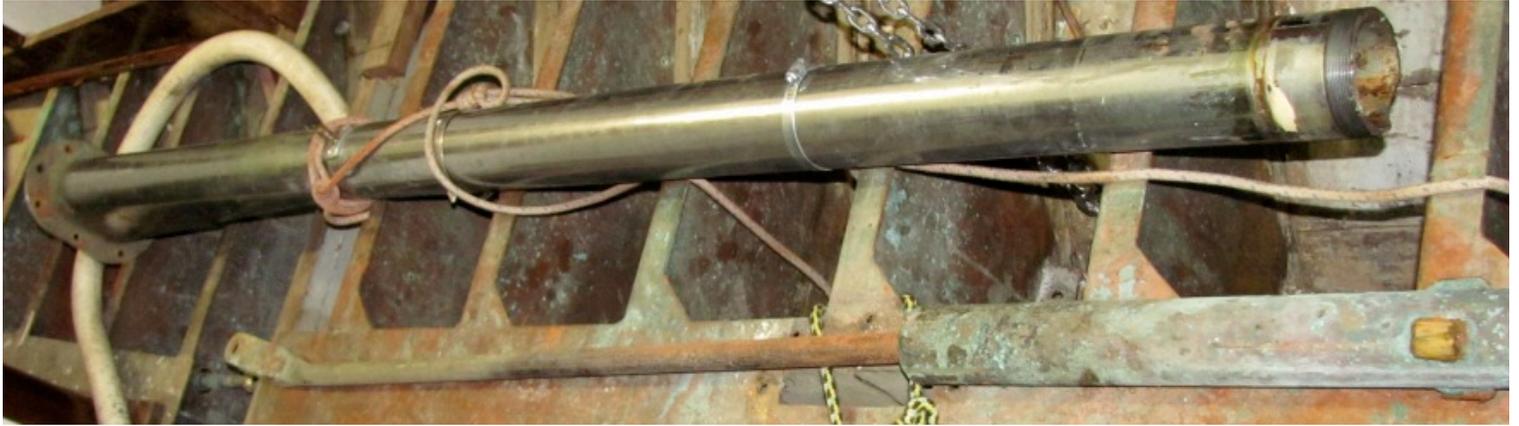
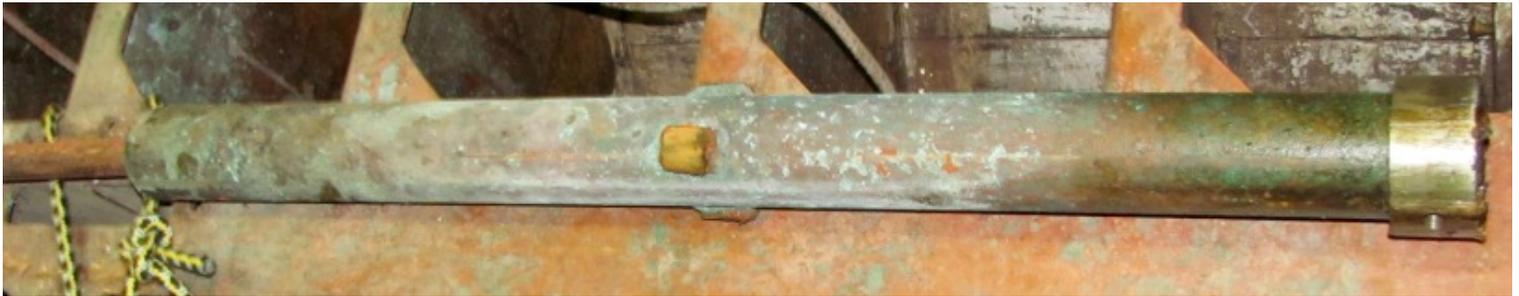
With the board removed, I could detach the lift mechanism from the centerboard trunk and remove the cylinder from the tube through the top of the tube.

Subsequently, I had the tube stripped of the chrome plating and then I applied filler and painted the tube with white enamel.
