Deadwood (4/19/2011)

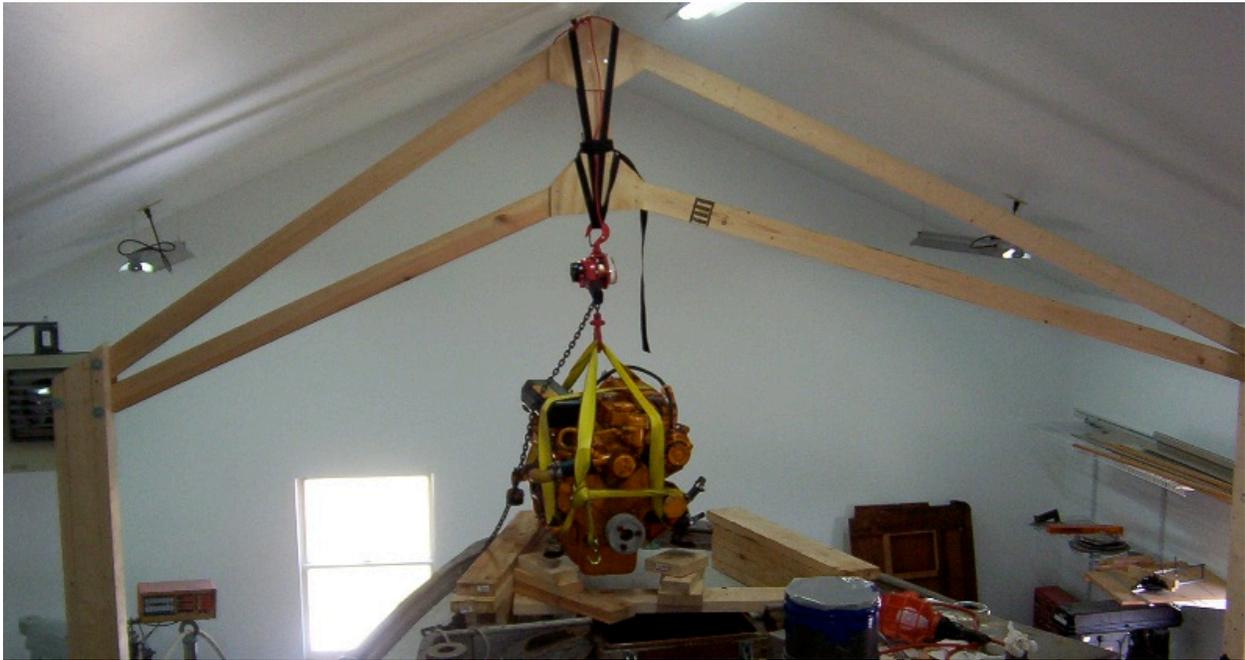
Using the gantry crane that I built to remove the engine, I removed the centerboard trunk to give me access to the top of the keel. This will allow me to remove/inspect the ballast keel bolts and ultimately replace the deadwood.

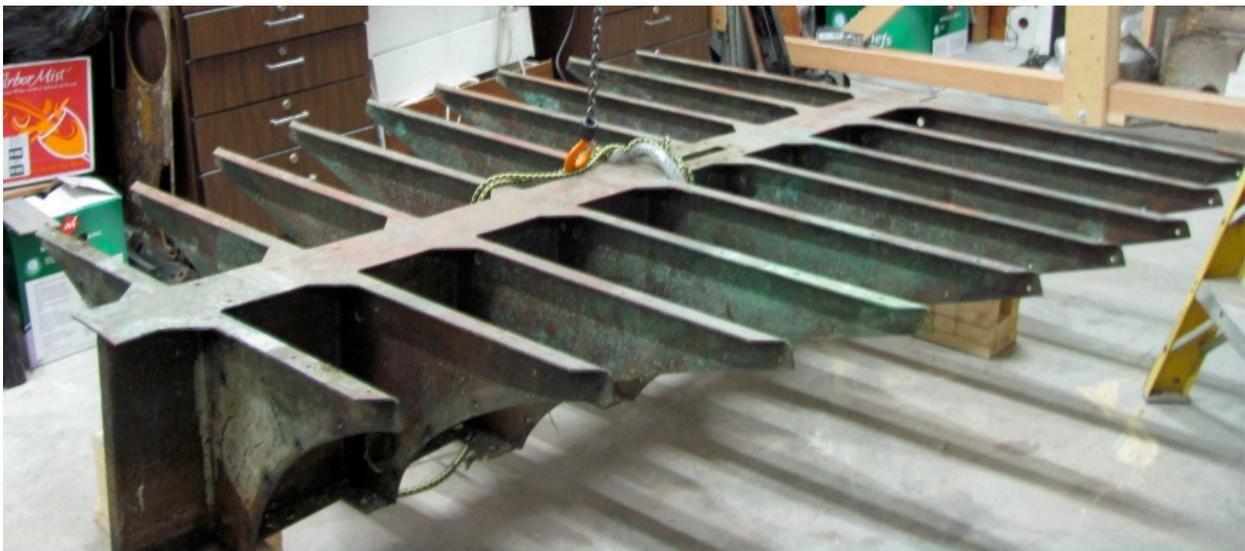
The centerboard trunk is now safely resting in the shop floor.

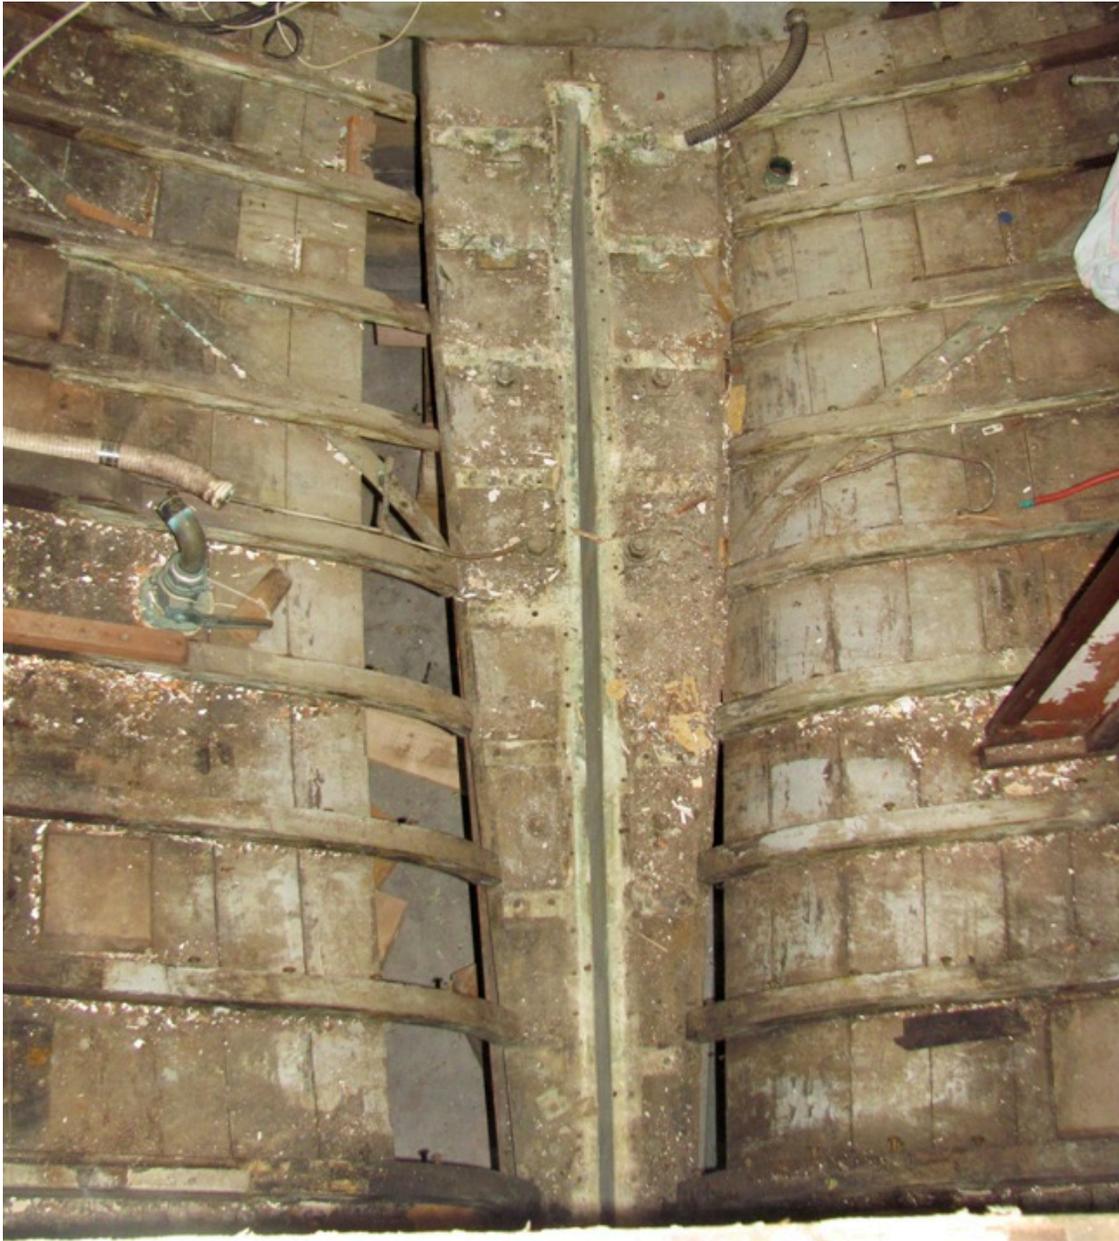
The pic below shows the top of the keel plank in the area of the centerboard well.

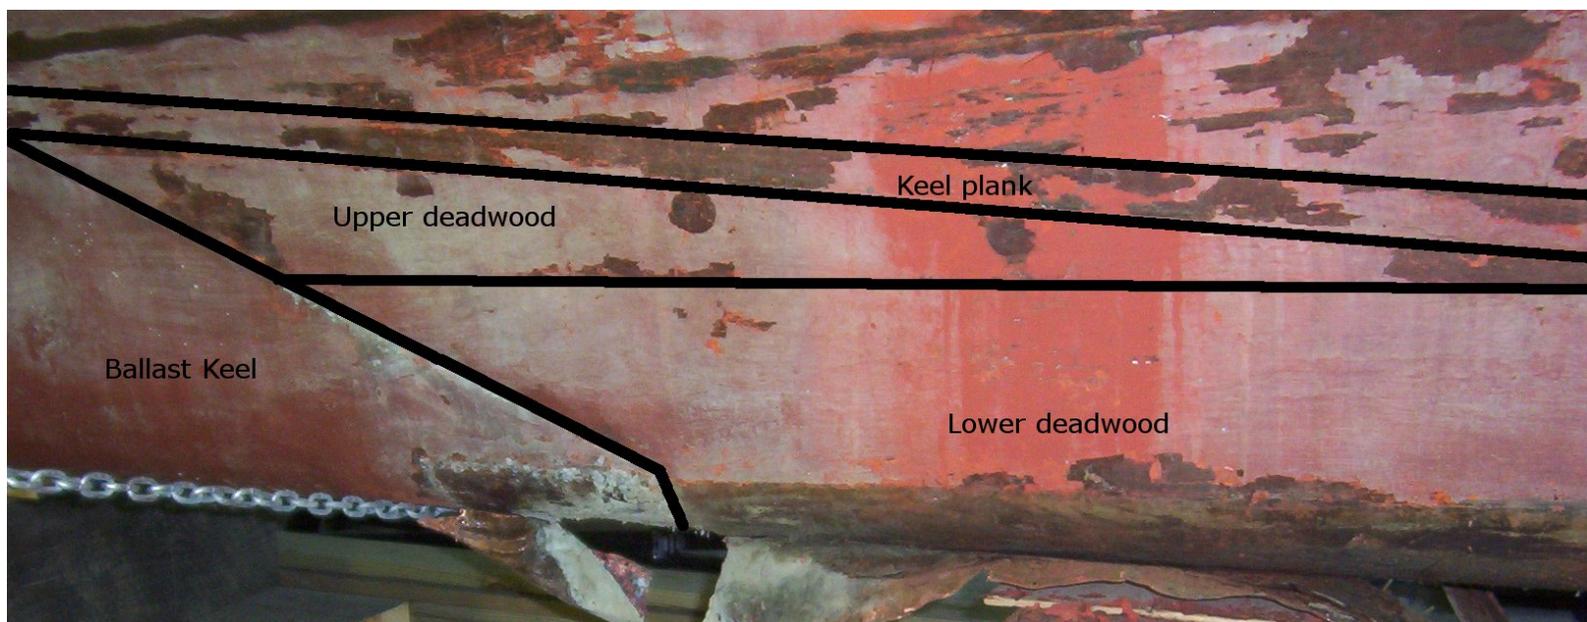
The goal is to remove the deadwood so that it can be repaired/replaced and to inspect the keel plank. The deadwood consists of 4 pieces of Amendoim - two on each side of the boat's centerline, with a longitudinal parting line, presumably to facilitate cutting the centerboard slot and limit the size of timbers. The two pieces on each side are symmetrical and consist of a large lower section and a smaller upper triangular piece (see the pic below).

As you can see to the left in the picture, the two deadwood components are wedged between the ballast keel below and the keel plank above.

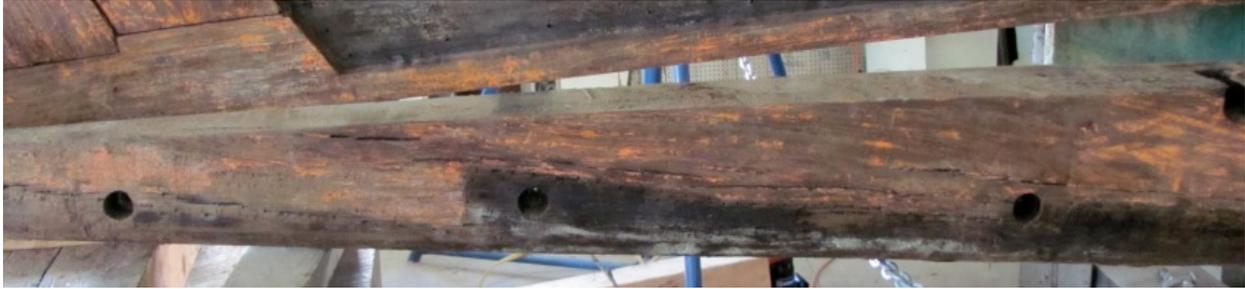
The deadwood is fastened vertically to the keel plank with long bolts at regular intervals (approx. 18"). The two lower sections are also bolted together laterally to hold the two deadwood halves together. Due to the presence of the centerboard, however, the number of lateral fasteners is limited and consists of three carriage bolts plus two wood screws at the very aft end of the lower section. The access holes for the three carriage bolts can be seen in the pic below (you are looking at the lower deadwood section, which has been removed from the starboard side).

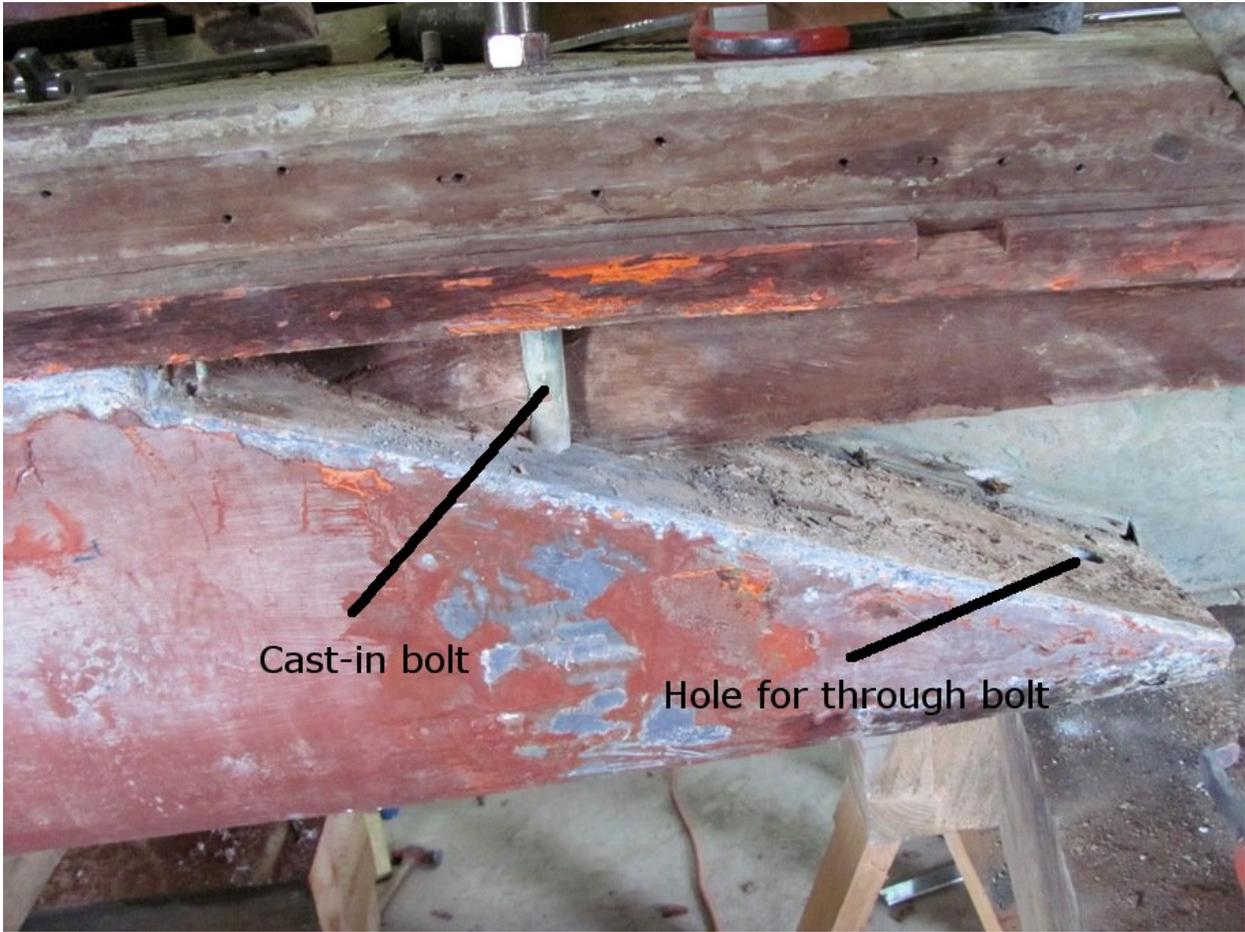
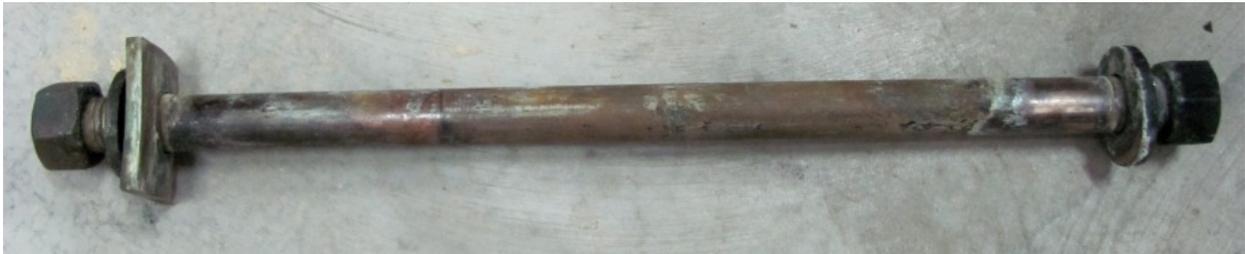
In addition to these fasteners, the four aft-most ballast keel bolts penetrate the deadwood. Only the two aft-most keel bolts penetrate the lower section, but all four pass through the upper section. Refer to the pic below. This pic shows the port side with the lower deadwood section removed and the upper section split to reveal one of the keel bolts. The aft most keel bolt has been removed, but the hole in the ballast keel is visible. The missing bolt is shown below.

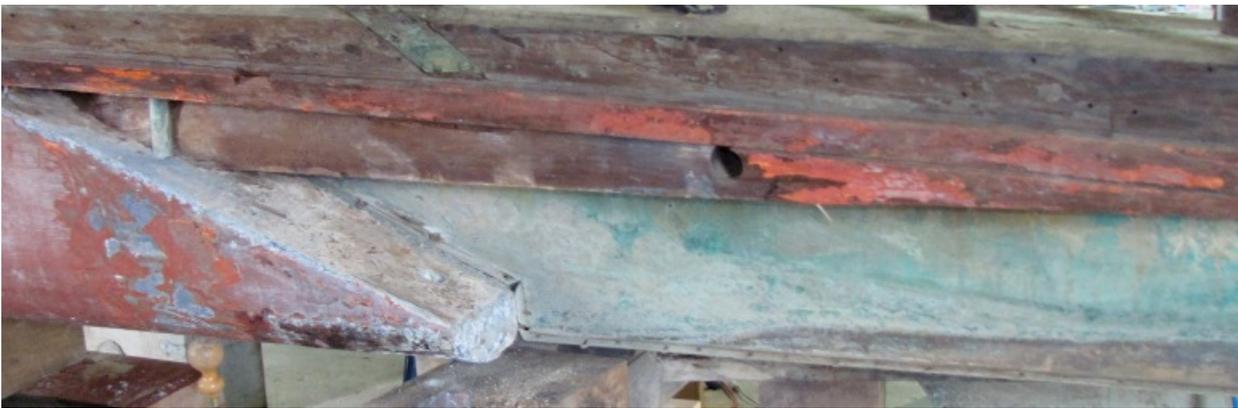
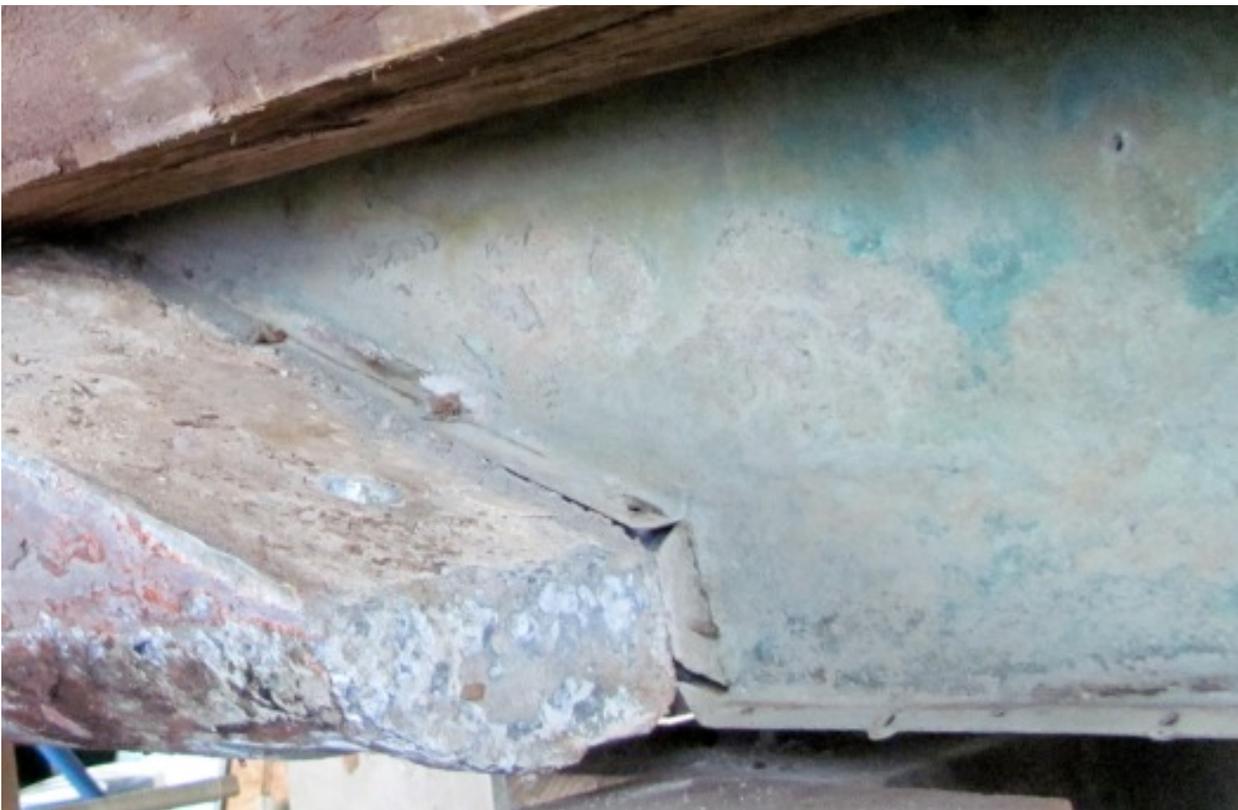
This was not the only problem. Observe in the figure below that the centerboard trunk has a liner - a rectangular tube made of copper - to protect the centerboard well from marine borers. This liner is fastened to the deadwood via a flange at the top of the keel plank and another at the bottom of the deadwood. The liner and lower flange can be seen in the pics below.

Evidently, the upper flange was formed on the bench, the liner inserted into the keel/deadwood from above, and then the lower flange was formed in place. The result is that the deadwood cannot be removed as a unit without destroying the liners. So this means that I have to separate the port and starboard deadwood halves, removing them laterally. So I remove the three lateral carriage bolts (easily driven out with a drift), the two wood screws aft, and all the screws (that are visible) connecting the lower flange of the copper liner to the bottom of the deadwood. But there is yet another flange in the way of the ballast that isn't accessible or even visible with the deadwood present. So I can't remove these fasteners without removing the ballast. Of course I didn't know this at the time!

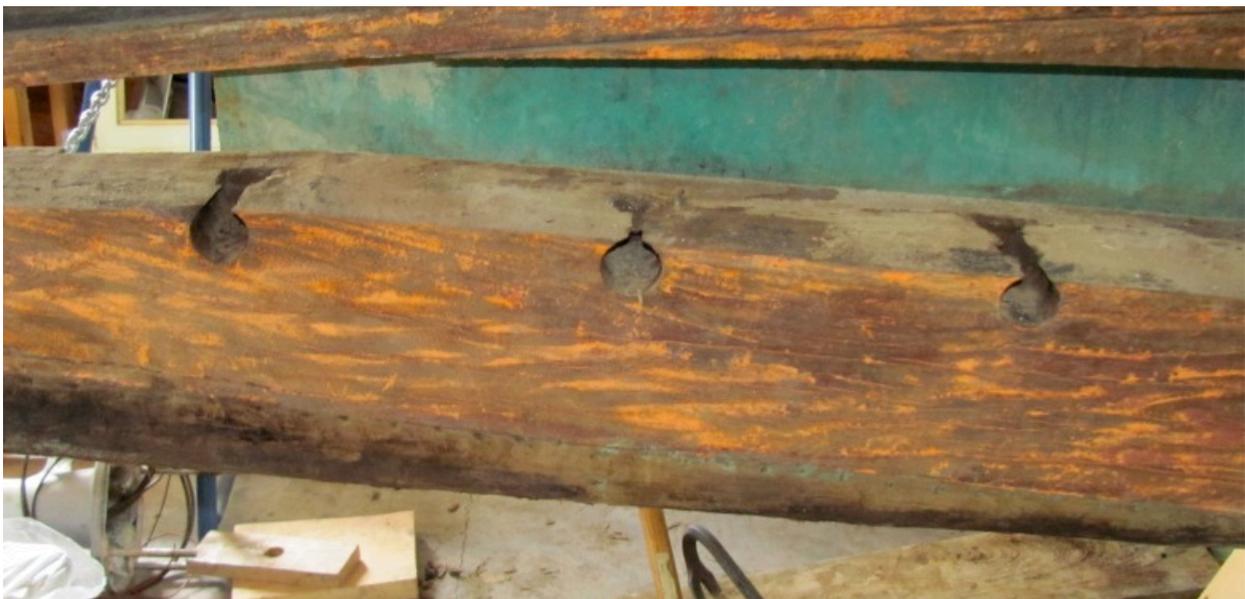
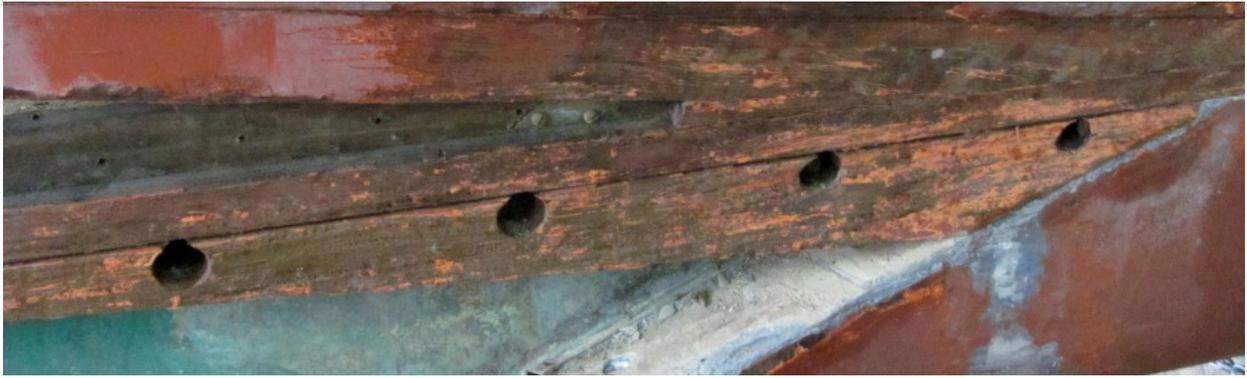
First I chopped out the bungs with a small chisel to gain access to the nuts. The access holes are shown in the pics below. The three in the first pic are in the lower deadwood section and four in the second pic are in the upper section.

A 7/8" box wrench fits the nuts, but in many cases I don't have enough clearance to turn the nuts (clearance holes are big enough to hold the nuts while tightening from above but not enough to remove the nuts). So I use a drift and hammer to spin the nuts a little at a time. Fortunately, corrosion has not seized the nuts to the studs. After removing both upper and lower nuts, I used an improvised puller to extract the studs.

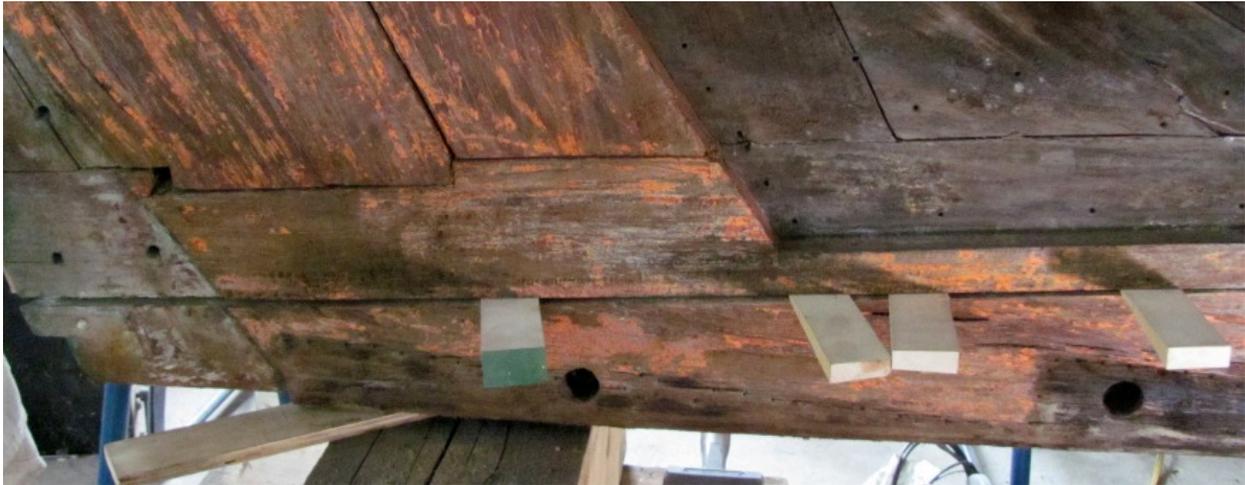
With the studs removed, I'm now faced with the problem of removing the fasteners that hold the deadwood to the keel plank. These are carriage bolts with heads recessed into the bottom of the deadwood. Unfortunately, they are so tight that no amount of hammering from above can drive them out - I don't even try, because even if I could, the flared head of the bolt (due to pounding) would enlarge the hole in the keel so that the new fasteners would probably leak! The only alternative is to wedge-open the seam between the deadwood and keel, enough to insert a saw blade, and cut the bolts.

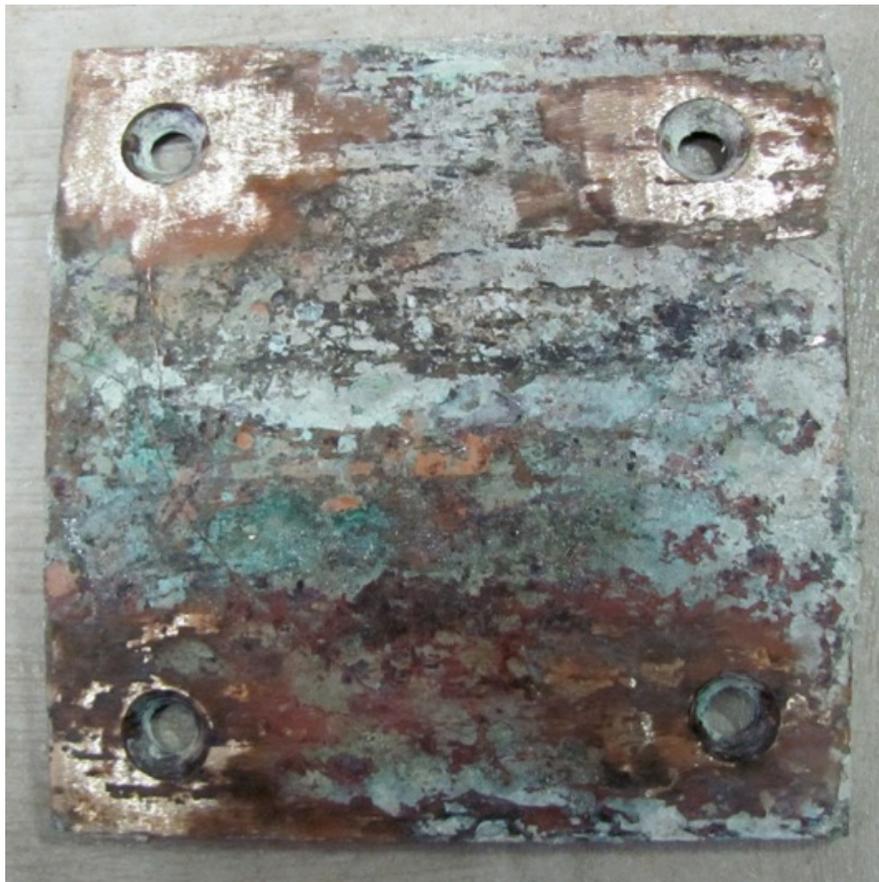
After all this, the deadwood is almost free. I just have to remove the four ballast keel bolts mentioned earlier. The aft two are through bolted. Removing a bronze cover plate below

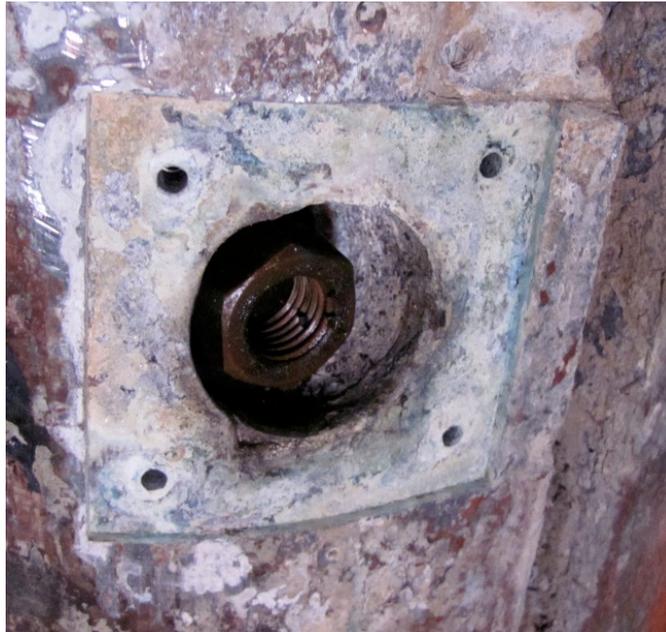
allows me to remove the nut.

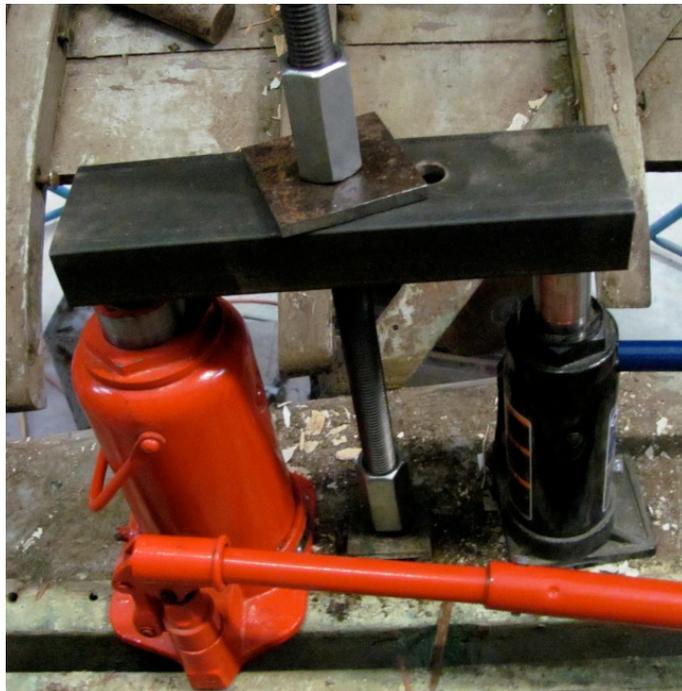
and another improvised puller (this one beefier, consisting of 6 ton and 20 ton jacks) is used to extract the bolt from above.

The first bolt came out without a whole lot of fuss, but the second one was very tight. I ended up bending the heavy angle shown in the pic above and had to use two heavy angles. I suspect that close to 10 tons was require to get it moving. In fact, I was so concerned about blowing the seals on the 6 ton jack, I replaced it with a solid 7/8" rod.

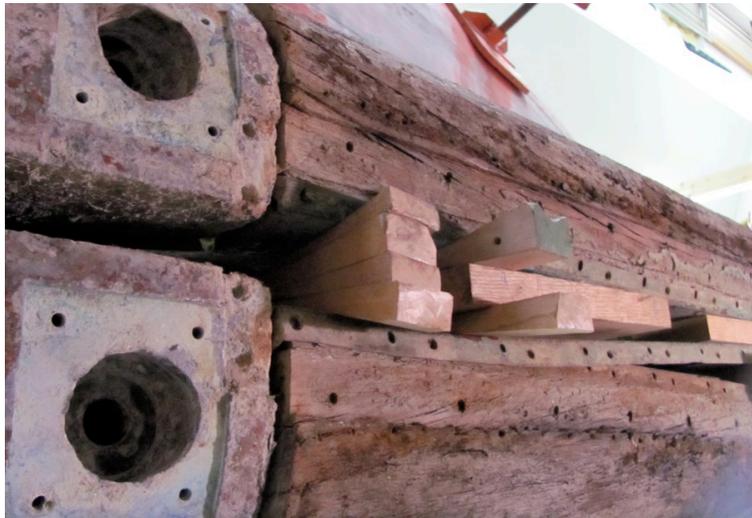
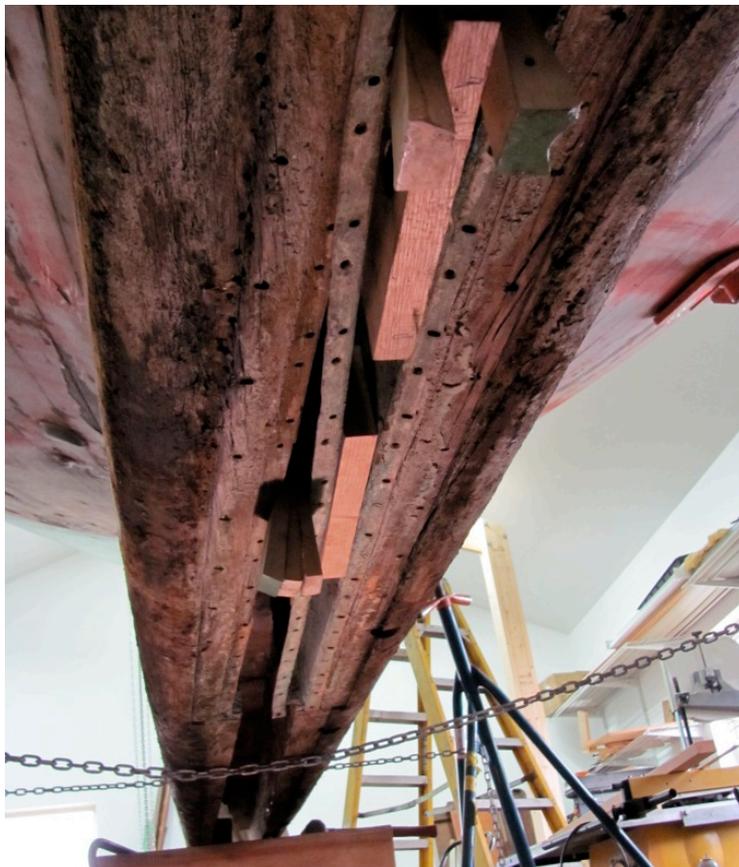
With the aft most ballast keel bolts removed, the lower deadwood should be free, but it doesn't seem to be! After much pulling and prying with wedges driven in from below

it finally comes free, and now I can see why it was so obstinate! The lower deadwood was in fact fastened to the upper deadwood with wood screws. Also the copper liner had a hidden flange (between the deadwood and ballast keel that is visible in the the pics above but not to me at the time) that was screwed to the lower (and upper) deadwood.

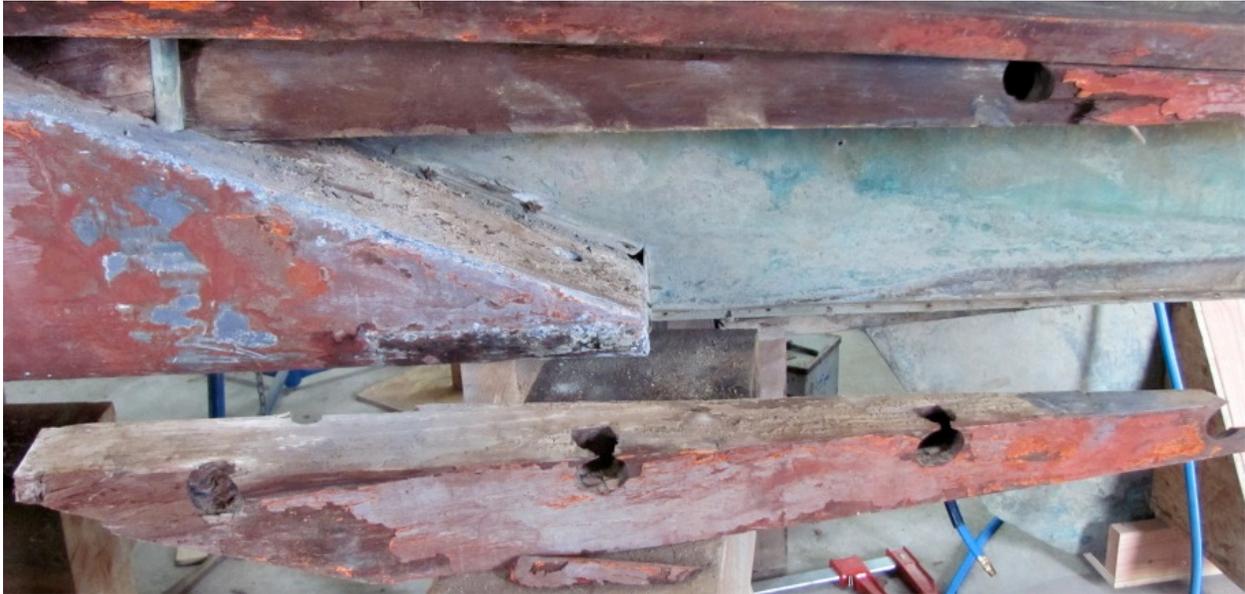
I now have the lower deadwood removed, but the problems are not over yet! To remove the upper deadwood requires that I remove two more ballast keel bolts. But these are not through bolted! They are either screwed into the ballast or were cast in place. If they are screwed into the ballast, I might be able to unscrew them using a double nut. This is no simple task. Simply tightening two nuts on the bolt doesn't provide enough resistance - my efforts just turn both nuts. So I need to Loctite the top nut in place. I'd also like to try an impact wrench but I can't fit a socket over two nuts - the flats don't line up. So I put the top nut in the lathe and remove the flats, Loctite the top nut in place and wait for the glue to set. The next day I have at it with an impact wrench - no luck. So I try a long pipe on a breaker bar - still no luck. I'm applying a considerable amount of torque here. I'm now wondering if this bolt is really treaded after all. If I get too aggressive, I might shear the bolt. Then where will I be? The only way I'm going to know for sure is to rip out the upper deadwood to inspect the bolt/lead interface. In some sense I'm lucky that the port upper deadwood is badly checked and will need to be replaced. The checks are so bad that a few well placed wedges are all that it takes to part the timber revealing the bolt - cast in place, darn!
