Engine (Rebuilding Begins) (2010)

6/18/2010

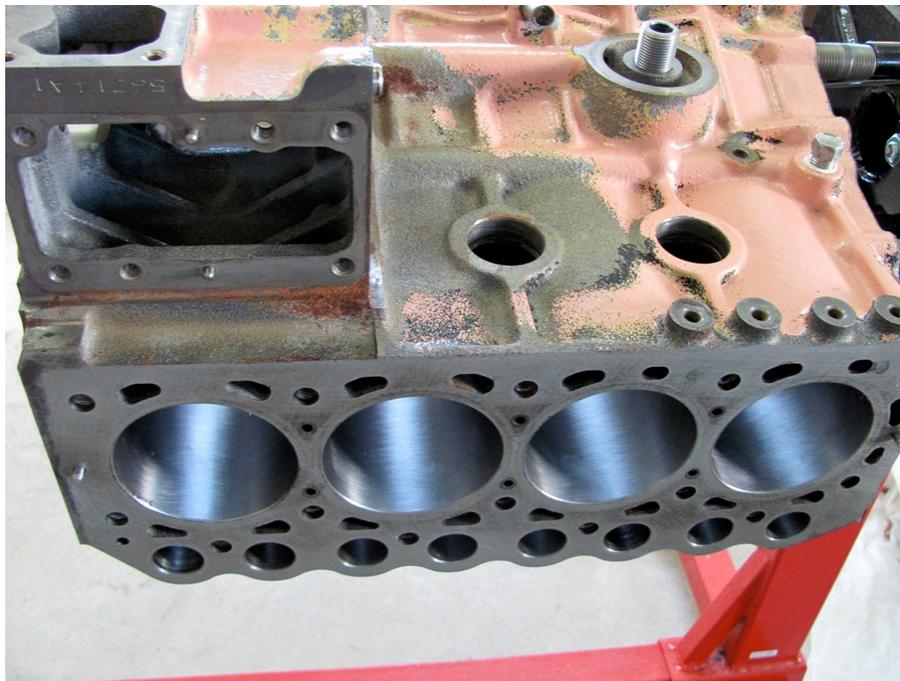
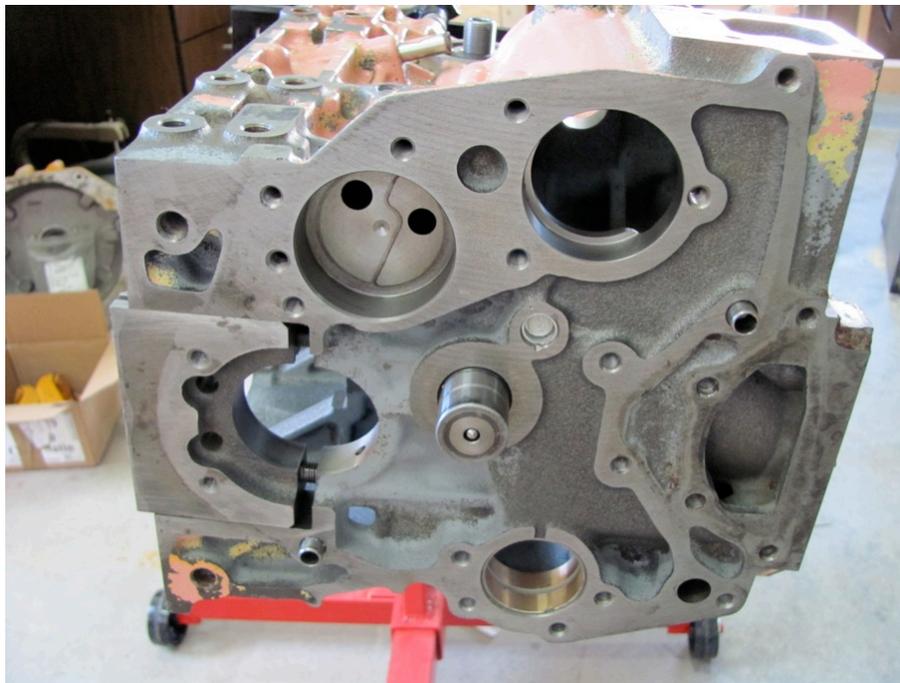
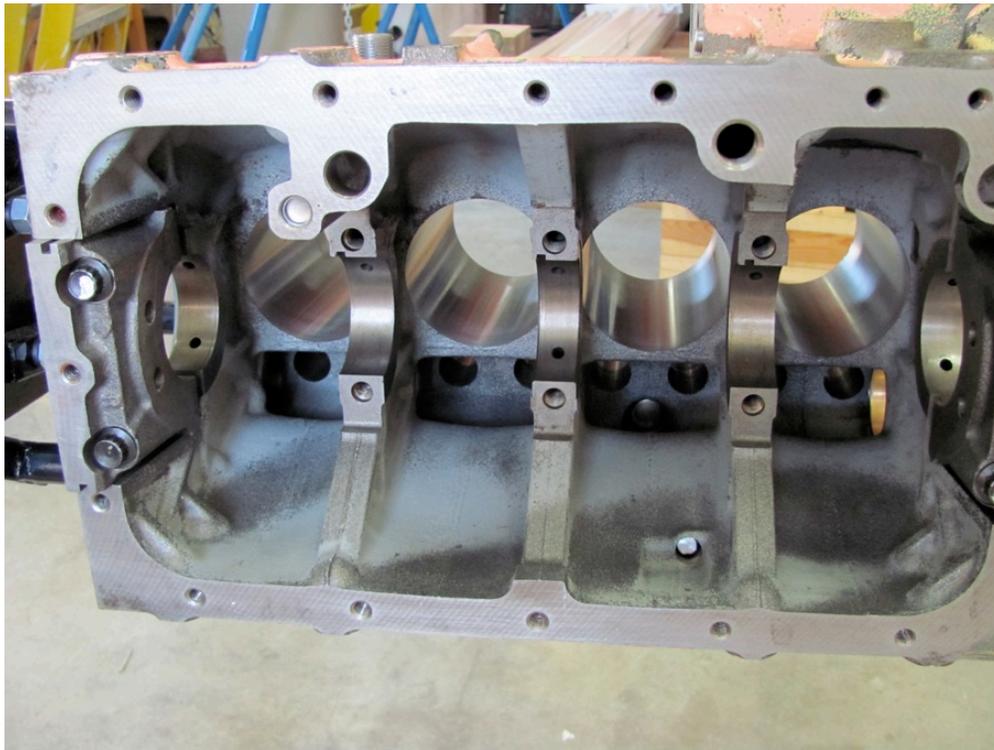
DL Automotive finished the block and head. Looks very nice – cleaned and polished. They were able to clean up the cylinder bores except in a few spots above the rings, so it should be fine. Notice the shiny brass-colored insert at the bottom of the second pic. This is the camshaft bearing and is a “crush” fit. This part came from Japan, but DL Automotive installed it. Requires a special tool. Got everything back in the garage – mounted the engine on the engine stand. The gantry crane comes in handy again, although now I’m using the chain hoist I bought from Harbor Freight instead of the one I borrowed from Carson Baird at PSU’s Learning Factory. Works well.

DL also installed the valves with new guides and seals in the cylinder head. Reconditioned the seats as needed. They also mounted the connecting rods to the new pistons using the new wrist pins and lubed the contact surfaces.

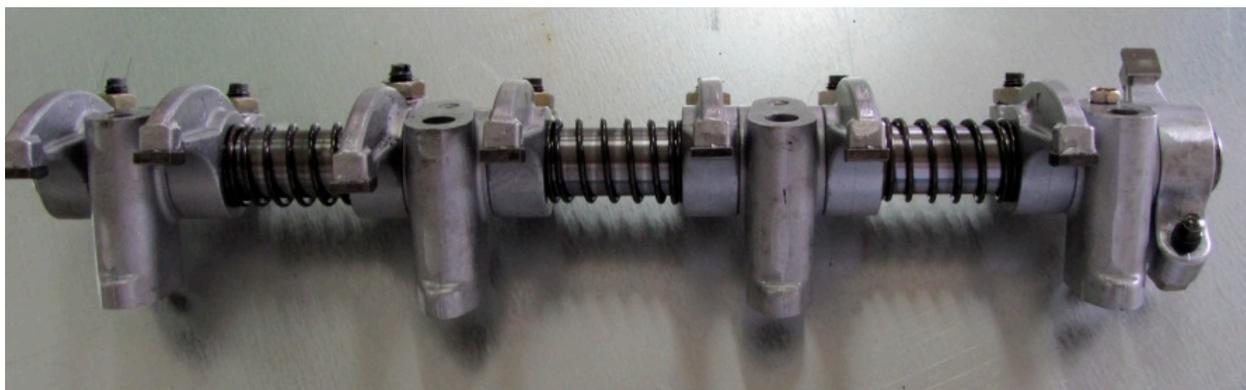
I also disassembled, cleaned (CRC Brake Cleaner), and reassembled (assembly lube) the rocker arm assembly.

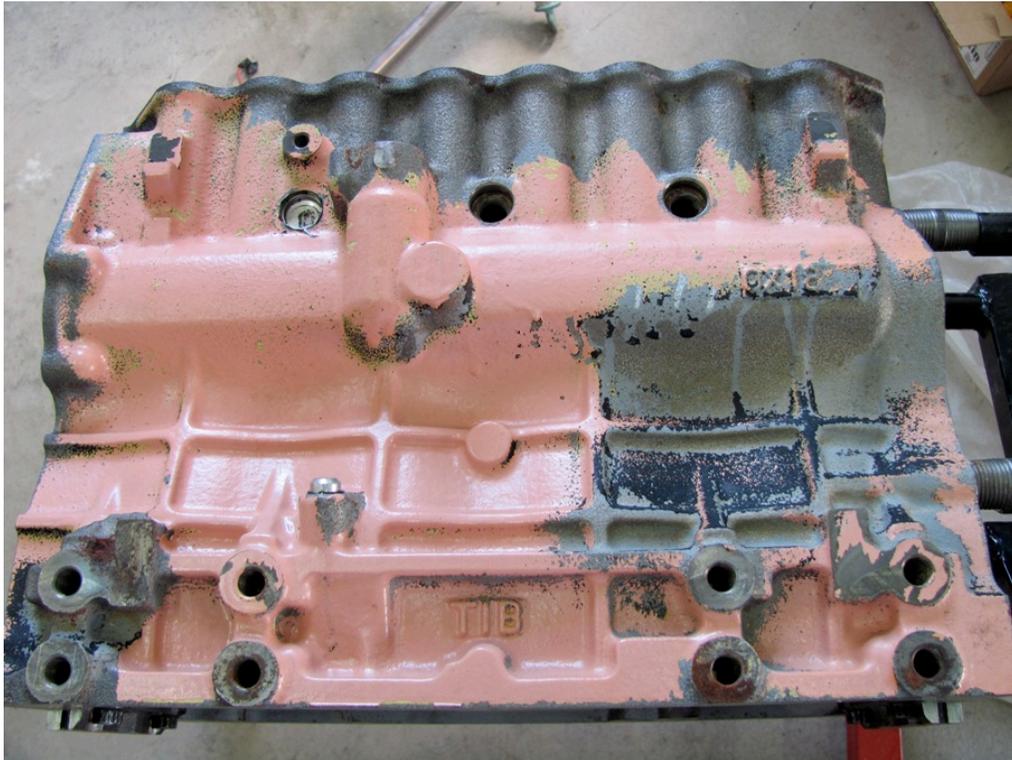
I received the freeze plugs from Stauffer and installed them with black RTV silicone. In the pic below, you can see one of three freeze plugs installed (shiny disc in the upper left).

Used a socket and hammer to seat them. Three small ones on one side of the block, two larger ones on the other side, and one in the rear. Have to be careful that the socket has sufficient clearance, otherwise plug will crimp onto the socket when it contracts in the seat.

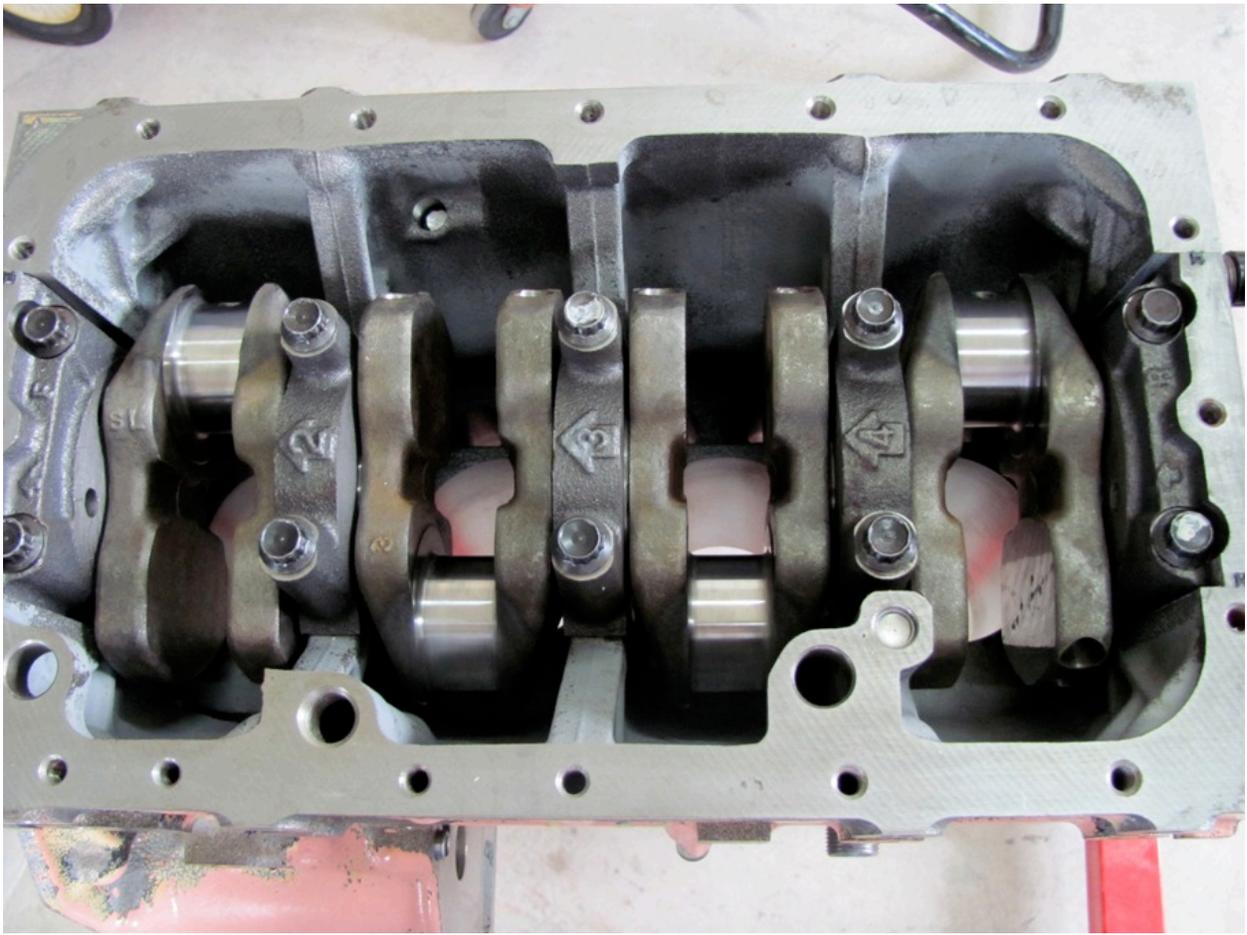
After cleaning and polishing the main bearings and journals (800 grit emory followed by grey Scotch pad), I Plastigaged the bearings. All were within spec but near the upper end of the range. Carson suggested that the range listed is to be viewed as a tolerance not an indication of wear and that more clearance is better than less. So I assembled the crank to the block using assembly lube.

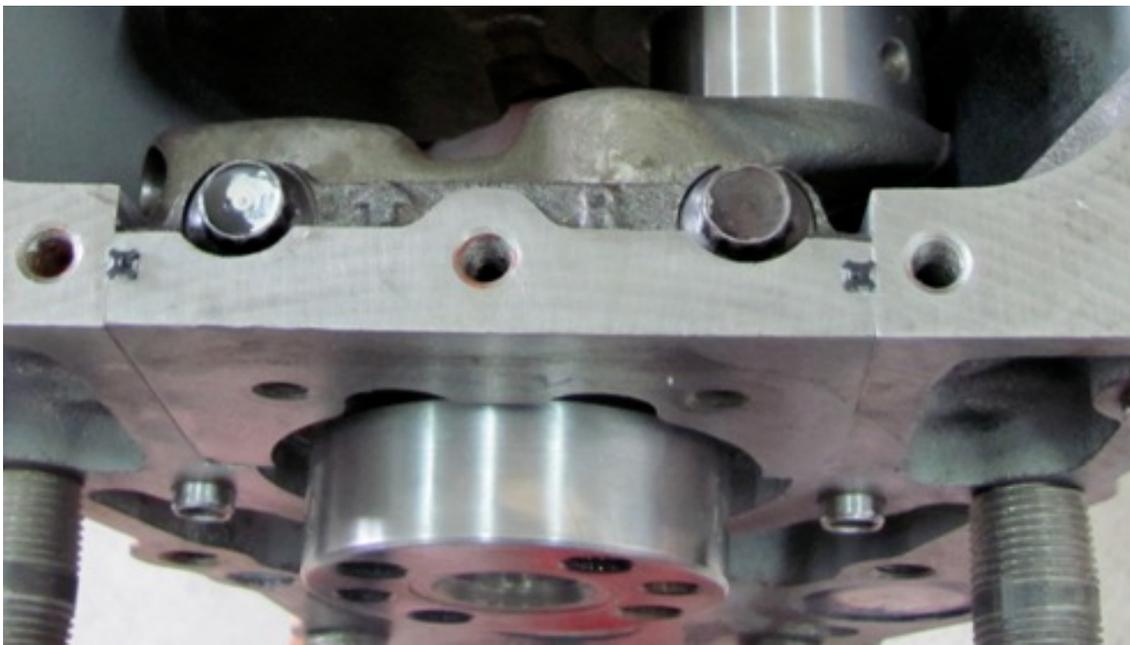
bearings. Lubed them with black silicone and pushed them into place. They appear as two small X's in the pic below.

They protrude a little to mate with the oil pan, I presume. When all done, the crank spins freely.

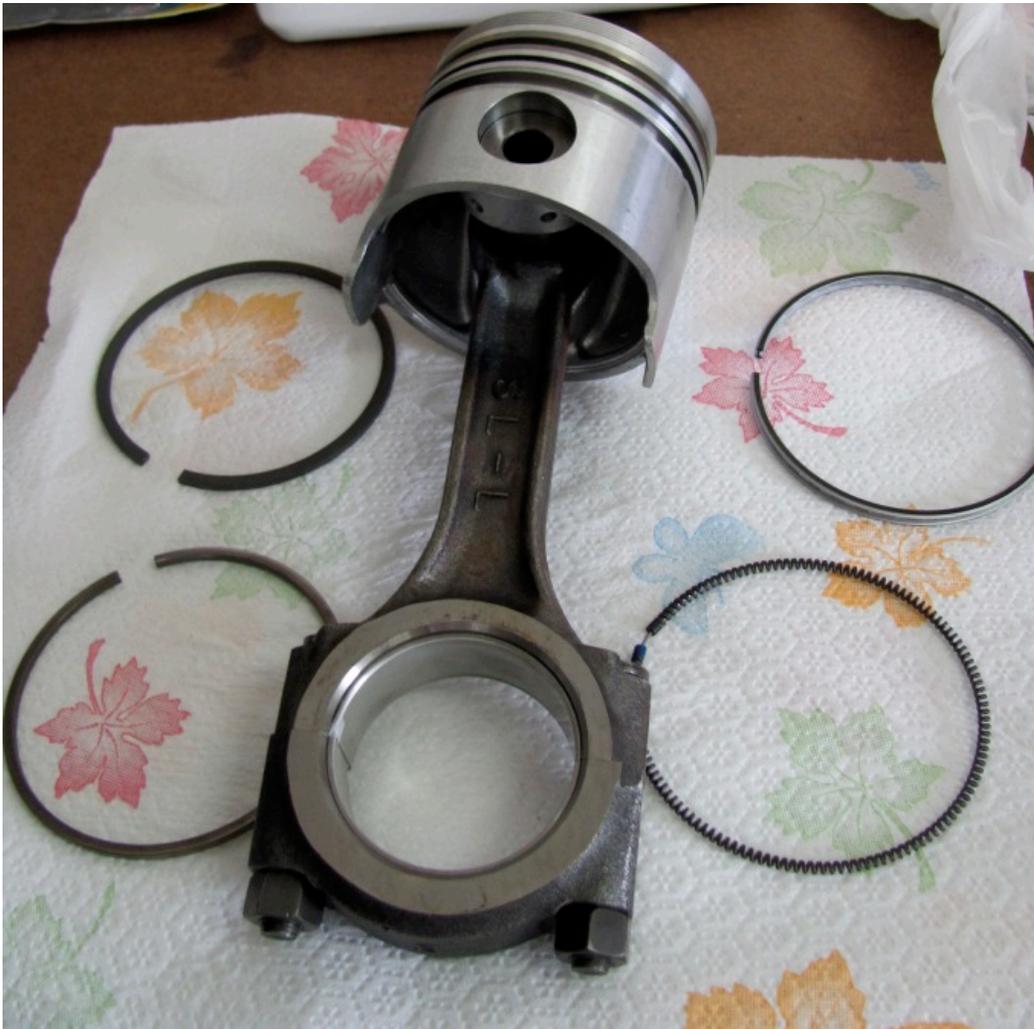
Then onto the pistons. DL Automotive already installed the pistons to the rods, so I just had to install the rings.

All went well with the first one; however, on the second one, I broke a compression ring. It turns out that it's easier to install them by hand than to try to use the (awkward at best) ring pliers. So that cost me \$100 and a 2-3 week wait on new rings. I Plastigaged and installed the remaining three pistons with rings (motor oil on cylinder walls and rings) and all went well. The crank turns

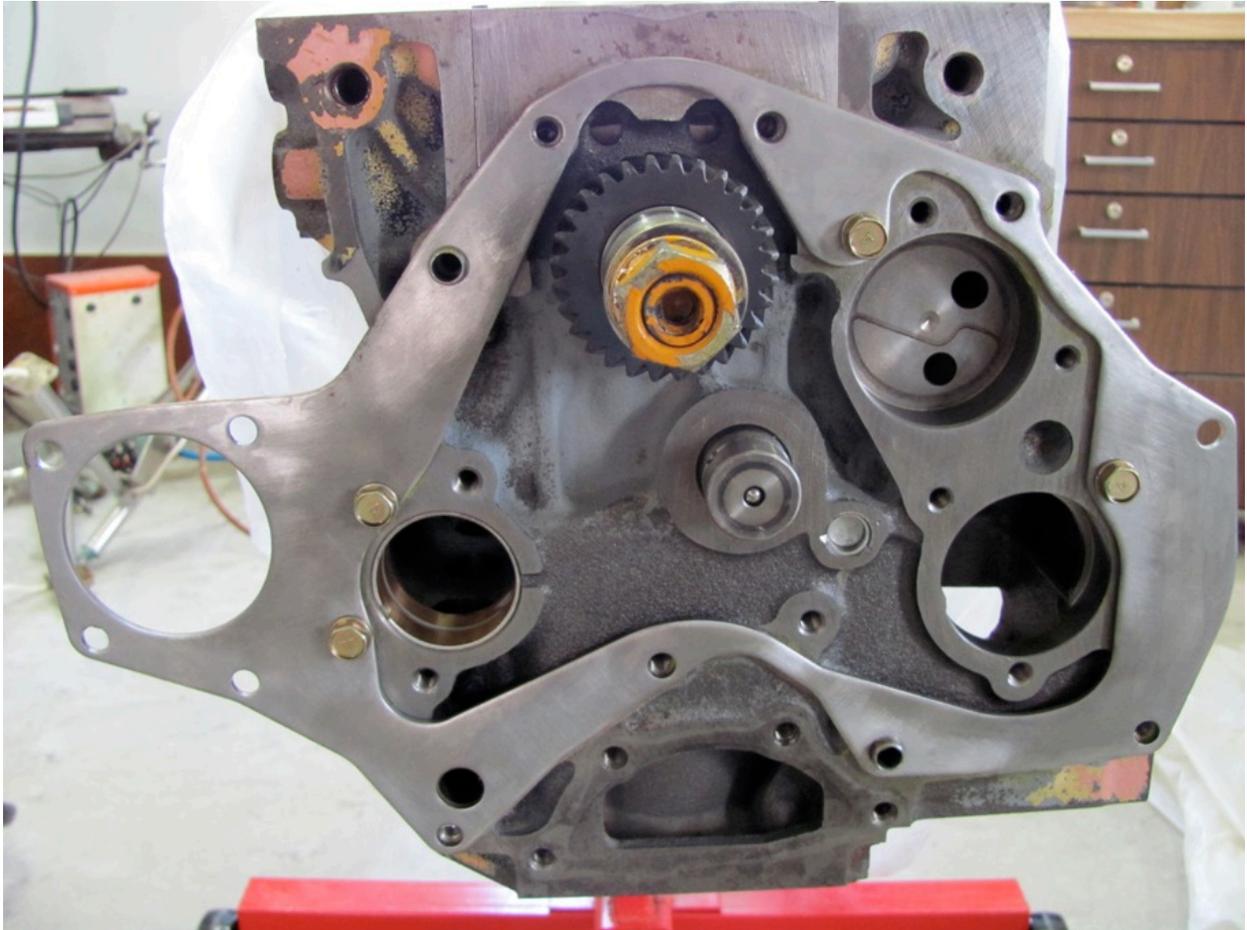
Installed front plate with gasket.

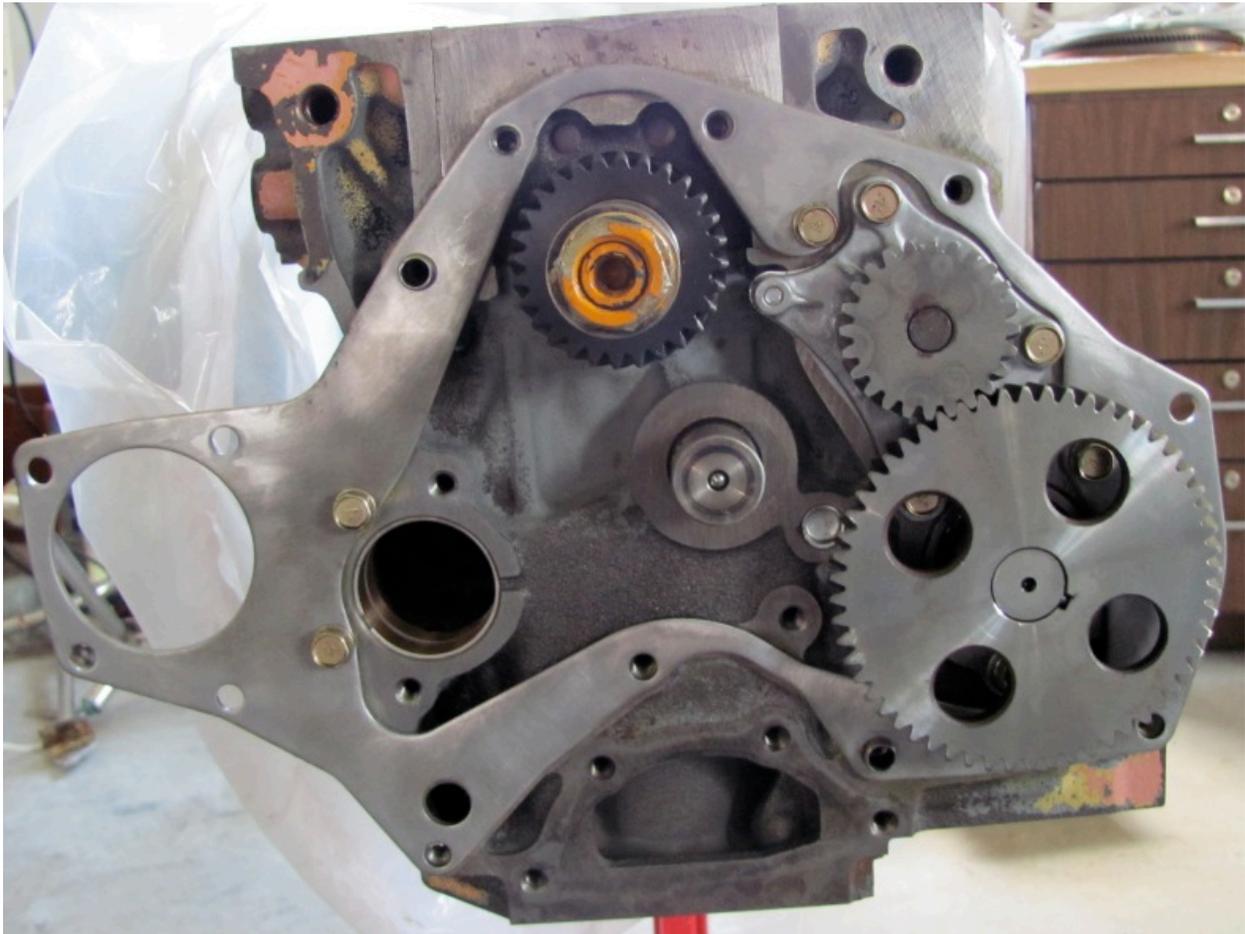
Installed the oil pump. Cleaned & polished the cam shaft and the fuel pump cam shaft. Installed both with assembly lube on contact surfaces. The pic below shows the oil pump (small gear) and fuel pump cam (large gear) installed.

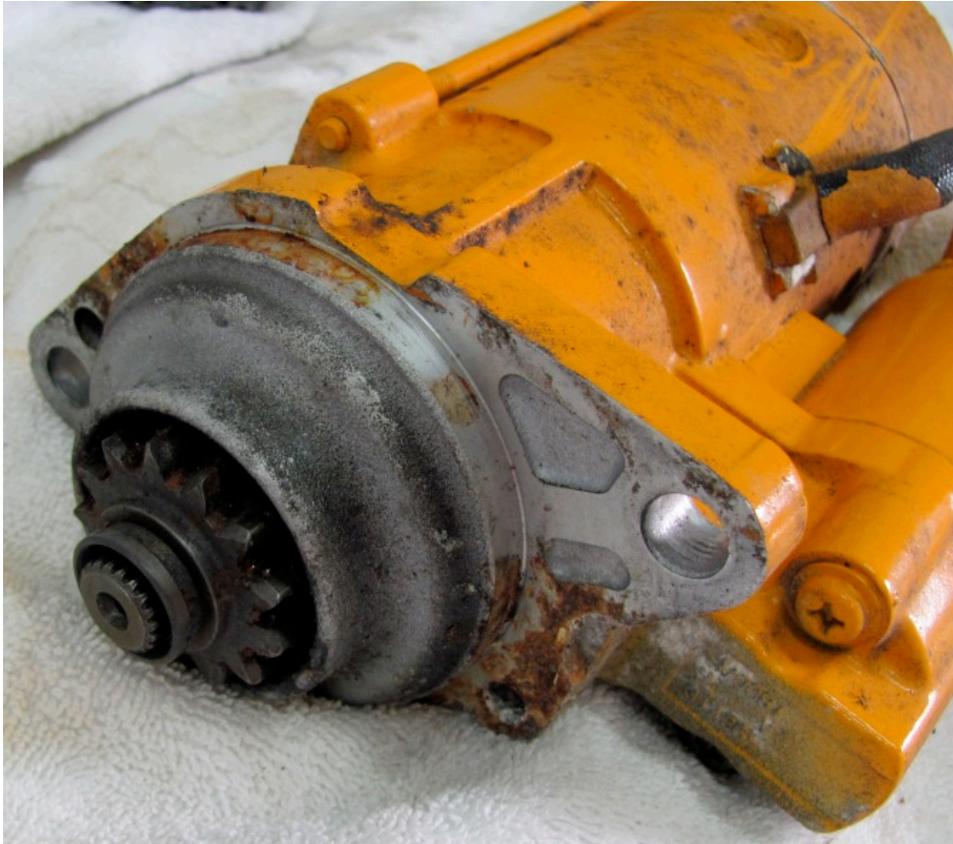
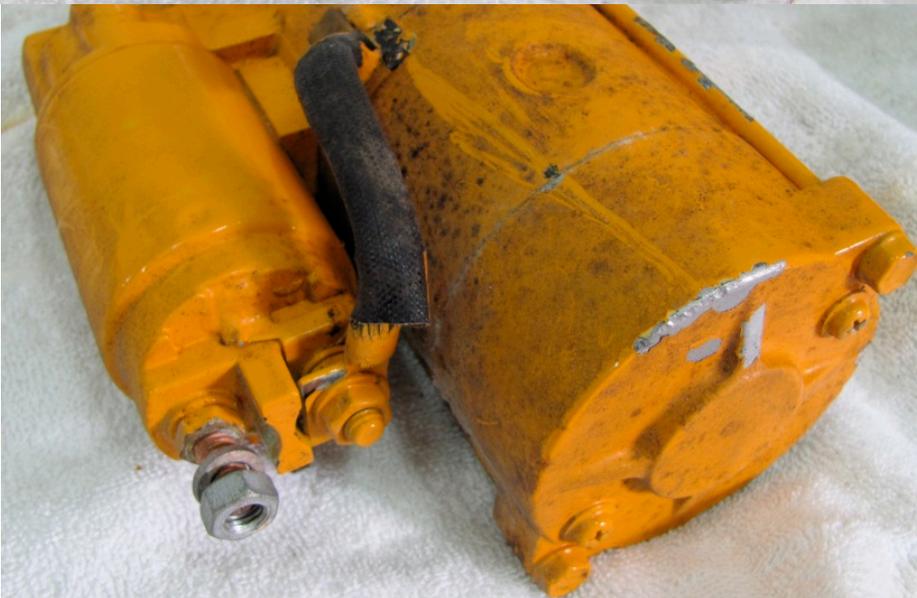
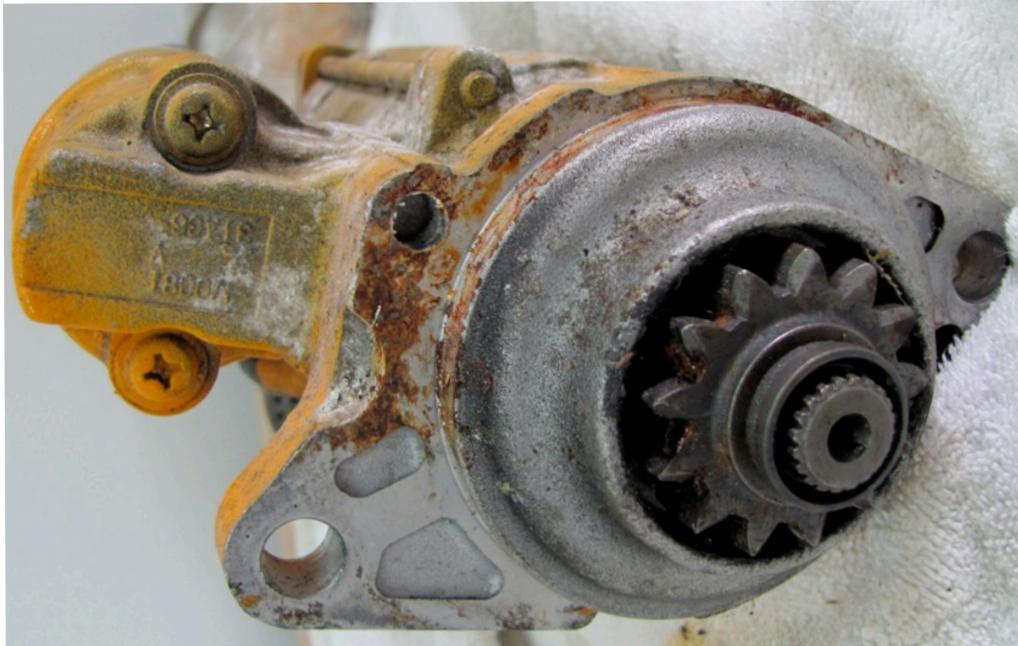
The starter looked ok from the outside – a bit of corrosion, but not too bad.

I decided to take a look on the inside, just to be sure. Oh boy! The manual describes in fair detail how to disassemble and inspect the starter, but as I found out a bit later, not this particular starter! First you remove two Phillips head screws holding the solenoid.

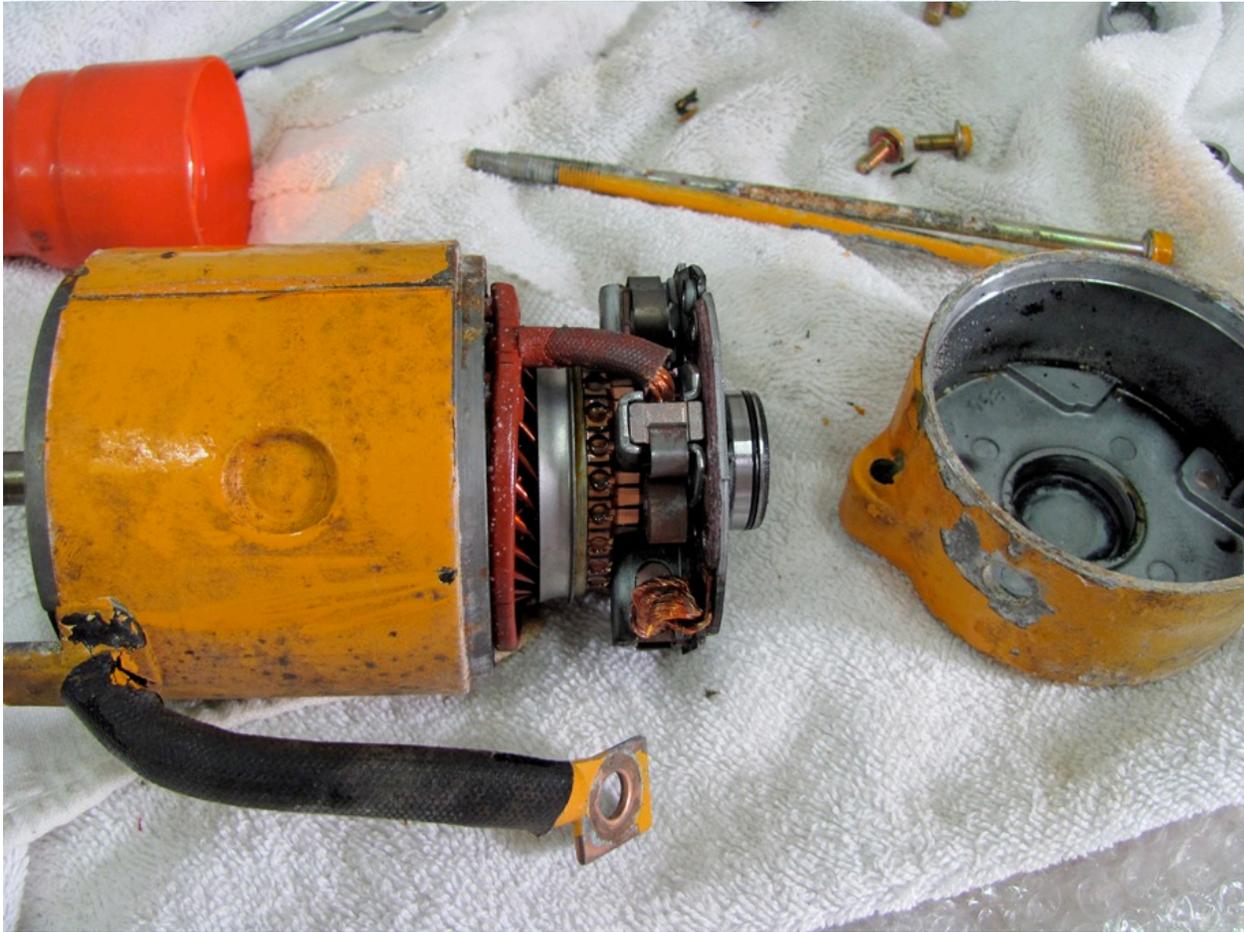
Unfortunately, the screws were Loctited in place and I destroyed the heads getting them out – at least I got them out. Next, remove the two long bolts holding the chassis together. Even though there was some corrosion, they came out without a hitch. Then two screws holding the brush holder – no problem. This allows you to remove the rear cover. It's a bit of a tug because the rear armature bearing seats into the cover. This bearing has a tiny o-ring in a groove around the outer race. I'm not sure of its purpose, and the manual doesn't mention it. There is also a thin thrust washer in the case, but it didn't come out easily, so I left it alone. The pic below shows the rear case (right), the long bolts, the short brush holder screws, the armature still in the housing, the brush holder with brushes on the commutator, and the rear bearing with o-ring. The "red" thing is a flashlight.

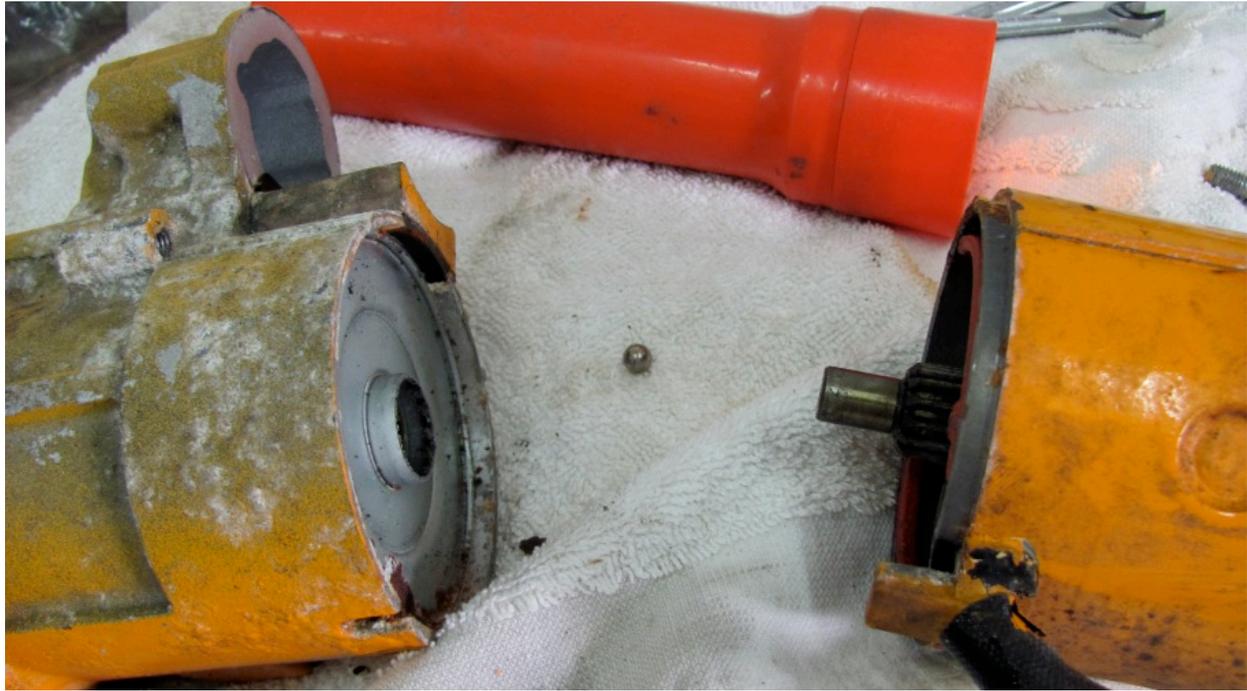
With the brush housing removed, I can pull the armature free of the case. All of a sudden I see a single ball bearing laying on the bench! Where did that come from? From what I can see, it must be a thrust bearing for the end of the armature. Well at least that's where I'm putting it, because the manual doesn't mention it.

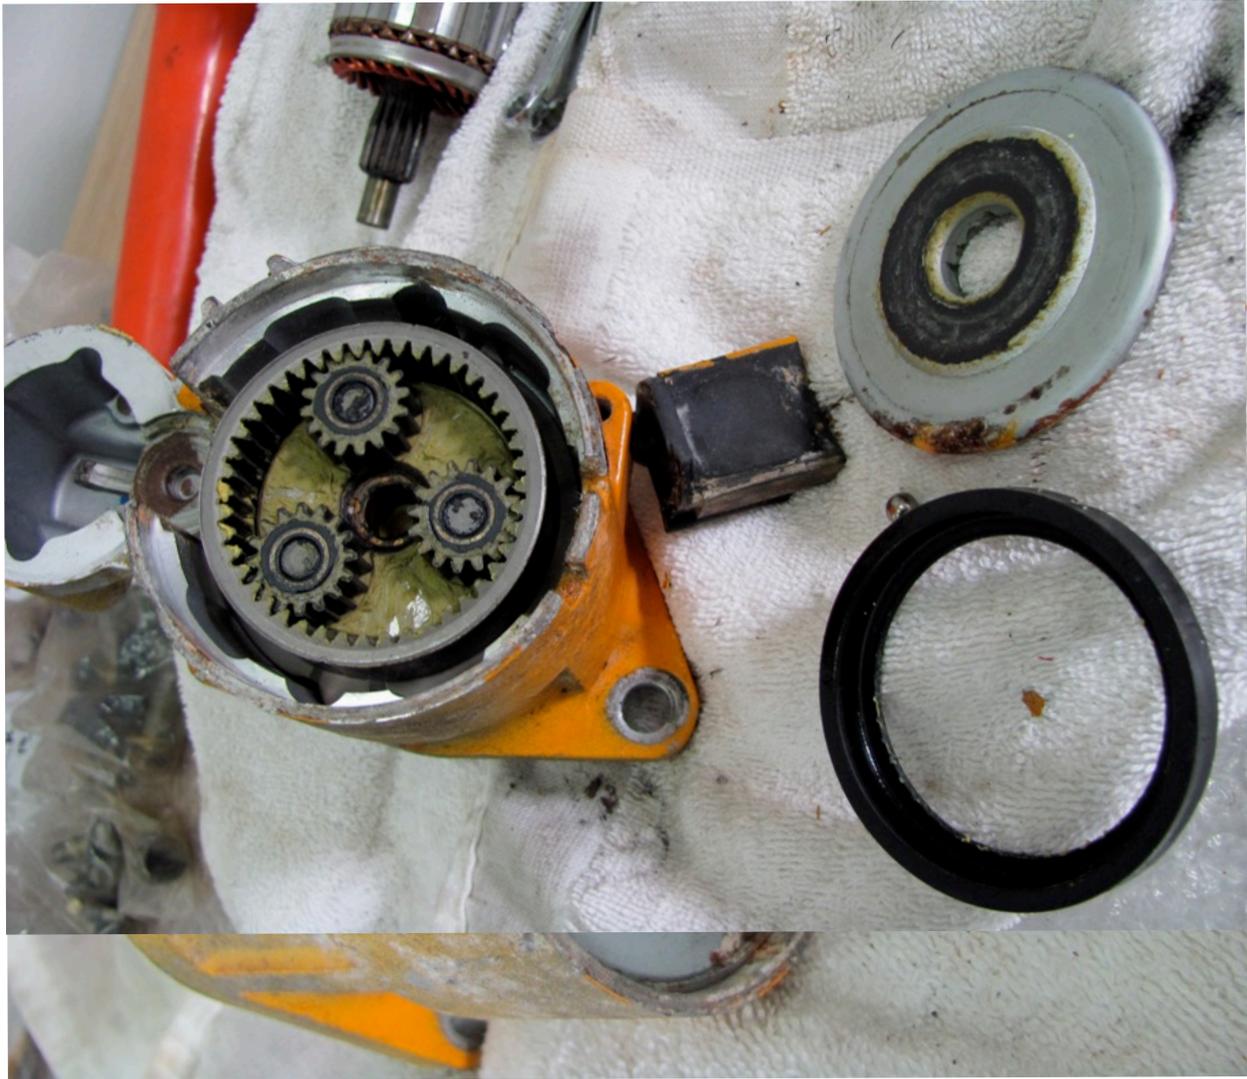
I can't see much of anything. So while I'm trying to see how to remove this plate, it happily chooses to cooperate by falling out! This reveals a large rubber seal and also drops out. Now I can see that this is a planetary drive, quite unlike what the manual describes.

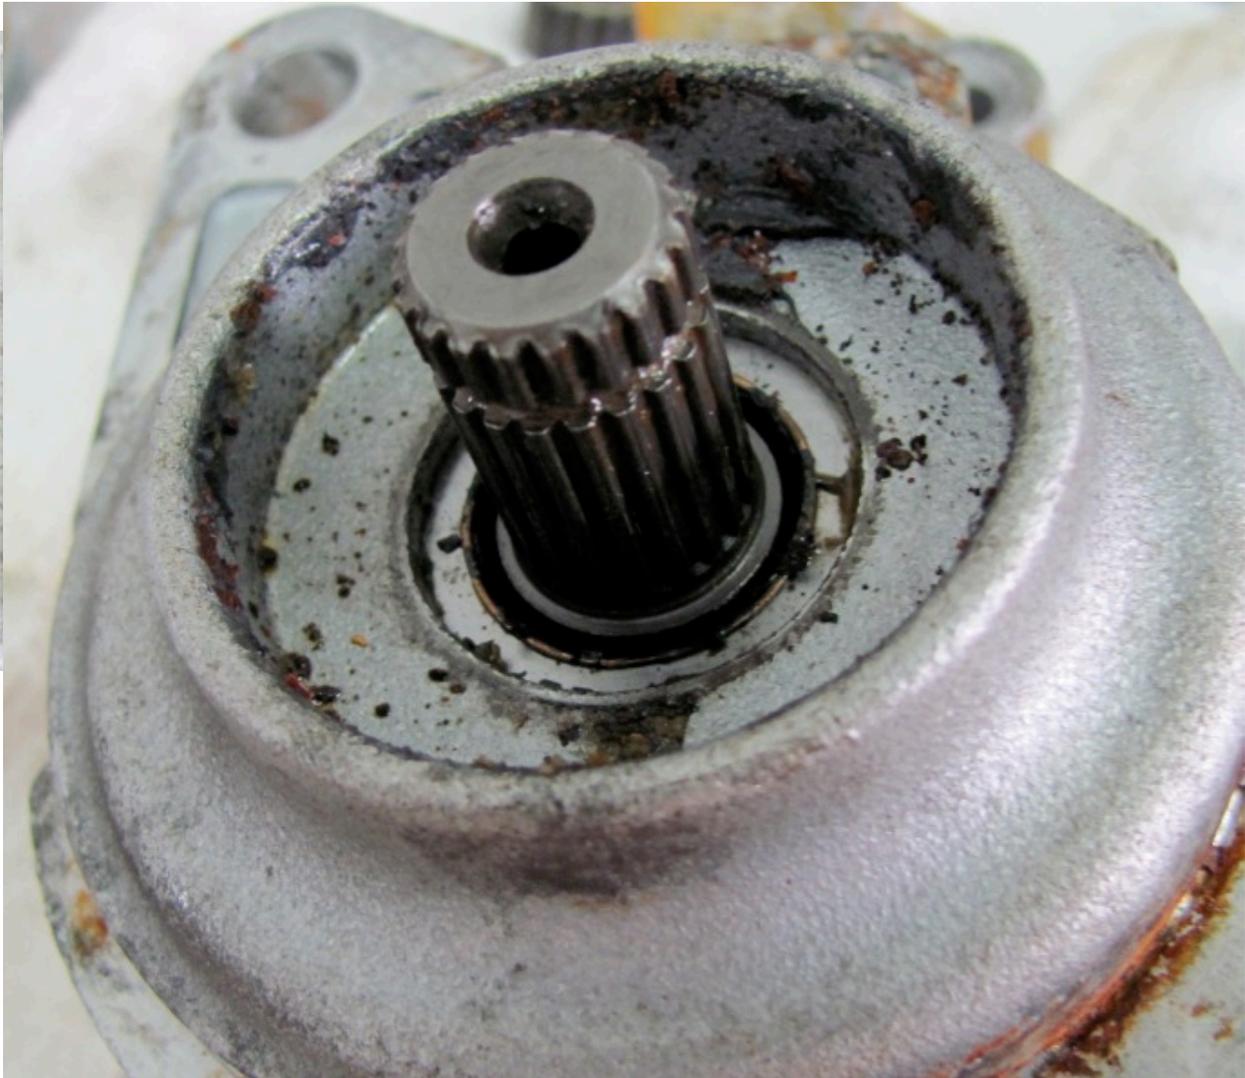
The three planetary pinions come out without a hitch, but to pull the rest of the gear train, I've got to remove the main pinion gear – the one that engages the flywheel. Well the manual is quite clear on this procedure. The pinion is held in place with a special snap ring and a collar that locks it in place.

You find a socket that fits the outside rim of the collar but has a hole big enough for the shaft, and you hit it with a hammer. In theory, the collar slides down the shaft clearing the snap ring, which you can then remove. In theory! Well I hammered ... and ... hammered a bit more ... nothing. Then to the arbor press ... still no luck. Then I realized that you have to shim the planetary apparatus from the underside to give the collar enough travel downward. A bit more hammering and it came free.

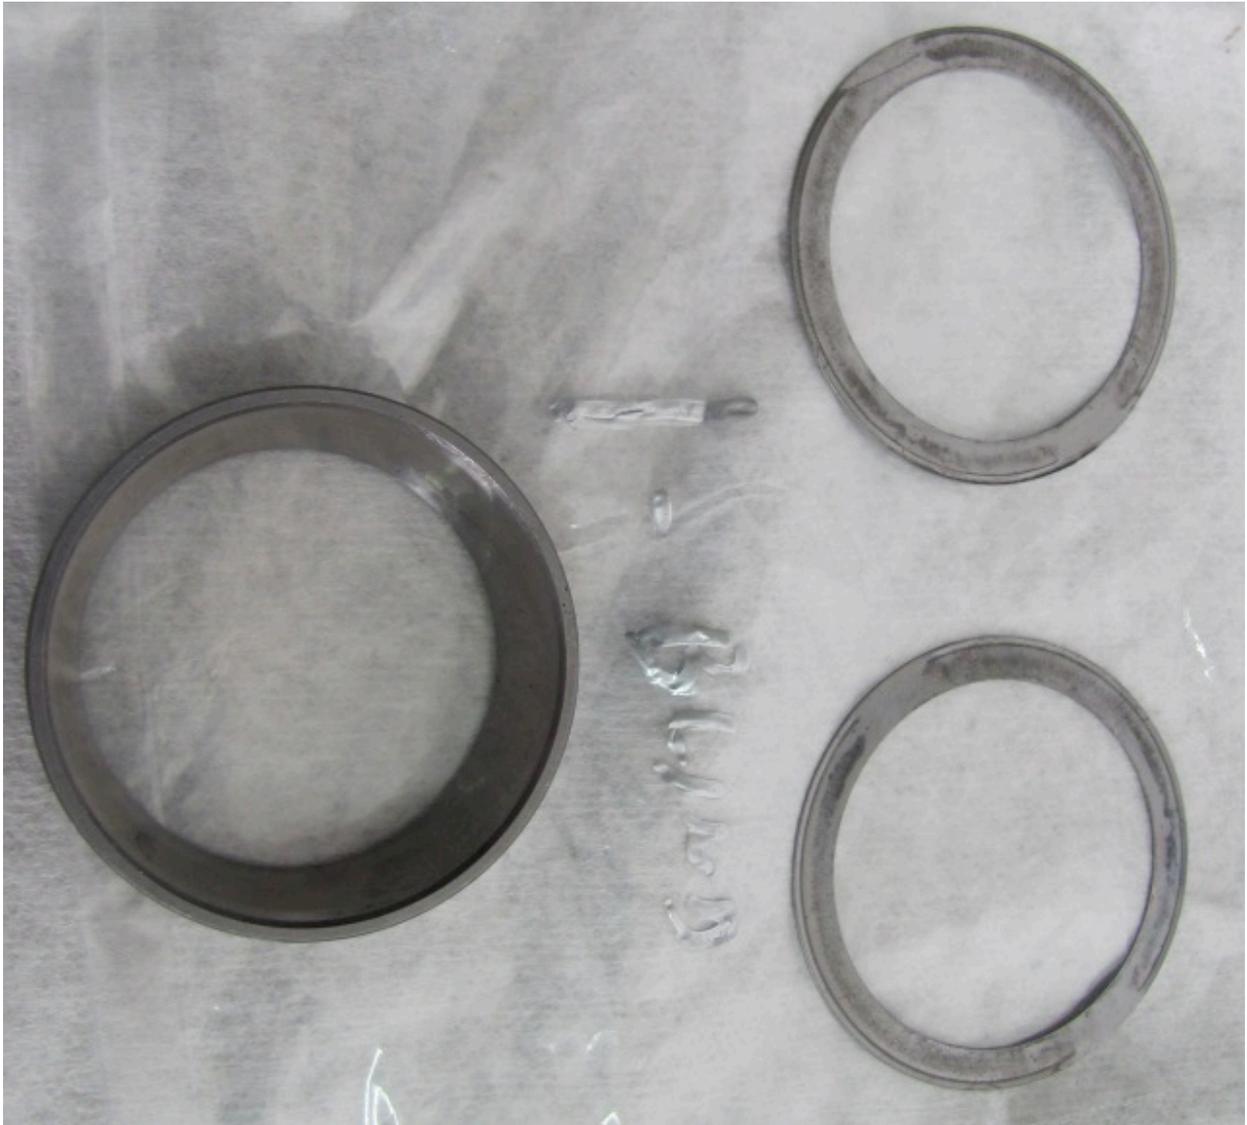
The disassembly went ok and everything looked fine, except possibly one of the bearing cups. This transmission is equipped with tapered roller bearings, which are required to be preloaded. To accomplish this, shims are installed behind one cup on each of two shafts. The shims are sized to provide the necessary preload. One of the bearing cups with shims is shown below.

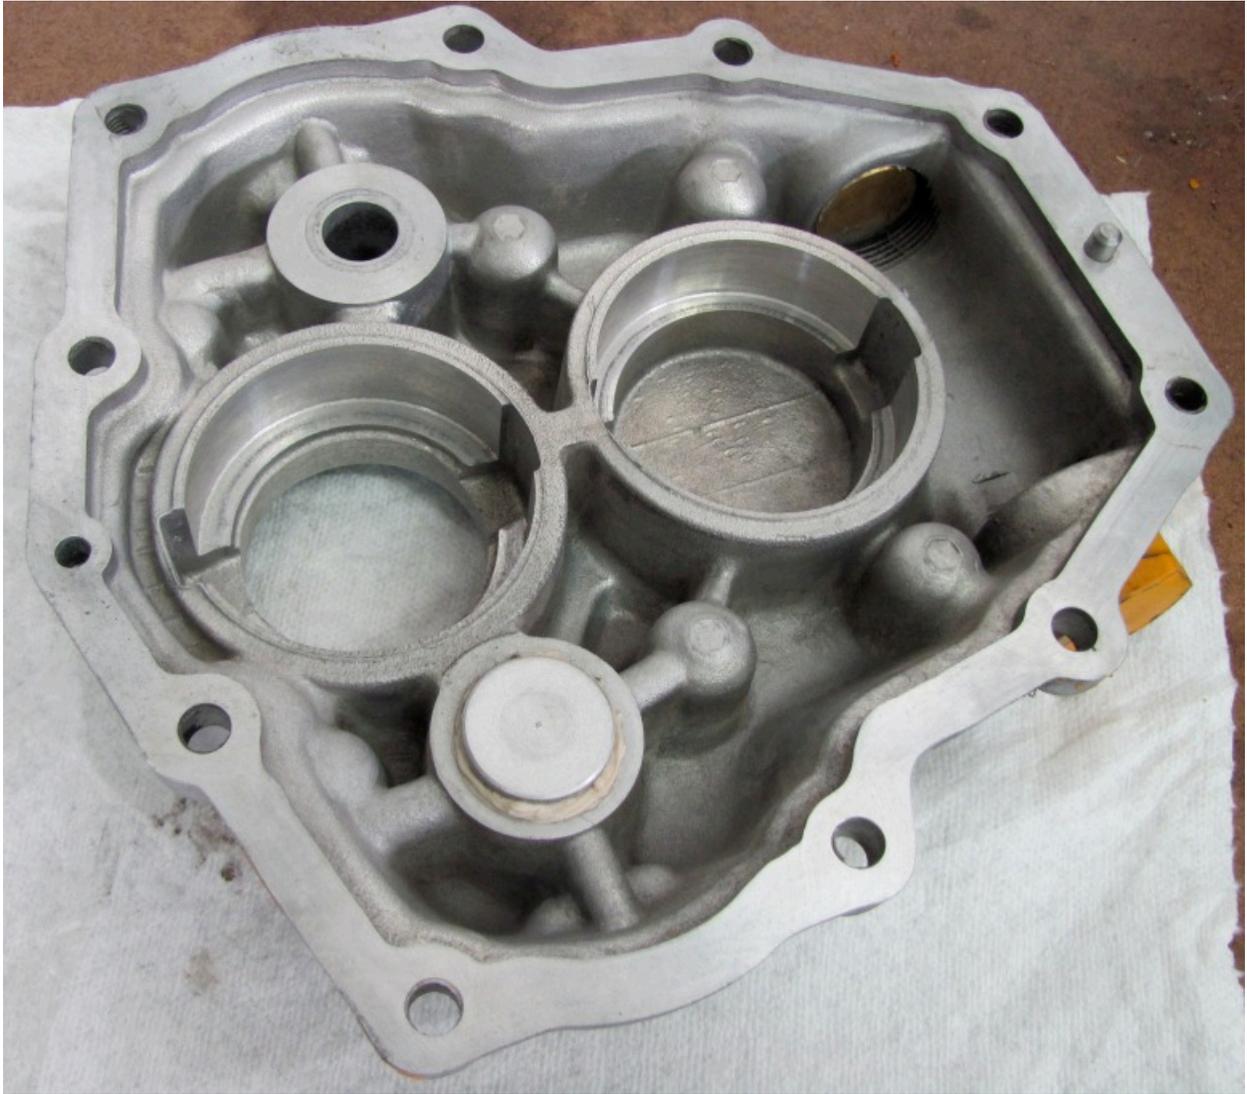
Now to prevent the cups from rotating in the housing, they should be pressed into the housing; however, I was able to remove both cups by hand. The pic below shows the housing with the cups removed.

So on reassembly, Carson recommend that I Loctite them in place. This was a bit tricky because the thin shims did not lie perfectly flat, so the cups had to be installed under pressure. So after

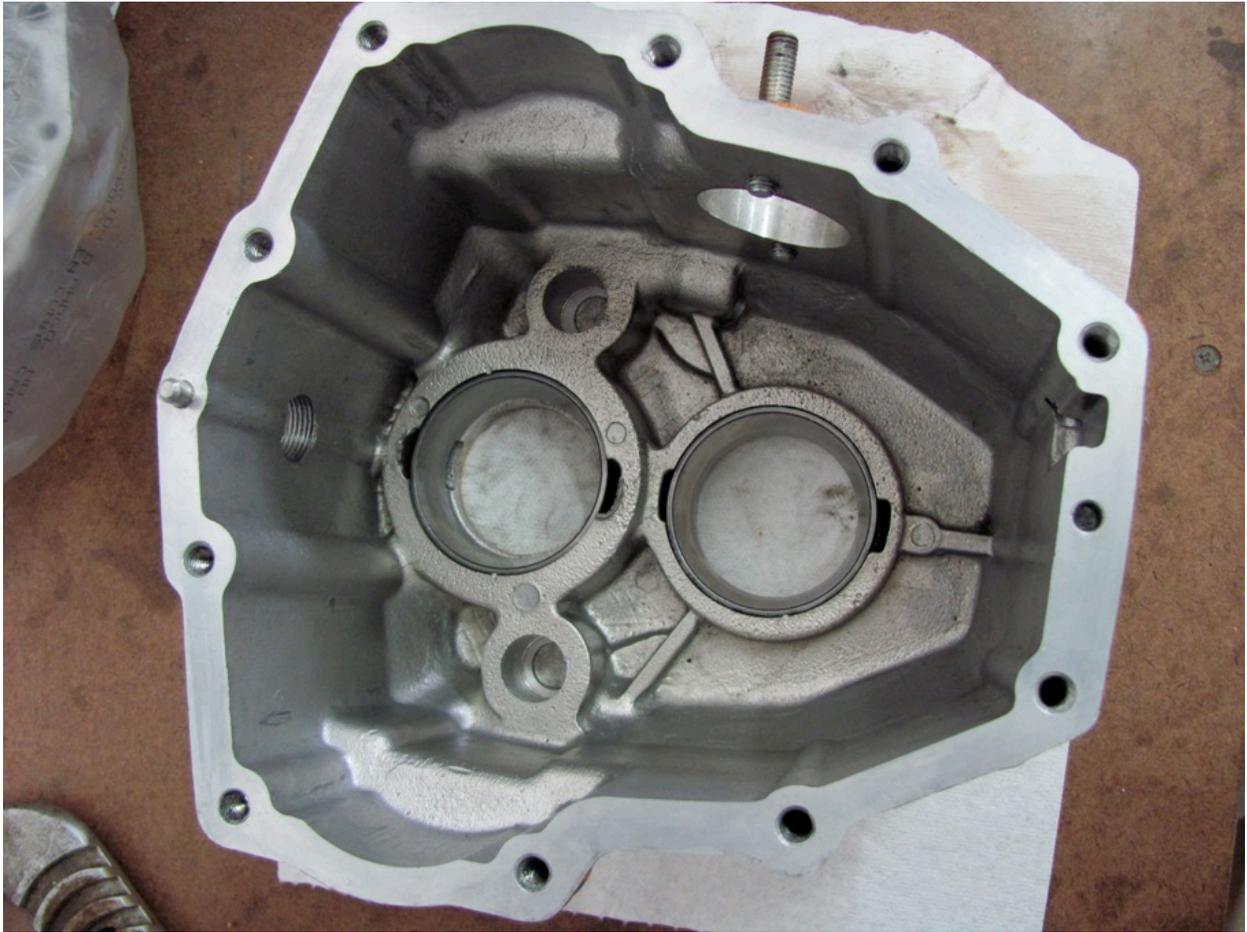
applying the Loctite, I installed the shafts and bolted the housing together until the Loctite cured. I then disassemble it again, applied ATF (automatic transmission fluid) to the bearings and reassembled for the last time. The pic below shows the housing with cups installed.

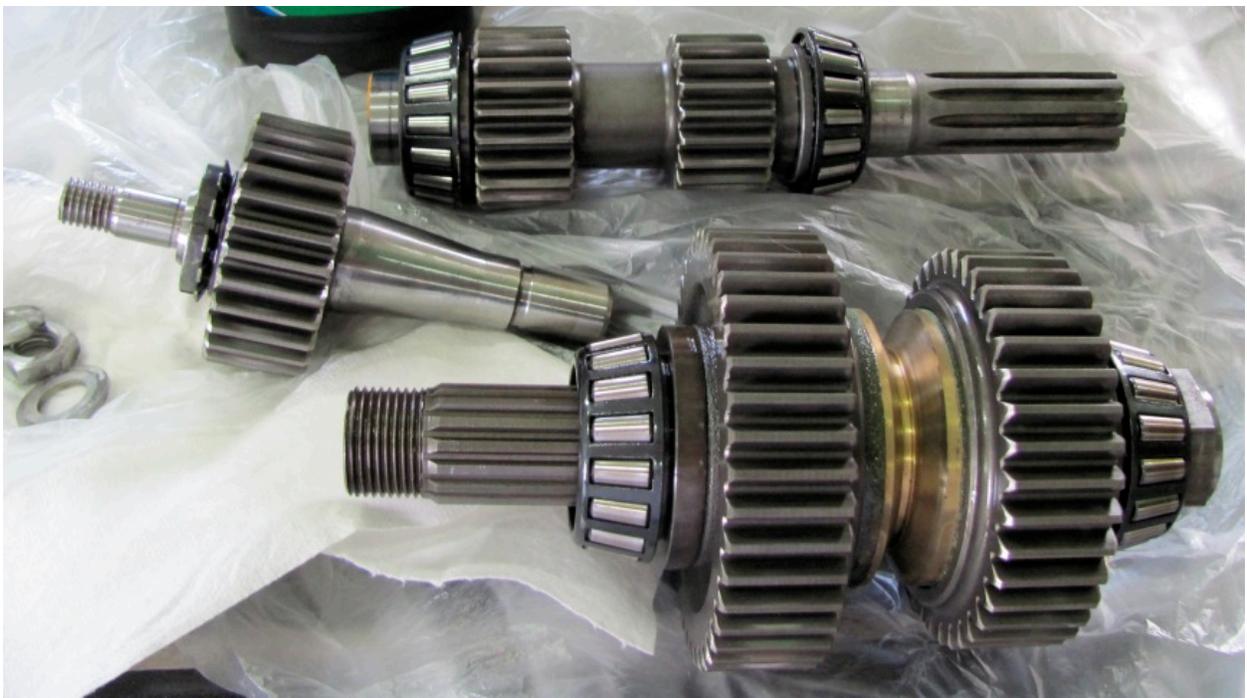
Here we see the three shafts. Top is the input shaft, middle transmission shaft, bottom output shaft.

When the seals come in, I'll install them and adjust the shift mechanism per the manual. My only concern is that the output shaft now turns somewhat harder than before I took it apart. Carson assures me that this is not unusual because of the preload and should get better after the transmission has been "run in." In retrospect, I should have checked the preload (measure the shaft end play without the shims and then check that the shim thickness is correct). I assumed that if the preload was right before I opened it, it should be fine afterwards. I did read later on a web site that you should rotate the shafts as you tighten the bolts so that the bearings self correct any misalignment, but I didn't know to do this at the time. There is also a VERY small chance that I interchanged the shims. I did label them with marker when I removed them and kept them in separate baggies, but I inadvertently removed the marks when I cleaned the parts. I could disassemble everything again to measure the preload, but this would be a lot of work. Not to mention that I'd have to deal with the Loctite on the cups.
