Cabin Sides (2010)

4/28/2010:

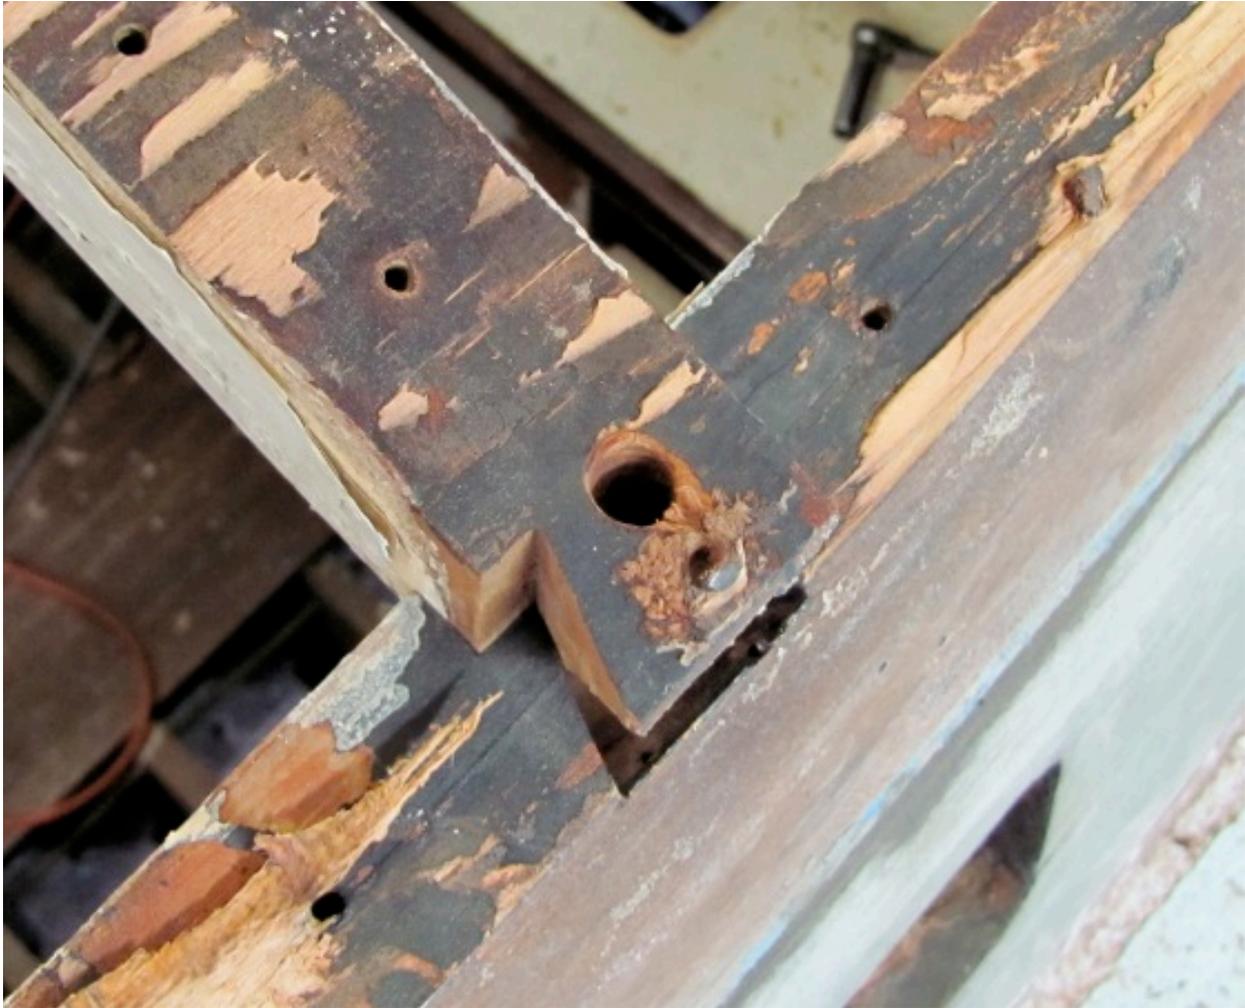
Unfortunately, some of the beams (the heavy beams) are dovetailed into the ledge and cabin side.

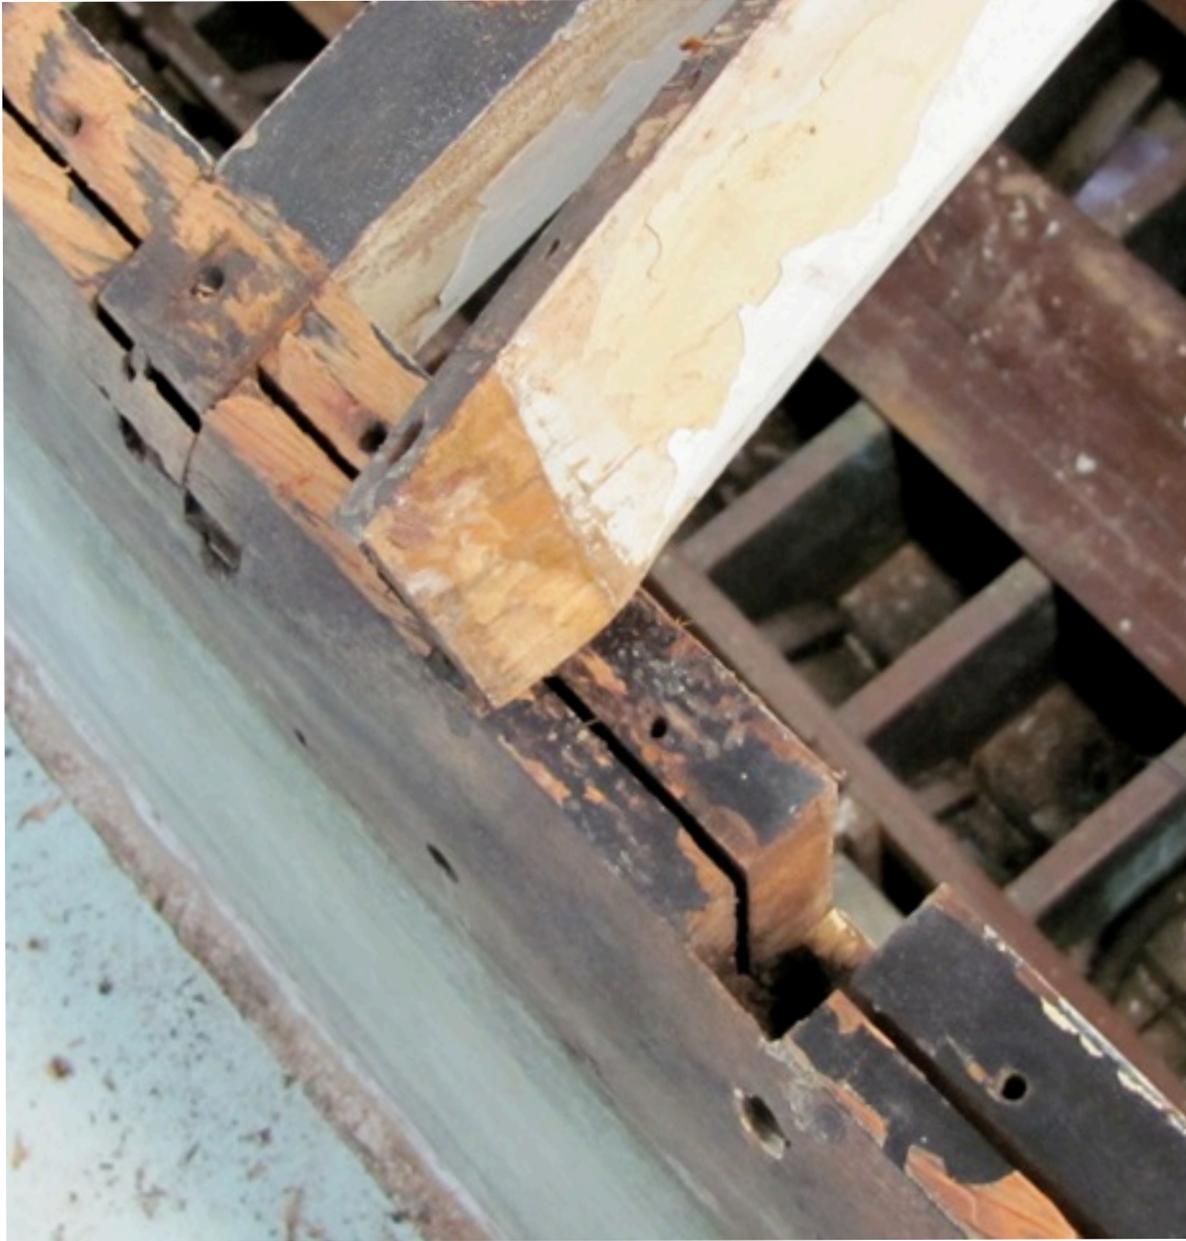
As you can see in this pic, some of the beams simply mortise into the ledge (no dovetail). These beams are constructed from a very light wood, maybe Spanish Cedar (to save weight?). The heavier beams in the way of the hatches and mast partners are Mahogany (I guess) and dovetailed.

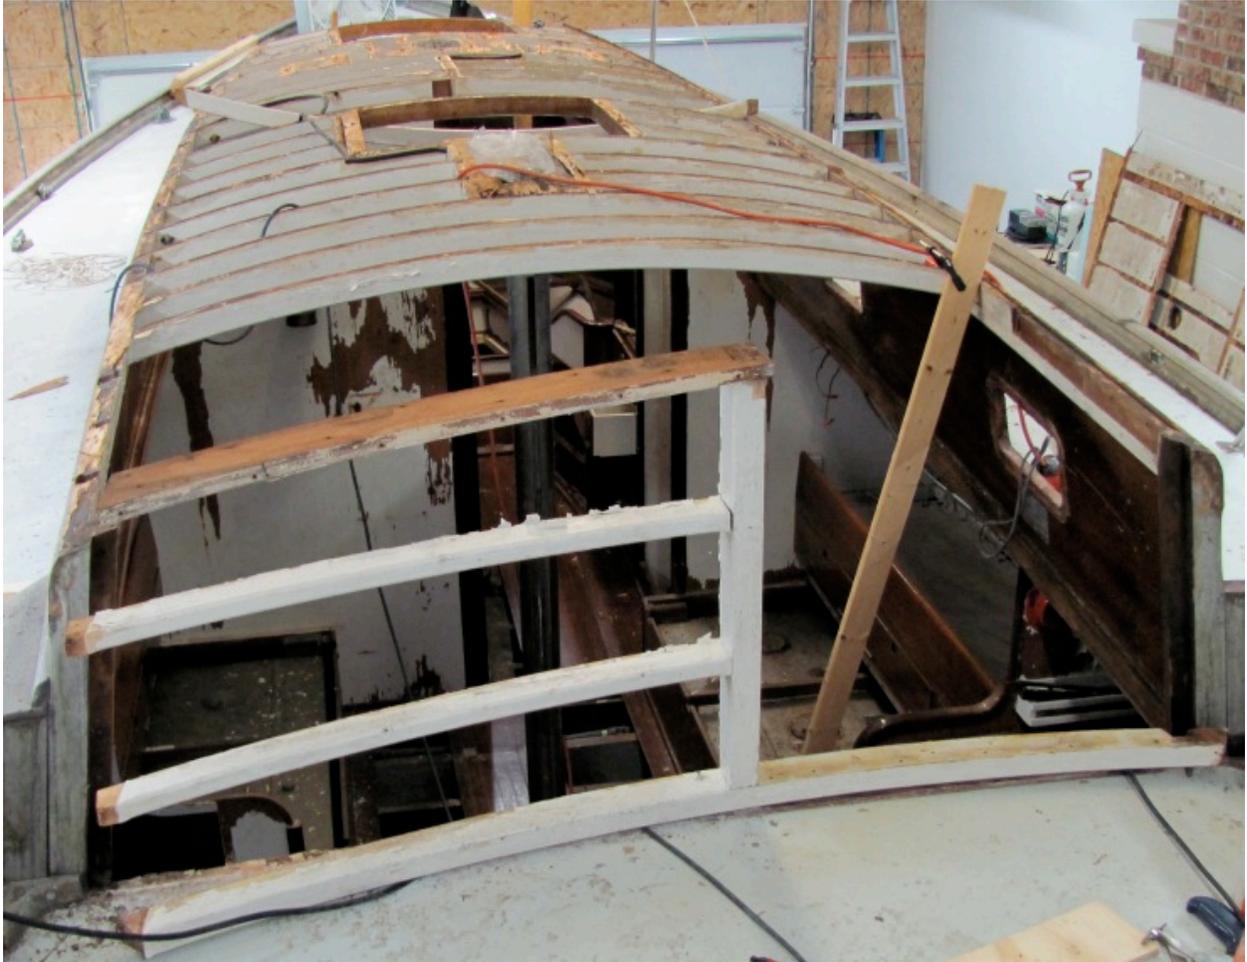
This pic shows the beams around the companionway removed.

The beams were sawn to shape and consequently the grain runs out making them somewhat weak. I ended up splitting a few of the cedar beams getting the top off. I'm considering replacing these solid beams with laminated beams. When am I going to finish this project????

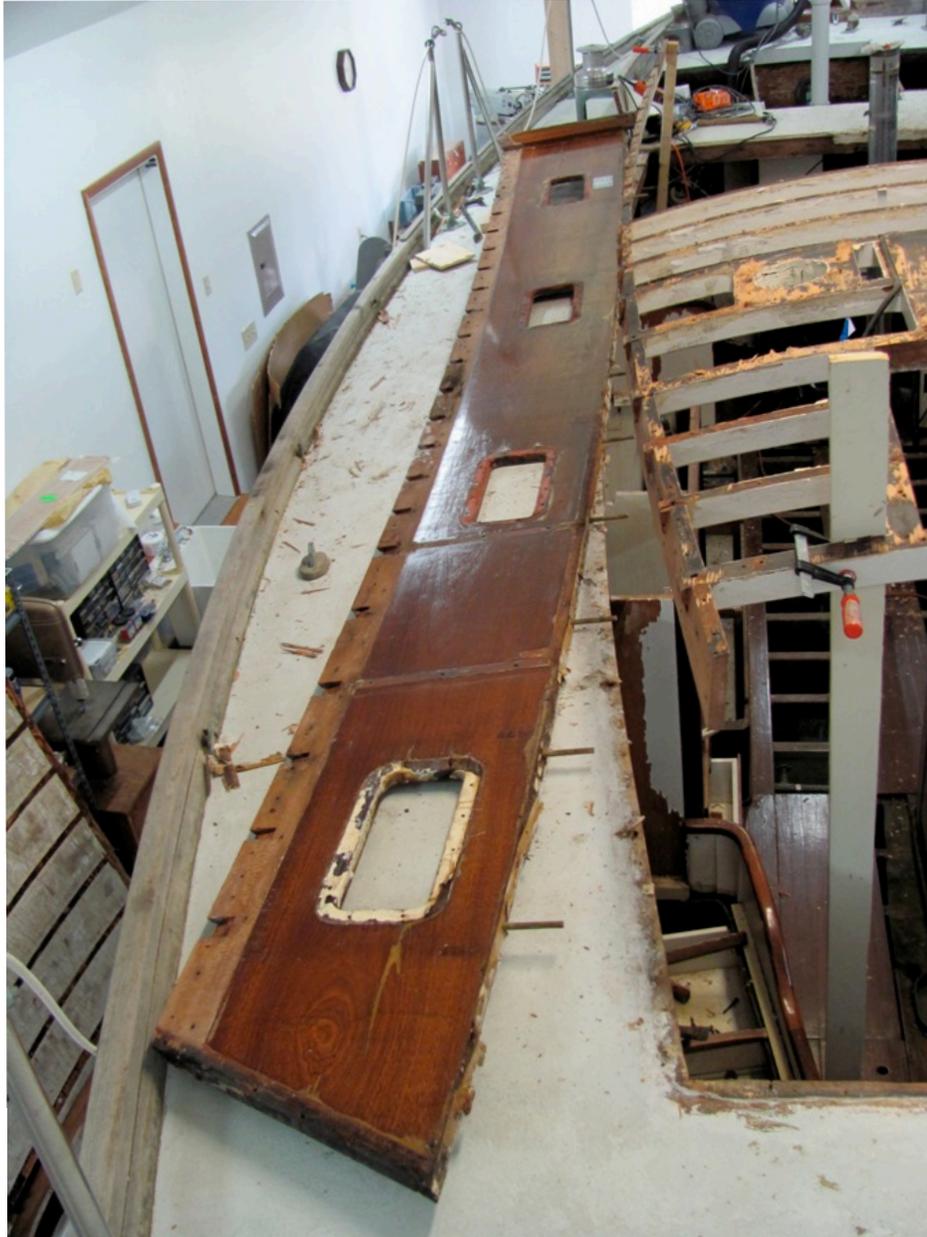
I'm thankful that the builder installed the cabin side bolts perpendicular to the edge. If they were inserted at an angle, I'd never be able to pry the cabin side loose. Working a little at a time from end to end, it finally yields. Although this plank is 1" thick, it's quite flexible over it's 16' length, so I doubt that steaming was need to bend the cabin side into place. Of course I might have a different opinion when I try to reinstall it! Note that the aft cabin corner post (at the far end) is still attached to the side.

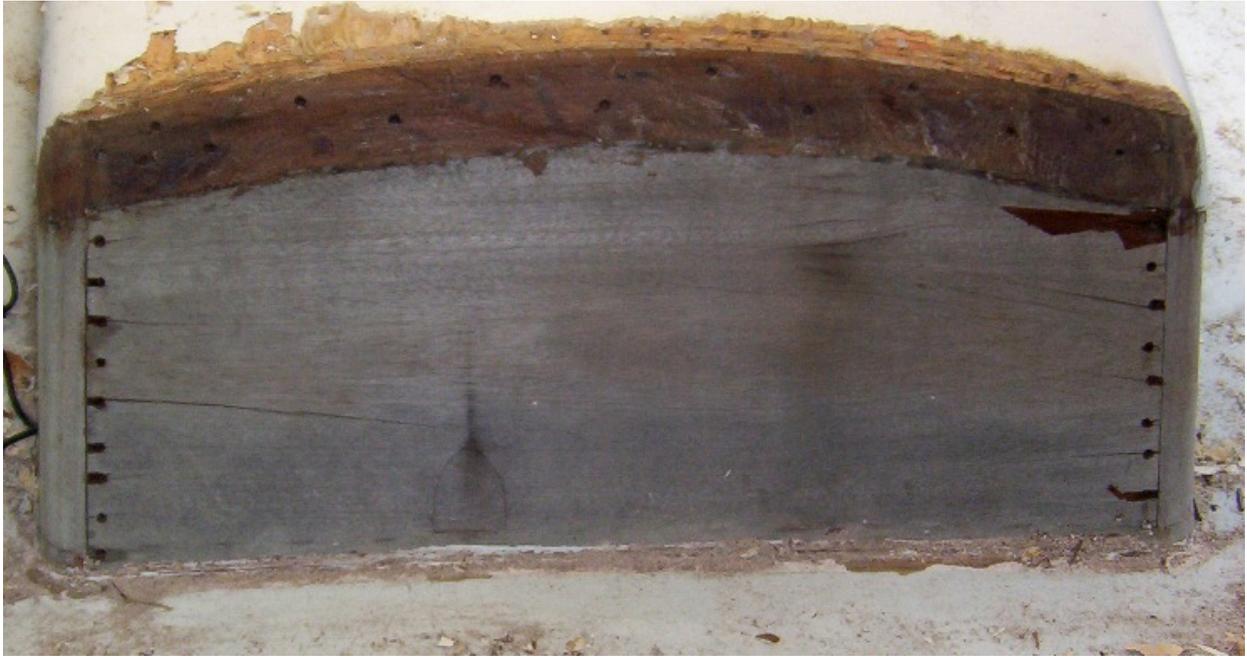
The front and back panels of the cabin are also badly checked.

Materials for repairing the cabin sides arrived this week. I started to work on the cabin front, a piece that I plan to replace, to see how it goes. Here is a pic of the cabin front as it appeared on the boat.

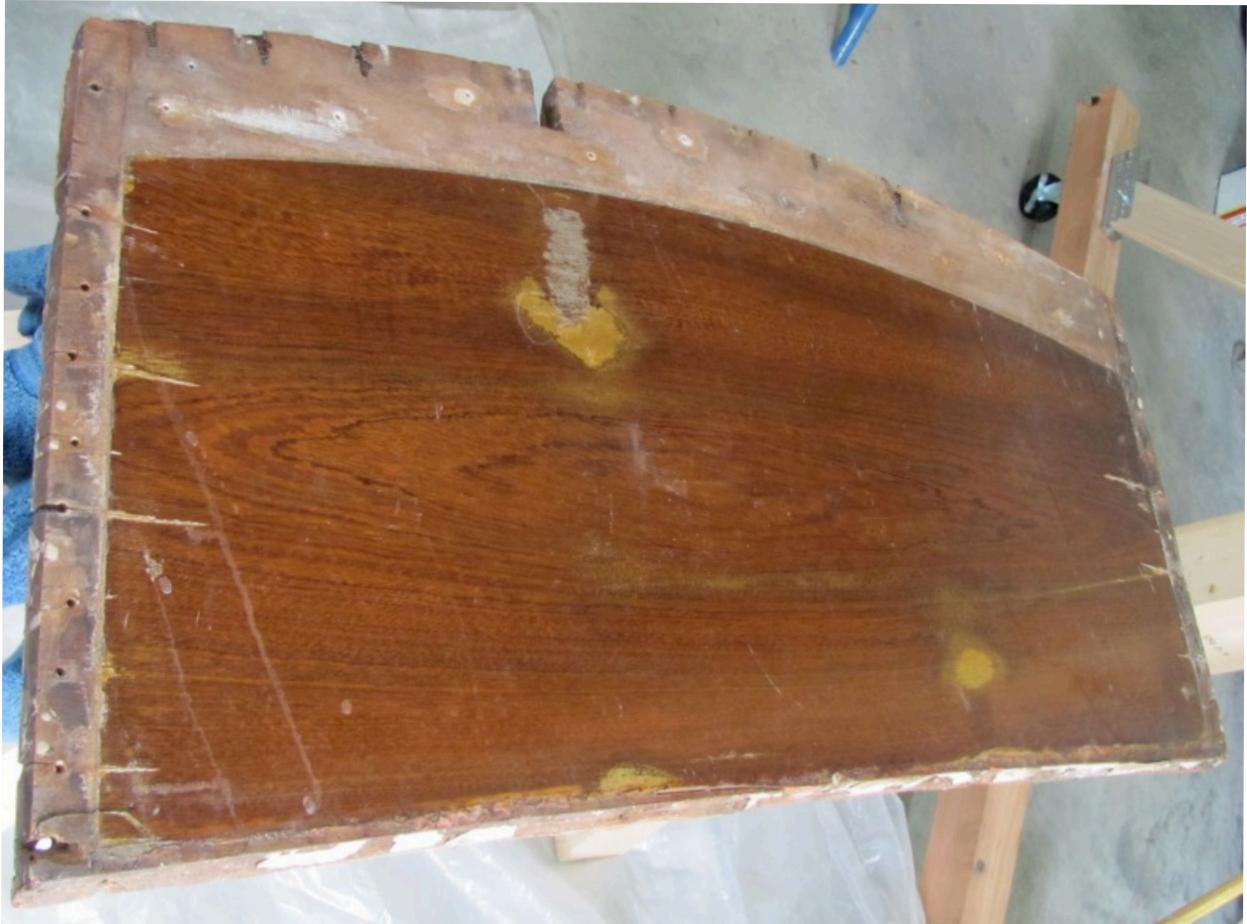
A look at the inside after it was removed.

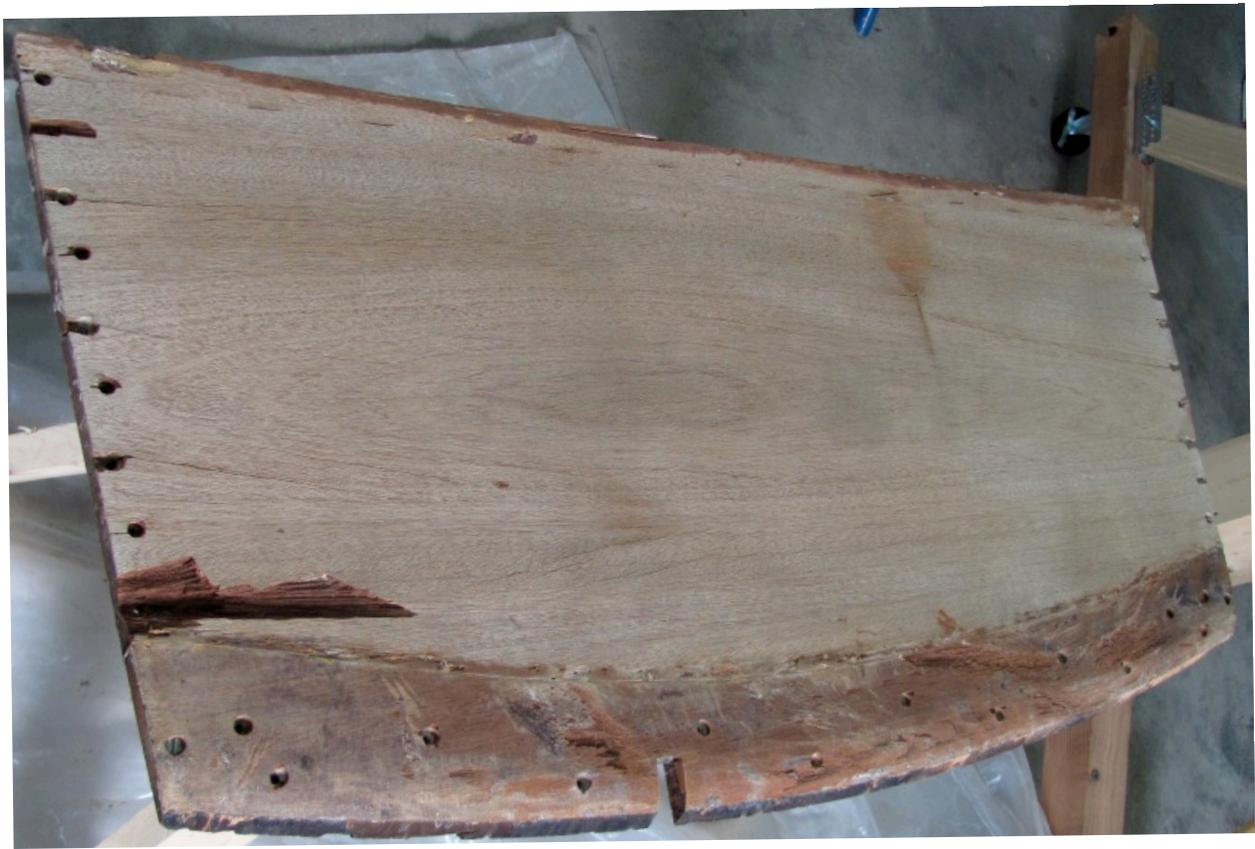
I've treated the outside of the cabin front twice with oxalic acid. Turned very white.

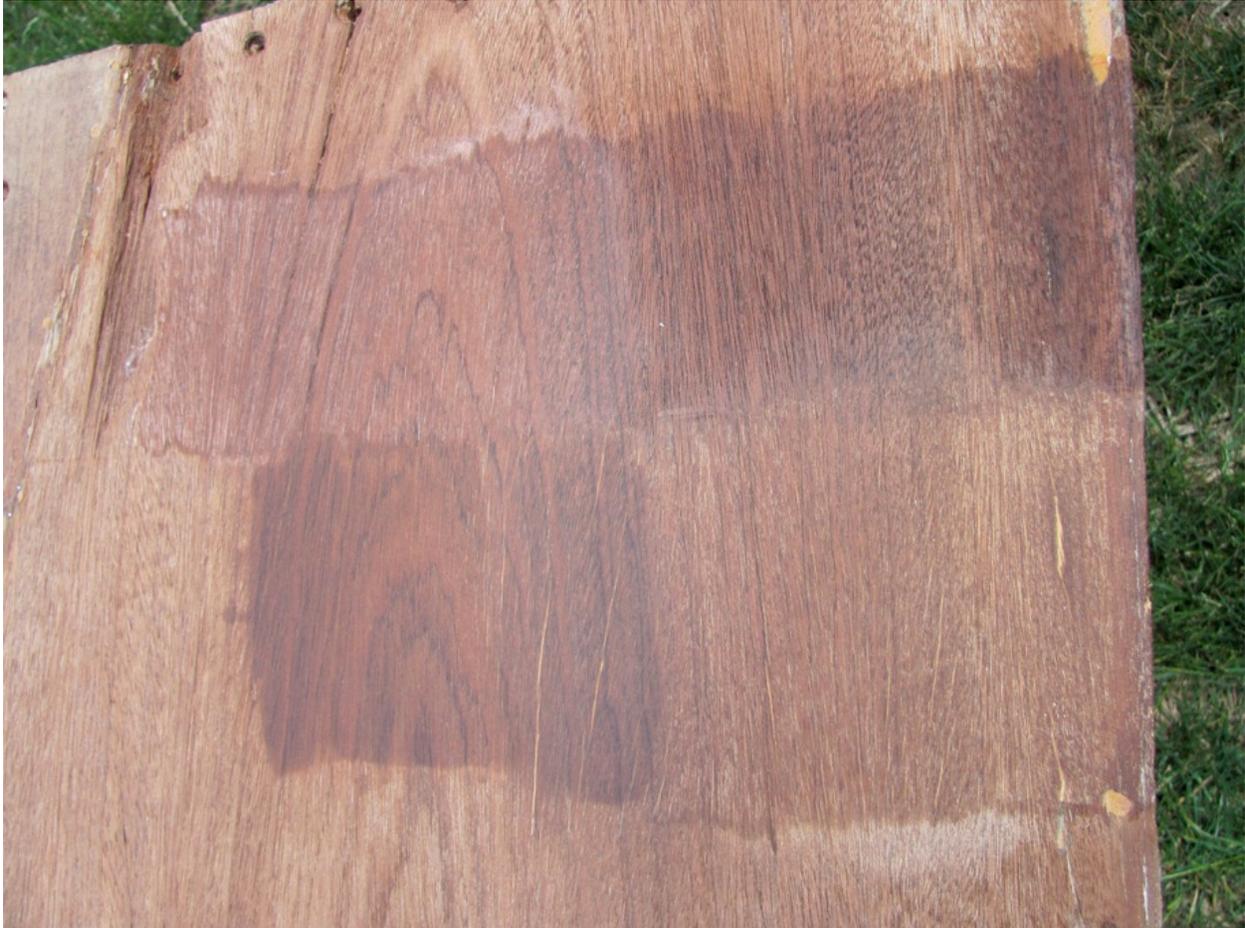
Note that both stains darken the wood considerably. I tried some pre-stain wood conditioner to try to limit the darkness, but the conditioner, being oil based, darkened the wood by itself. In this pic of the outside surface, there are five regions with different stain combinations (upper right and left about equal size; lower right same size as upper right, small region in lower center, and a little bigger region in the lower left). Wish I had Photoshop to make this clearer!

The region in the upper right was treated with just conditioner. In a further attempt to limit the darkness of the staining, I tried using a paste filler colored with some stain. The region in the upper left was a mix of about 12g of filler, 6g of mineral spirits and a few drops of General stain. The region on the bottom right is a combination of 7g filler, 3g mineral spirits, and 16 drops of Varathane. Note that although both of these regions are lighter, the white streaks from bleaching remain. It appears that the thinned filler doesn't fill the cracks adequately. I also tried unthinned filler (7g) and 10 drops of Varathane (lower region center), and 12g filler, 32 drops Varathane, 2 drops General (lower region left). The lower region center still has white streaks. The lower left region is the best thus far. In all of these experiments, it seems that the stain leeches out of the filler and darkens the wood. Consequently, I tried to apply plain filler first and then stain over (new region in lower left in the following pic), however, the dried filler did not accept much stain, so again white streaks appear – this time due to the light-colored filler. I

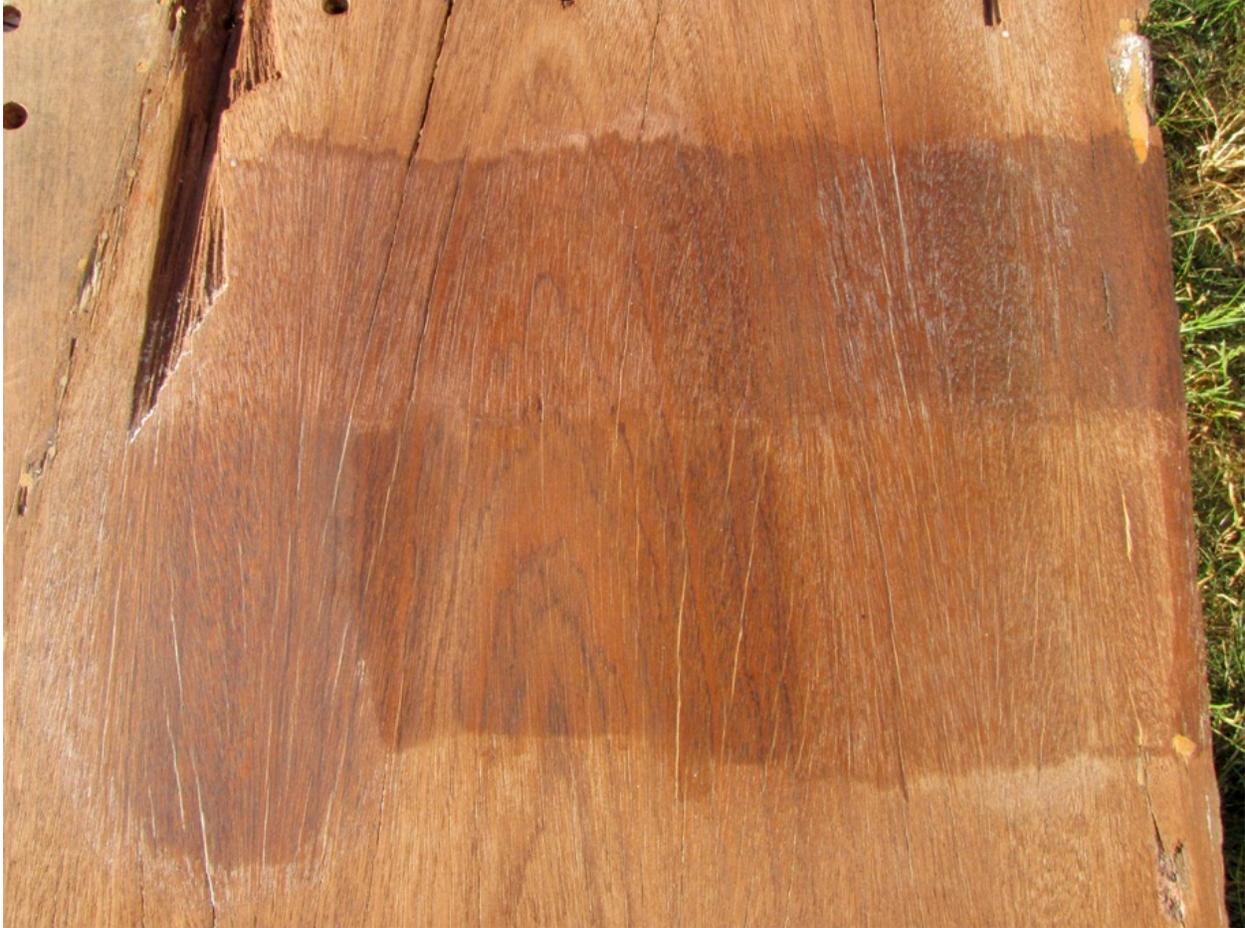
also tried applying filler over the previously conditioned wood, followed by stain (upper right), but this was also streaky. Not sure why the two previous pics are different shades - just different camera exposures, I guess.
