## Hanging S5

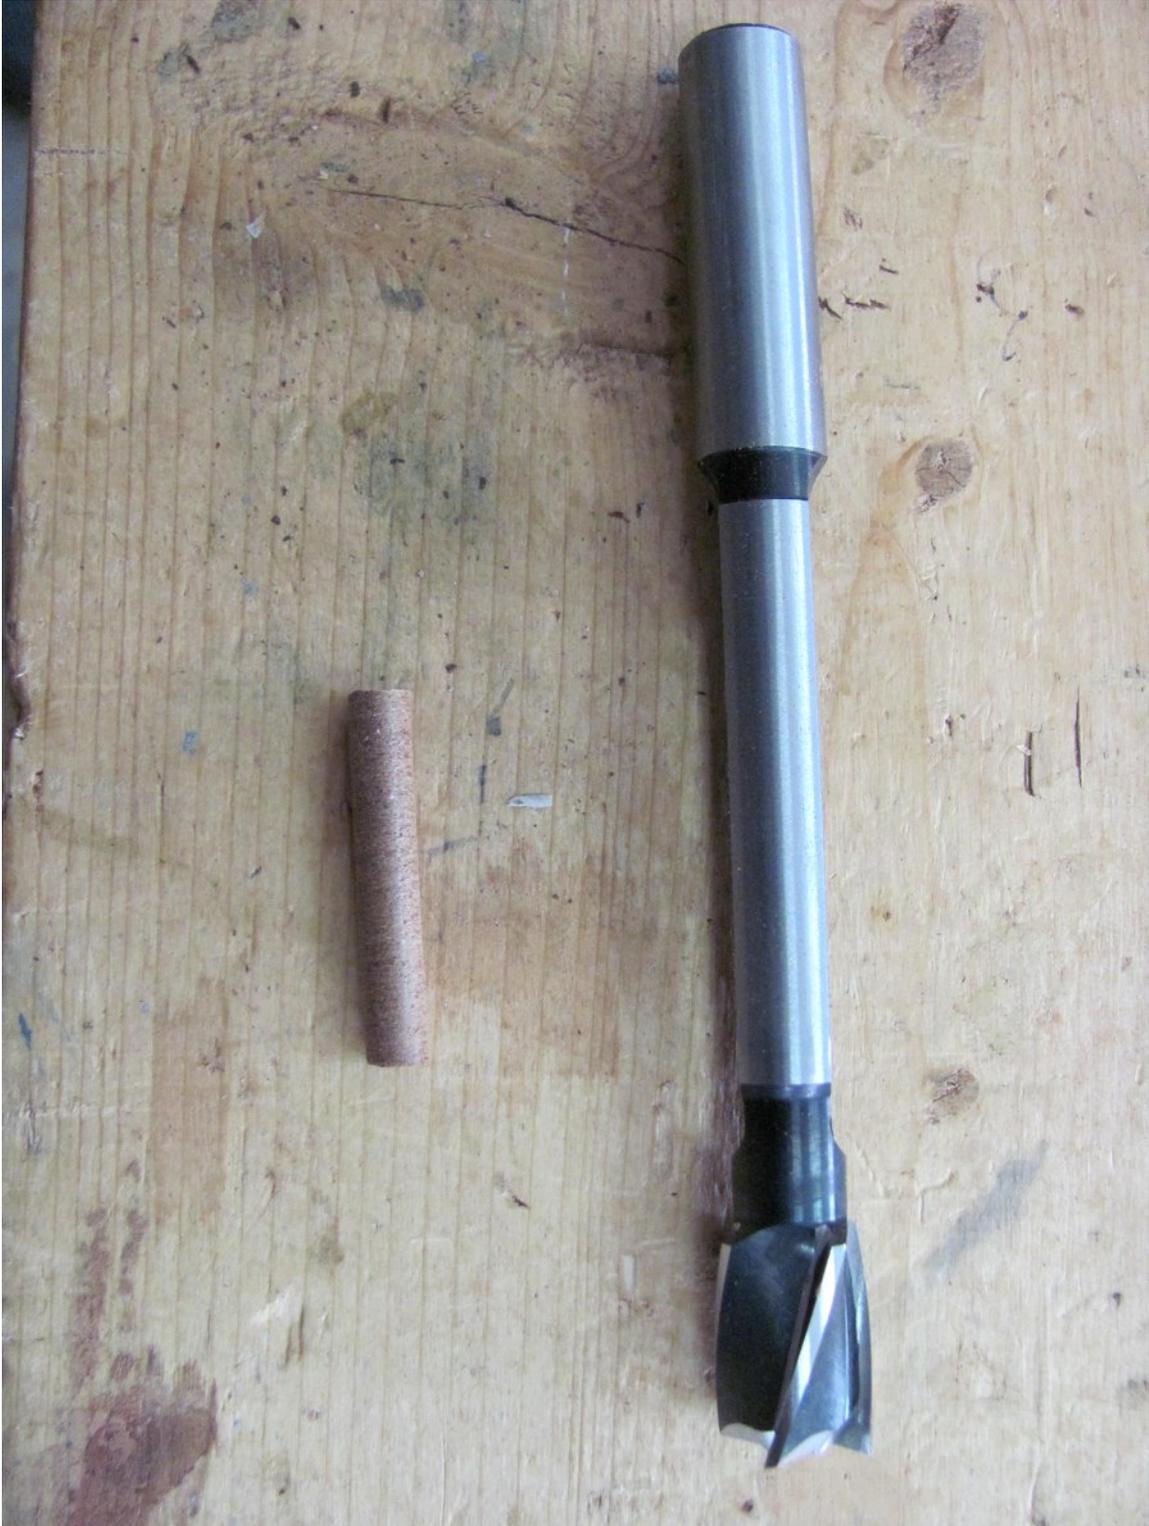
When it's time to hang S5, I'll need to make room for the clamps. So I removed S6. I then cleaned the wood behind S6 by scraping and followed by a wipe down with lacquer thinner. I then plugged the old screw holes with H. Mahogany bungs. Recently I had Mike Powell from the PSU Forestry Department identify the frame material as H. Mahogany. (Actually, I gave him one of the lower end shims, but I believe the material is the same.) I bought a special bit from Germany for making the bungs. The bit can make 6 mm (.236”) bungs 1.5” long.

This allows me to fill each hole with one bung. So I enlarged the screw holes to the diameter of the bungs to a depth equal to the thread length of the screw. I then used a pipe cleaner to coat the inside of the hole with epoxy (105/205) and then set the bungs in the G-flex blend. When the epoxy cured I trimmed the bungs flush with a chisel and cabinet

scraper. I then painted the contact surface with two coats of Primocon (1<sup>st</sup> coat thinned 10% with Xylene).
