Installing New Deadwood and Ballast 11/22/2012

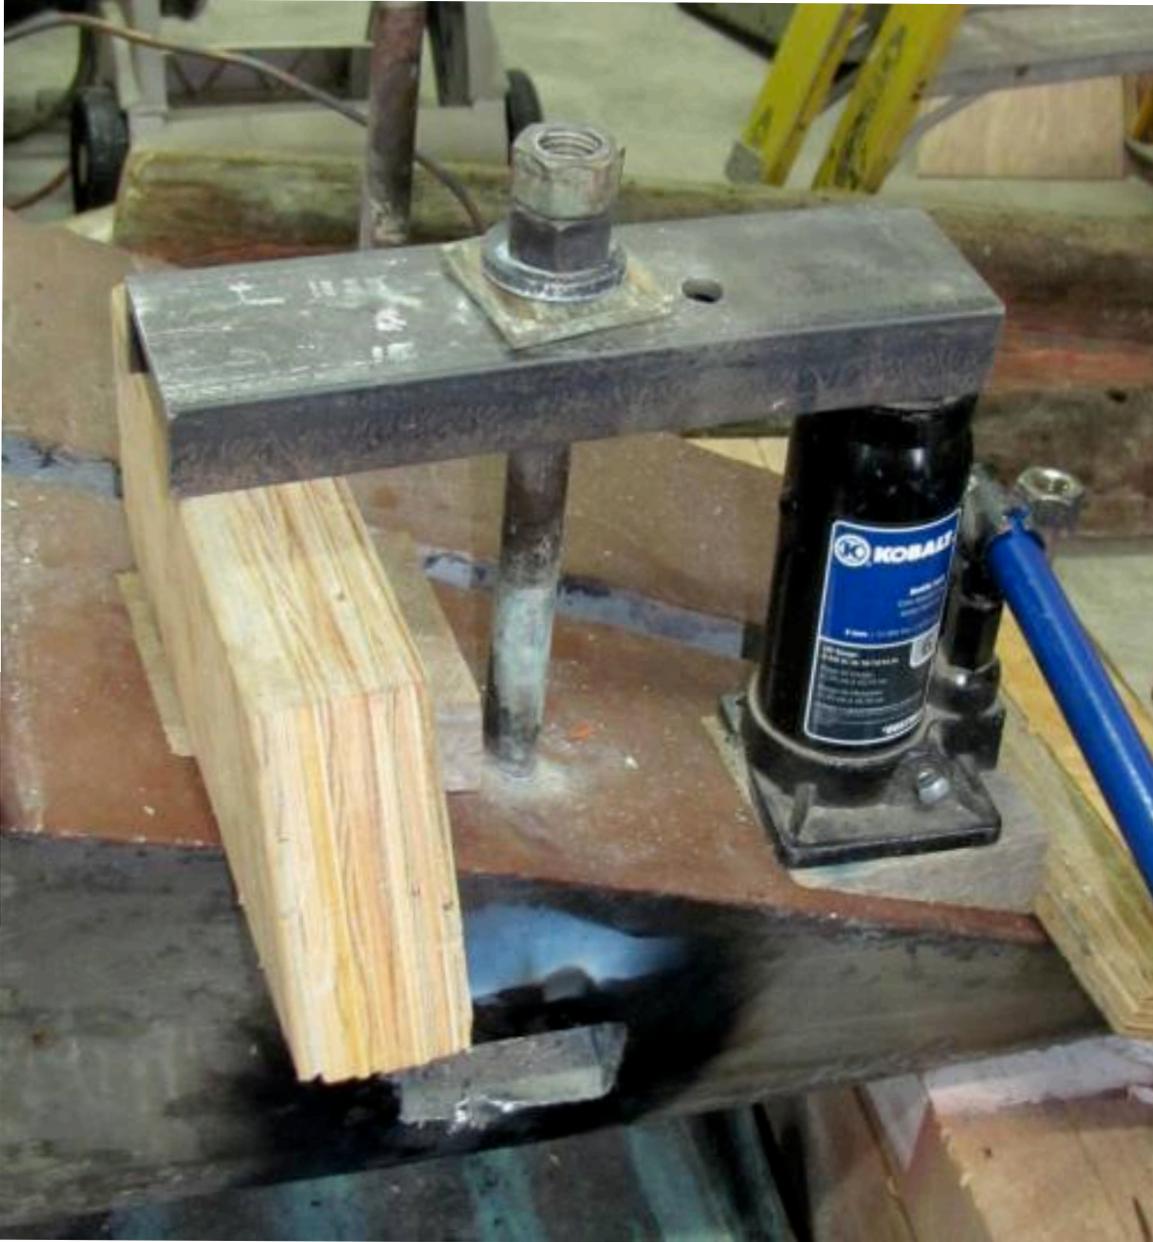
One of the problems working alone on a project of this magnitude is that you forget some of what you learned months ago. In this case, I forgot that the copper centerboard liner must be attached to the deadwood with wood screws, many of which are covered by the ballast! So the deadwood has to be installed before the ballast, so that you have access to these screws! So I removed two keel bolts unnecessarily.

After removing the nuts, I was able to remove the two bolts with an improvised puller.

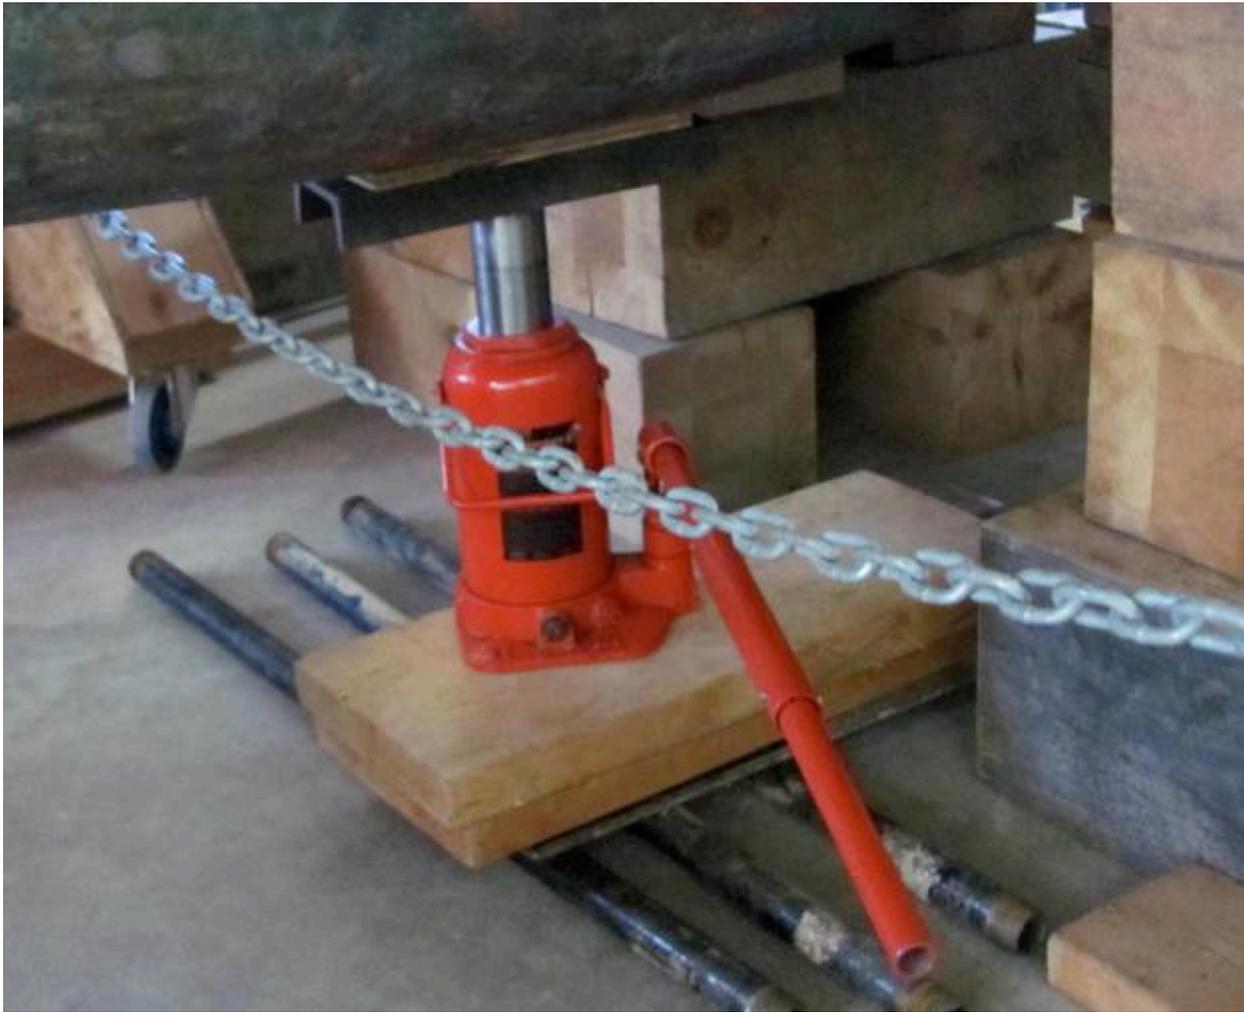
Moving 5800 lbs. $\frac{1}{4}$ " or less in any direction was no small feat. Hillman rollers are designed to roll in one direction at a time. You can change the direction, but this requires some effort. We tried levers and block & tackles to control the amount of movement, but these proved to be unsatisfactory. Ultimately, we had to call it a day and return the rollers (they cost \$75/day).

After some thought and helpful ideas from neighbors, a solution emerged. The key was to establish controlled incremental movement both longitudinally and athwart ship. The control of longitudinal movement was discovered accidentally.

In the picture above, the pipe rollers are arranged for fore/aft motion. A steel plate is inserted between rollers and wood blocking. Rotating the pipes 90 degrees provides the desired lateral motion.

The idea is to lift the ballast at its center of gravity just high enough to take weight off the blocking (which is still bolted to the ballast). A pry bar between the steel plate and the floor can then shift the ballast as needed.

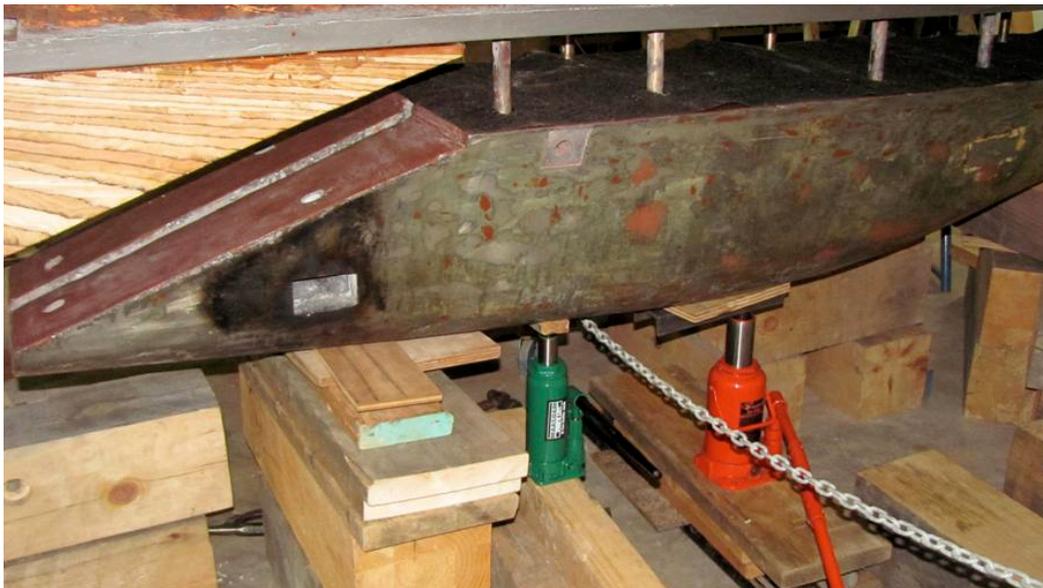
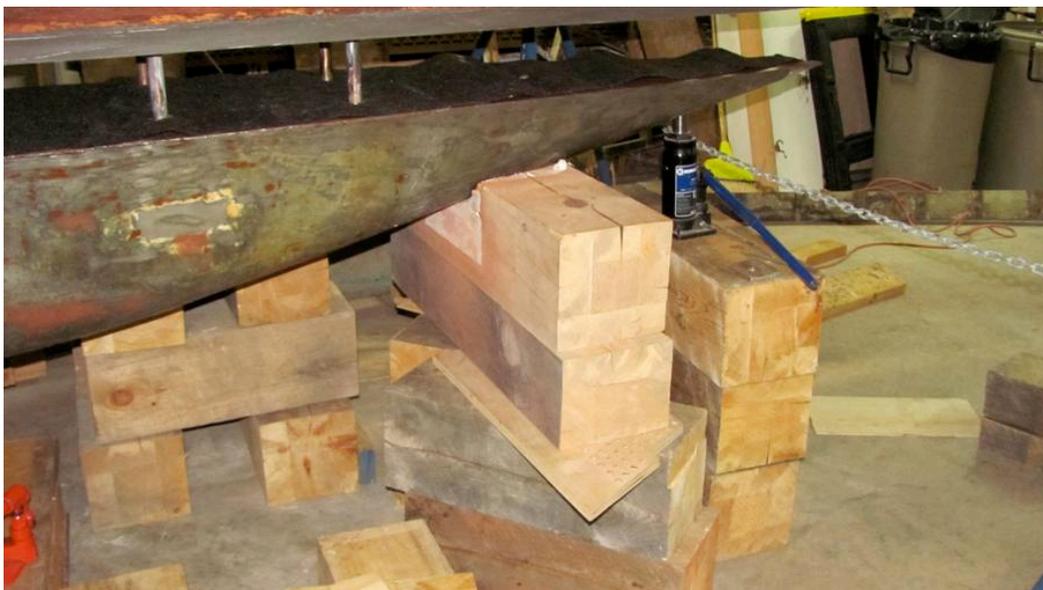
At this point we discovered that a single jack was insufficient – one or more bolts would bind in their holes. This is actually quite easy to determine. One can watch the bolts as the jack is raised and see if they are moving in the holes. Also, if the bolts are binding, the hull begins to lift and the poppets become unloaded. Through experimentation I learned that by adding a jack forward and one aft, provided the necessary control to lift the ballast in place.

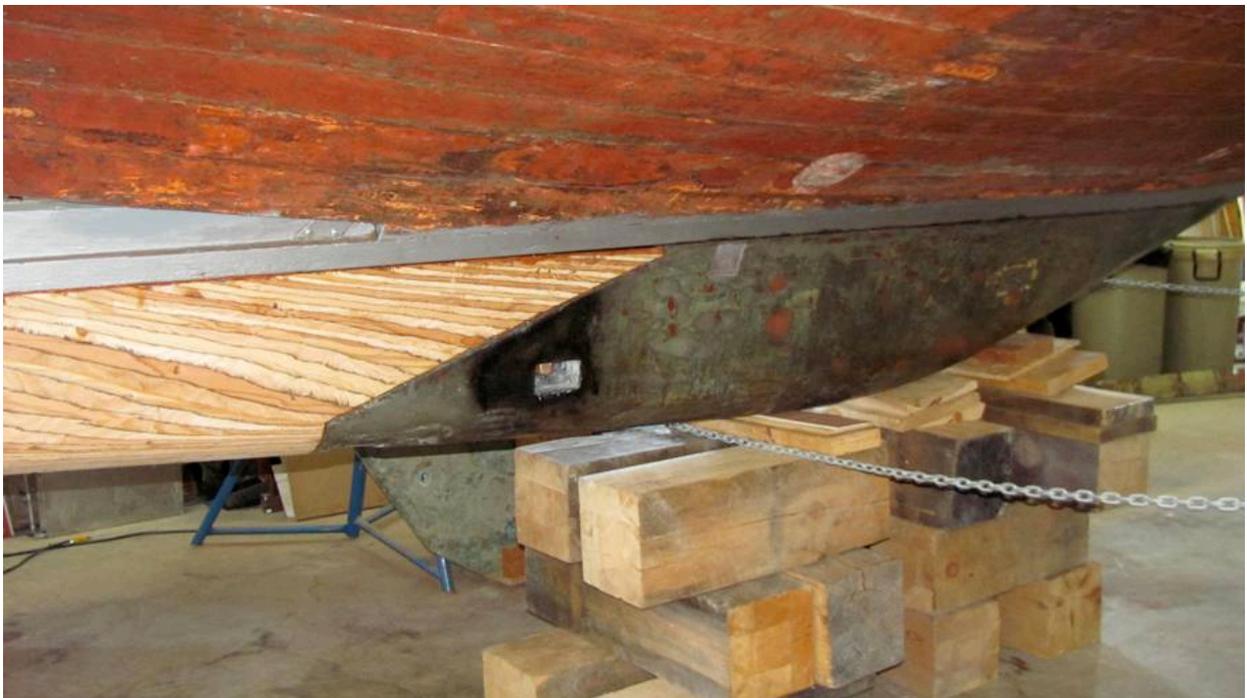
After several hours of jacking and blocking (1/4" at a time), the ballast is finally home!

- Although the template idea for adjusting the fit of the deadwood was a good one, I was careless with my measurements. Specifically, the ballast was about 1/8" too far aft and I neglected to account for the thickness of the felt. These errors combined to produce about 1/16 – 1/8" gap between the deadwood and ballast.
