Keel Repair (11/3/2011)

Keel Rabbet

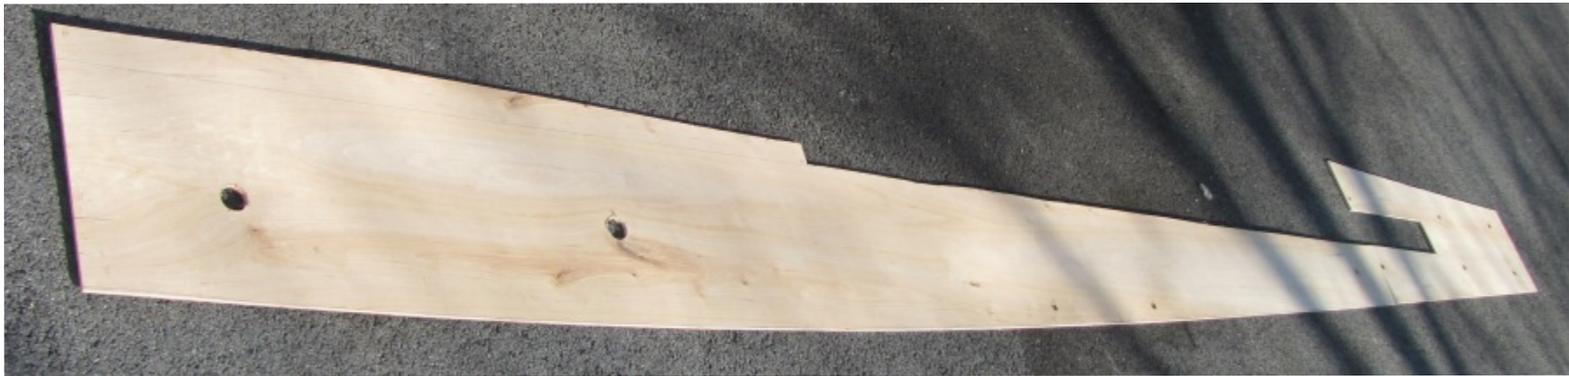
I used Luan underlayment, which is cheap and works well. I just clamped the Luan to the bottom of the keel and drilled down through a few of the vacant bolt holes to register the template's location. Then I just traced the shape of the keel onto the template, removed the template from the boat, rough cut the curve with a bandsaw and planed to the line.

Because of the length of the repair, the template consisted of two pieces. In the picture above, the two pieces are laid together with the longer forward section in the foreground and the short aft section in the background. The keel curve is towards the bottom of the photo.

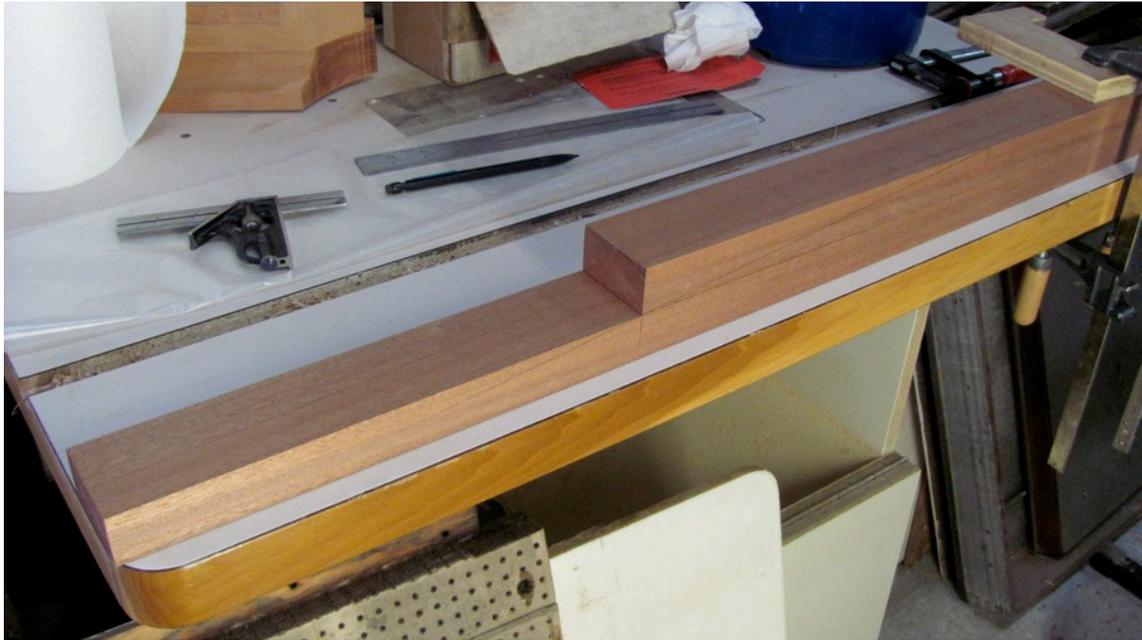
I use a method for cutting scarf joints that pretty much guarantees a good fit. First, look at the grain of the two pieces to be sure that the grain will be running the same direction when the two pieces are assembled. Otherwise you end up with grain tear out when you later plane the finished piece to shape. Then clamp the two pieces together as shown in the pic below - the top piece set back the length of the scarf (12" in this case, since the piece is about 1-1/4" thick). Now draw a diagonal line starting from the bottom left hand corner of the bottom piece to the top of the top piece, 12" back from the front of the top piece. You can just see the line in the pic below.

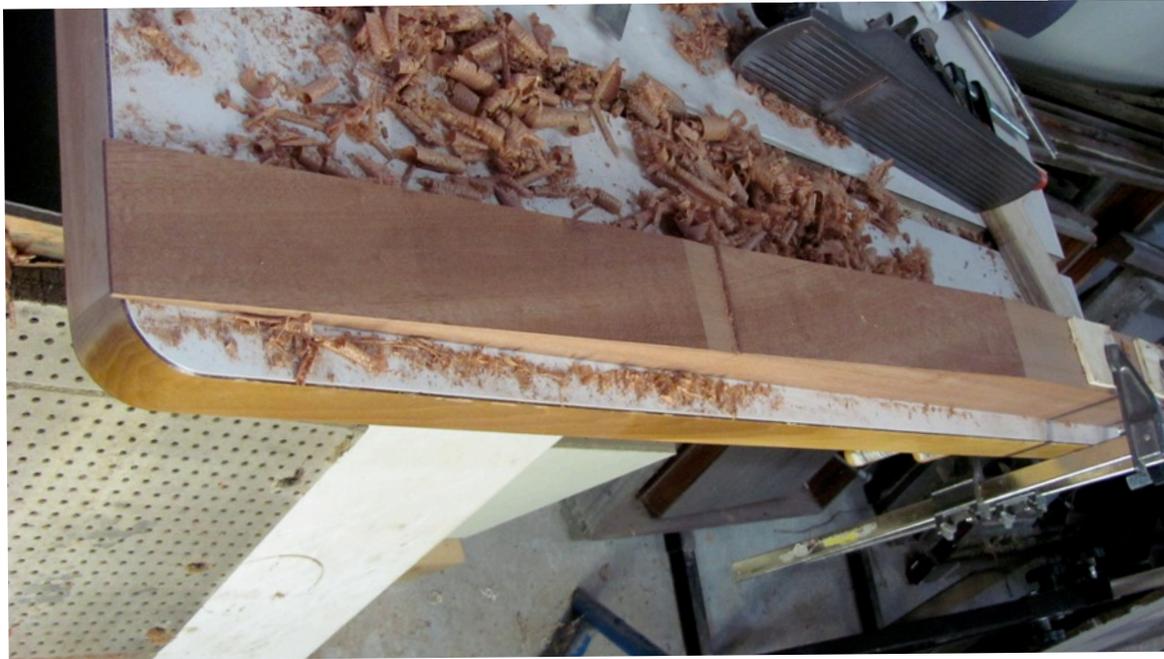
The pic shows the process almost complete. Even with a long-bodied plane, it's possible that the tapers on the top and bottom pieces can differ. There are two visual checks that allow you to keep the tapers the same. The first is the thickness of the feather edges on the two pieces. Keep these thicknesses the same and uniform across the width. Also keep the lengths of the tapers the same. In the pic below, you can see where the bottom taper ends by the change in color.

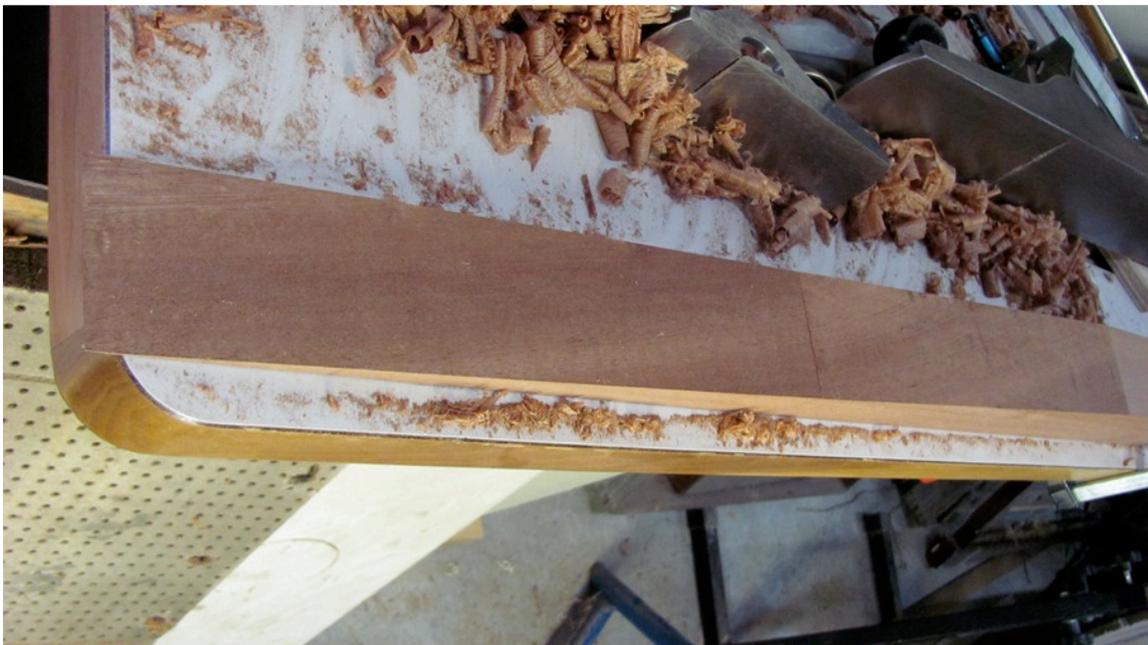
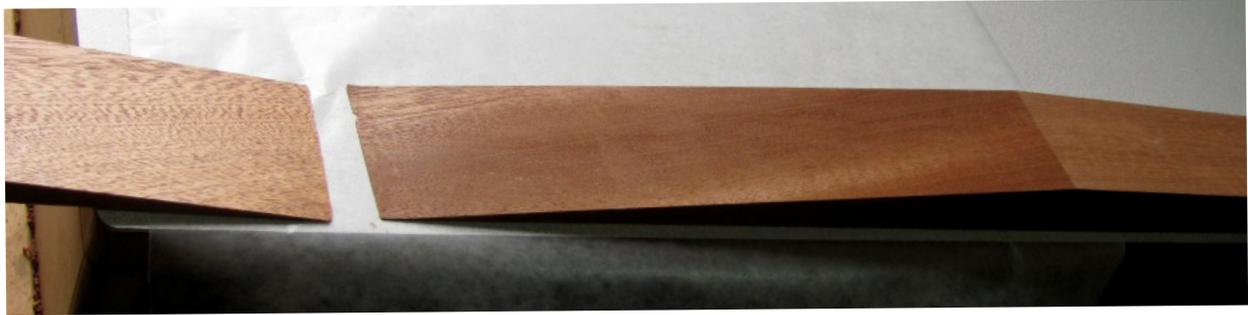
If you maintained these visual checks, you should end up with a continuous taper as shown in the pics below.

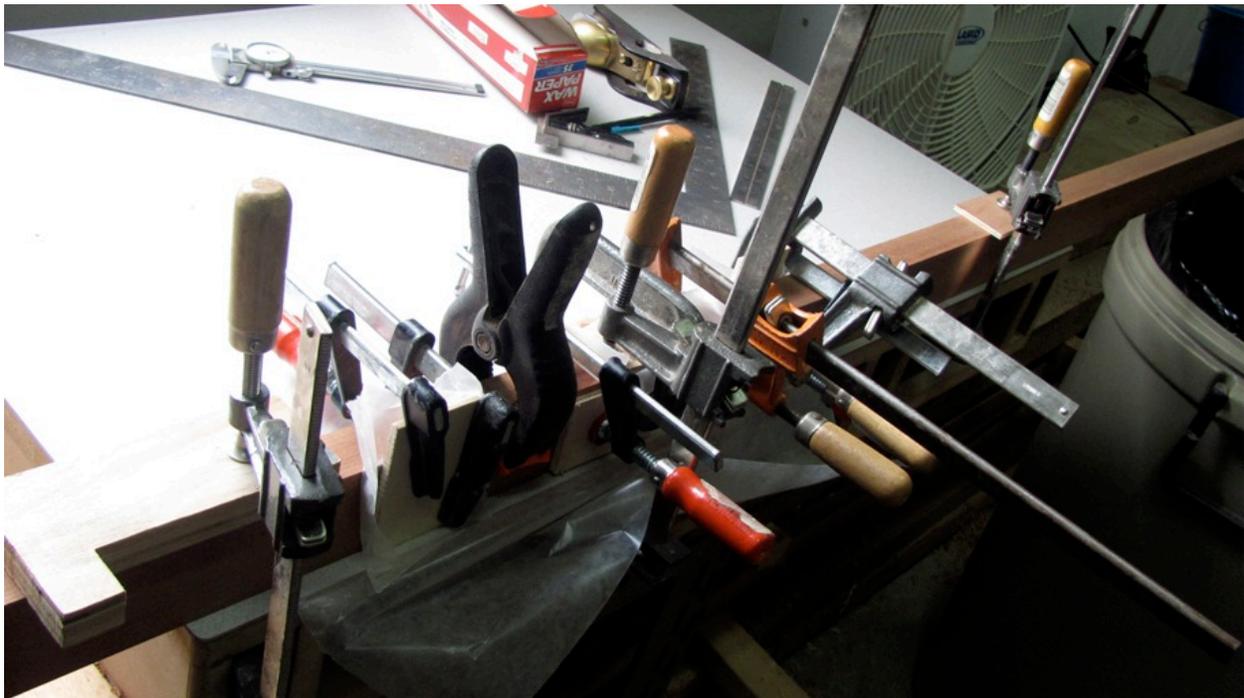
Here the two pieces are being glued together. If you've been careful, you will have little or no trimming to do when the glue dries.

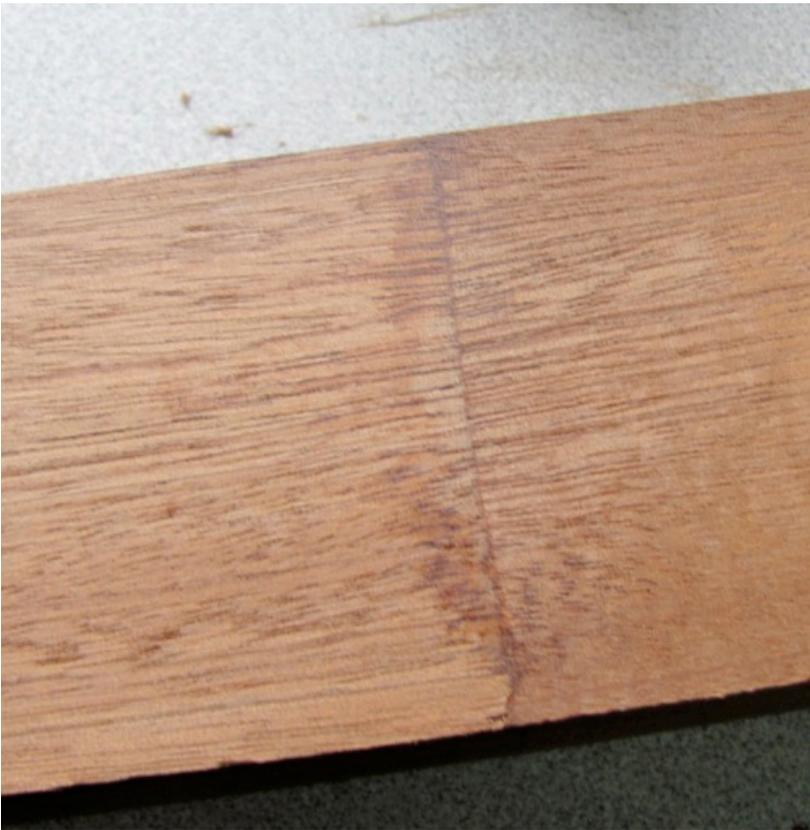
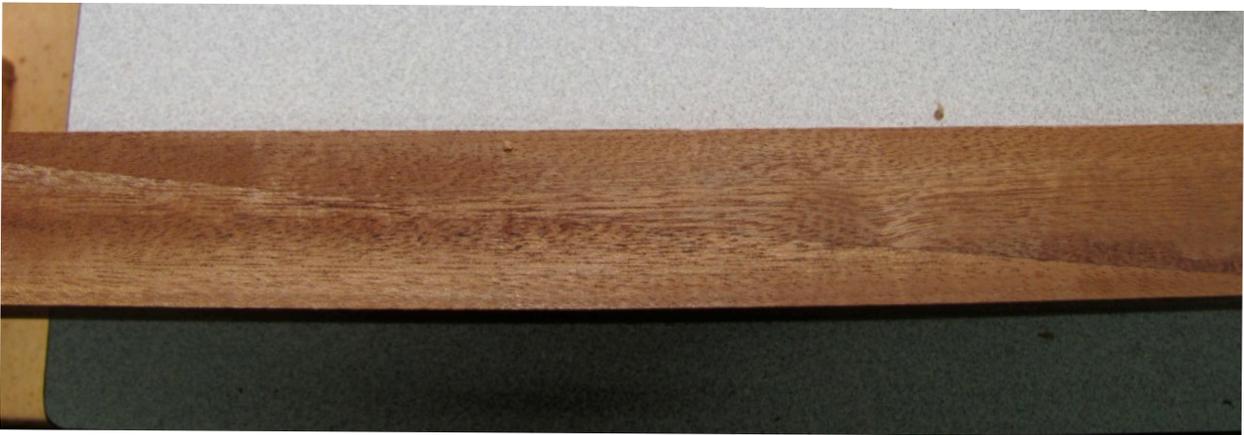
The next two pics show the finished scarf.

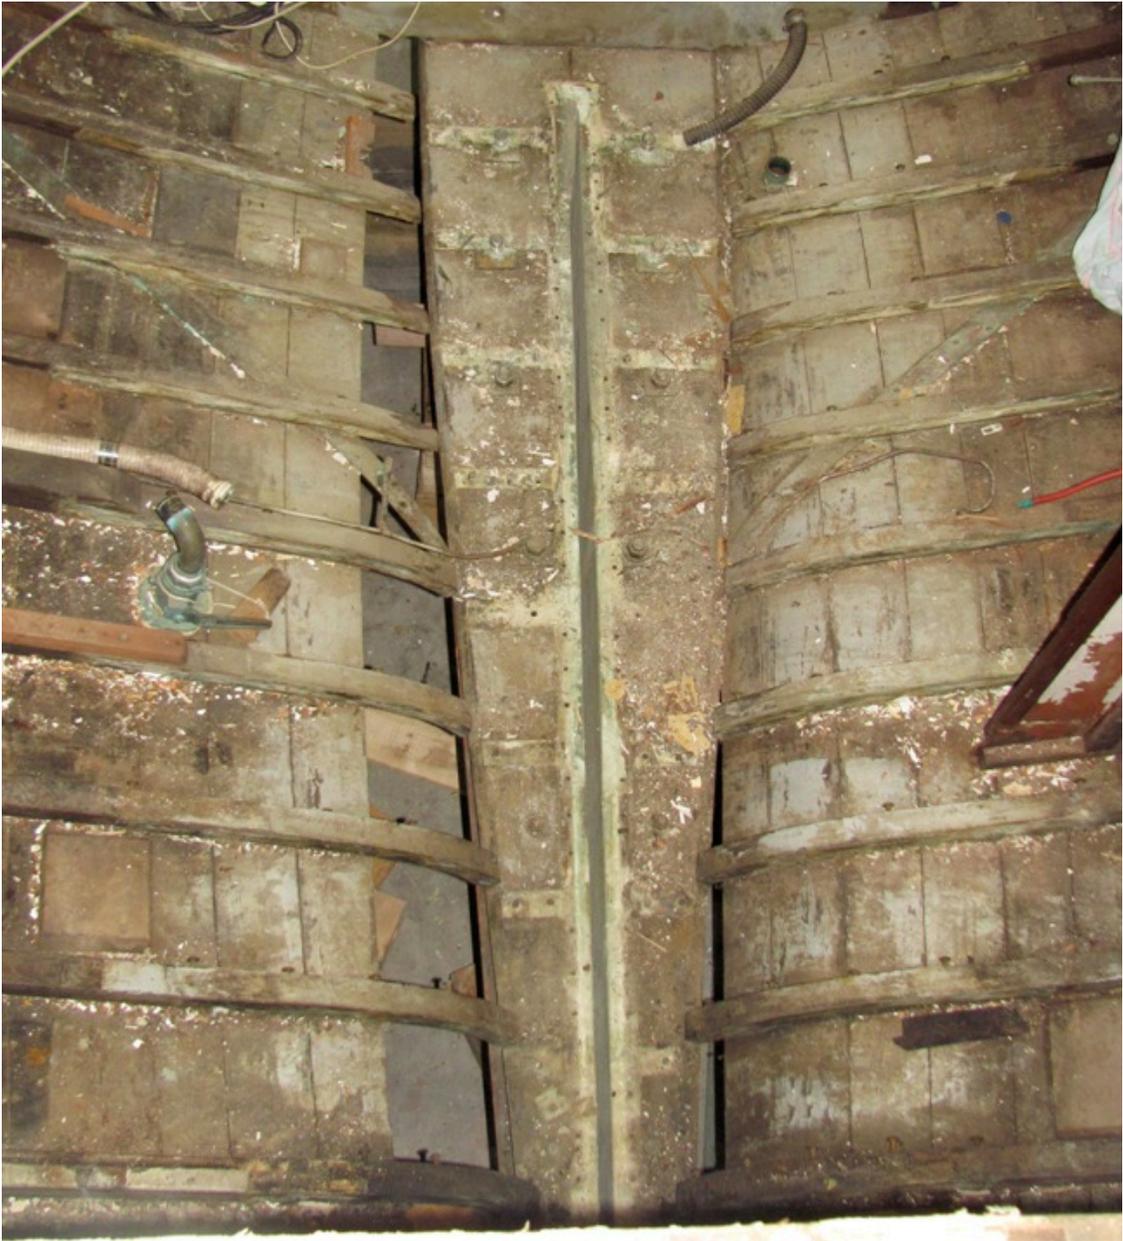
Ok, so now it's time to glue the replacement piece to the keel, but there is a bit of fitting to do first. To see why this is necessary consider the shape of the keel plank viewed from the top. A picture of the keel is provided below.

In summary, the keel is very narrow aft, widens to a maximum somewhat forward of amidships, and then tapers towards the bow. The repair does not extend the length of the keel, however, so the repair must be tied in to the original/remaining keel rabbet. Typically, this would require two scarf joints (one at either end), but the geometry of the keel leads to a simplification. I need a scarf joint aft but because the keel tapers towards the bow, I can just let the repair run out to a feather edge.

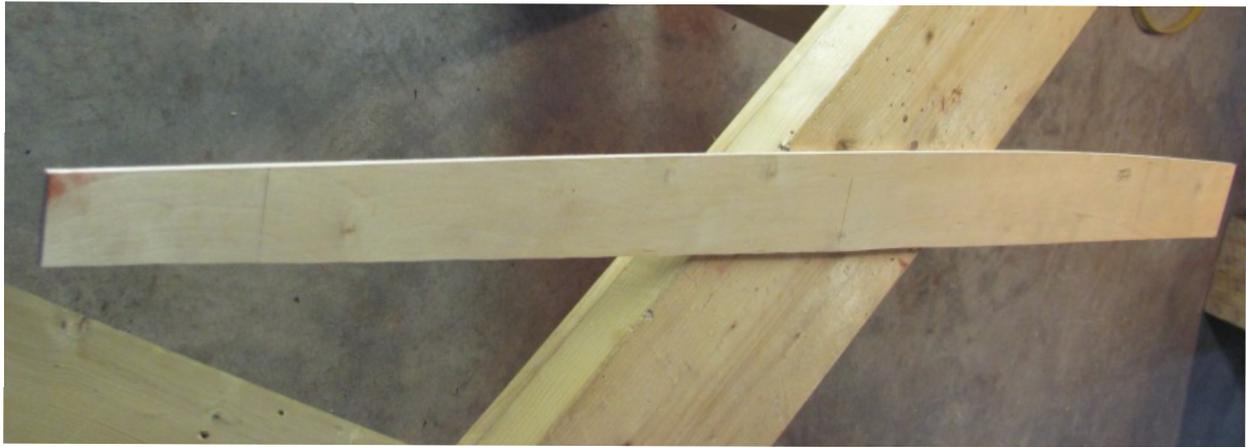
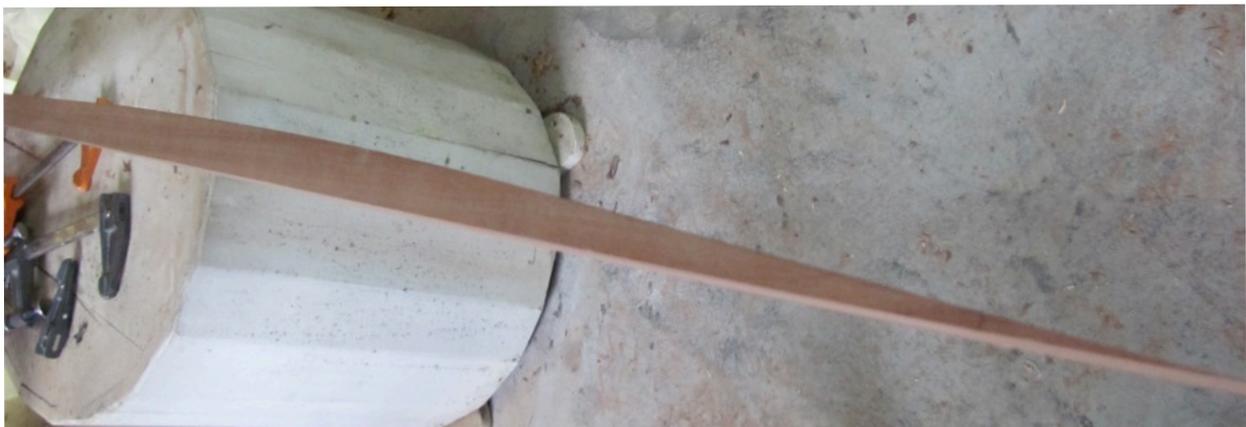
Normally, I would use a typical 10:1 scarf aft. In this case, however, removing the damaged wood aft with a plane left me with a curved surface rather than a straight taper. I could have opted to remove some additional wood to make a traditional flat scarf joint, but I decided it was easier to just make the repair fit the curved surface. So I made a template of the curve (just clamp a piece of template stock to the bottom of the keel and run a pencil along the keel), traced it onto the repair piece and planed to to shape. The template and the tapered repair piece are shown in the next two pics.

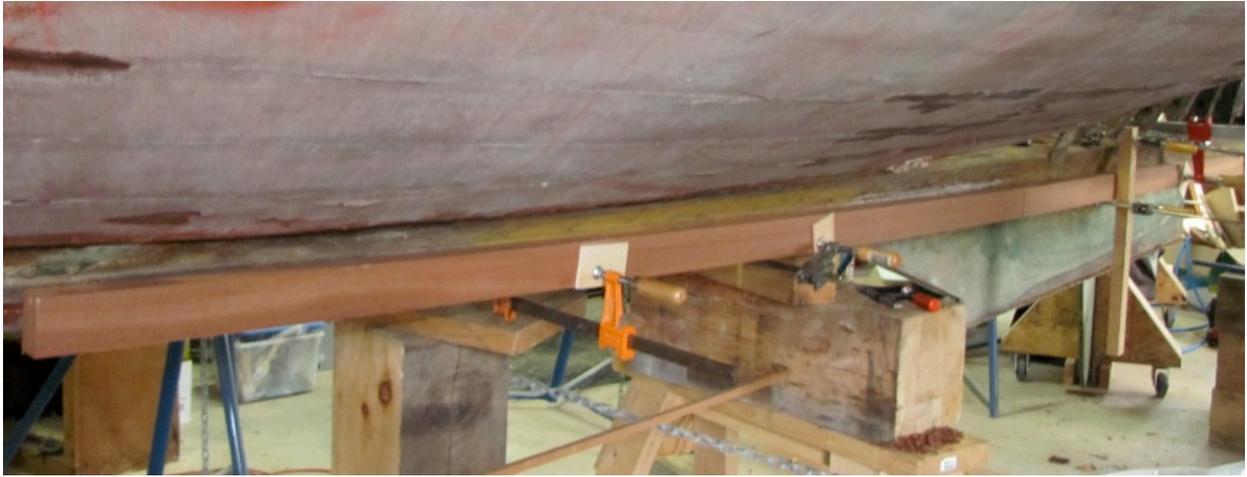
Clamp the repair in place.

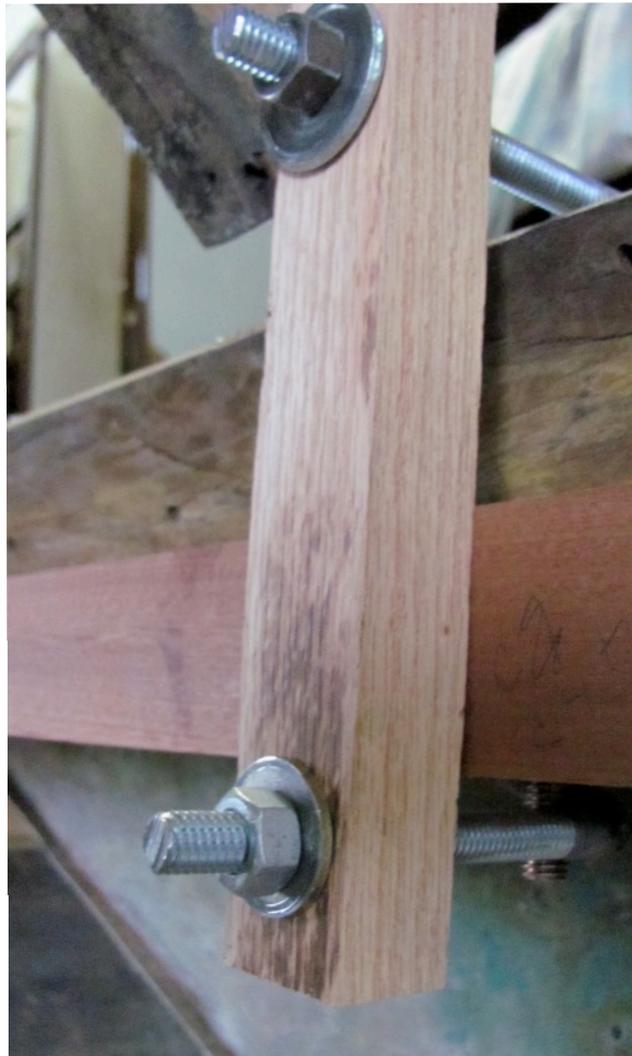
Sometimes custom clamps are required.

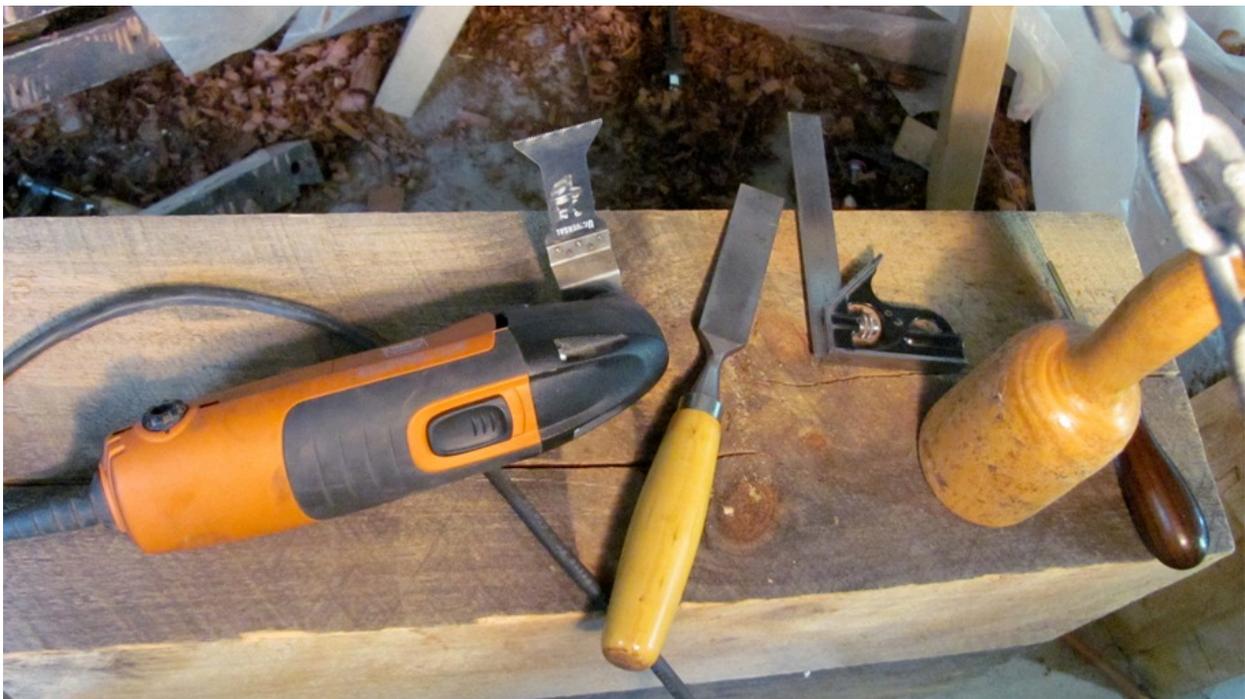
Trimming the repair flush with the bottom of the keel was fairly straight forward using a jack plane. Cutting the bevel was next. Here are some tools that I used.

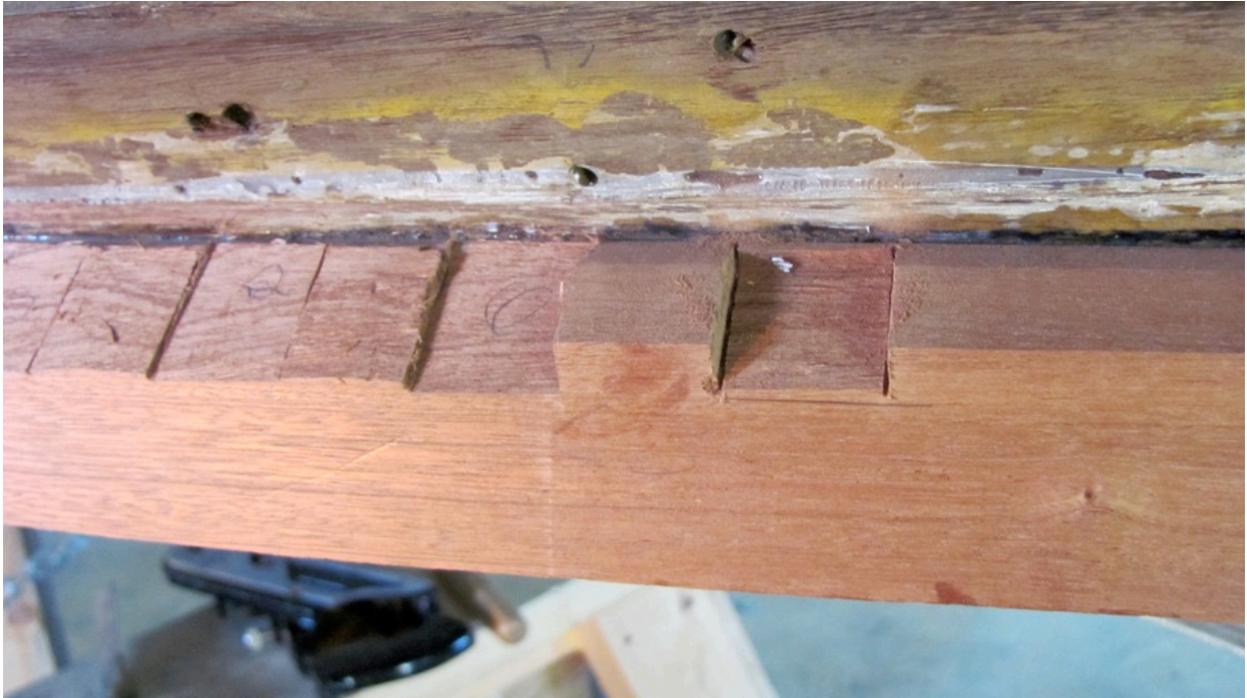
I used the Fein Multitool to plunge cut a pair of saw kerfs about 1" apart and then cleaned out the wood between the kerfs with a chisel, being careful to maintain a 90 degree angle between the two surfaces (rabbet to back rabbet).

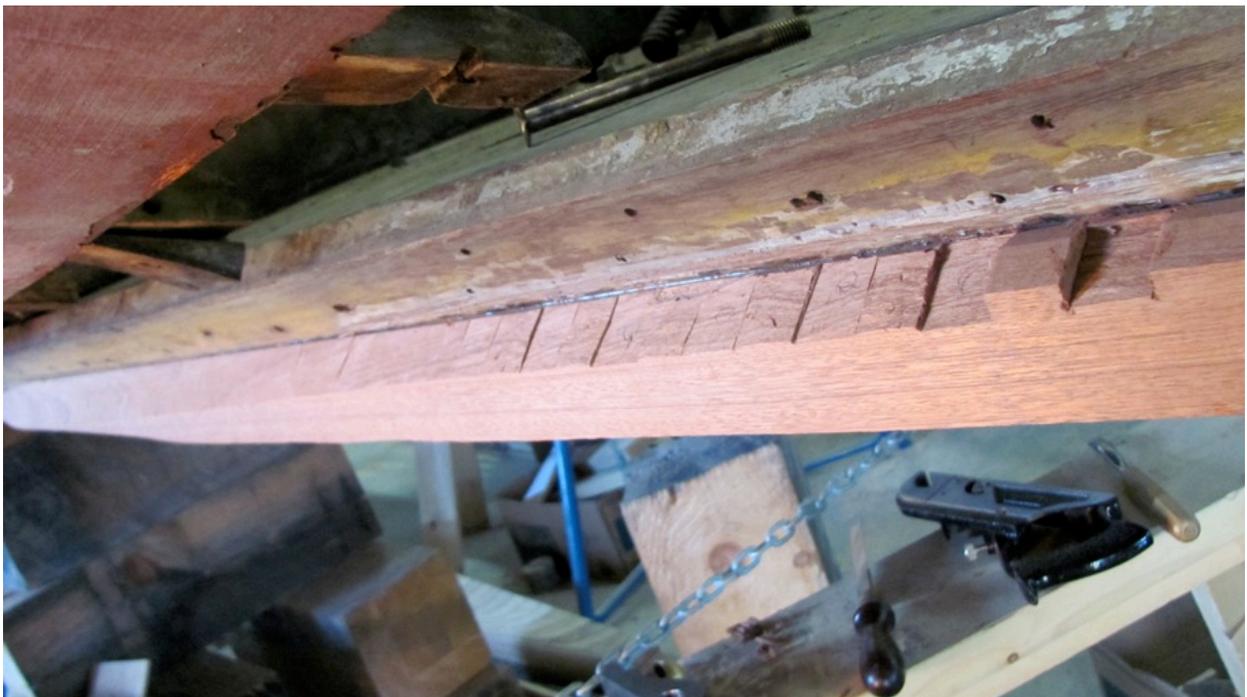
After that, I used a shoulder plane to clean up the rough spots. The pic below shows the process about 1/2 done. The left side has been planed smooth while I continue to cut slots to the right. The shoulder plane is visible at the bottom of the photo.

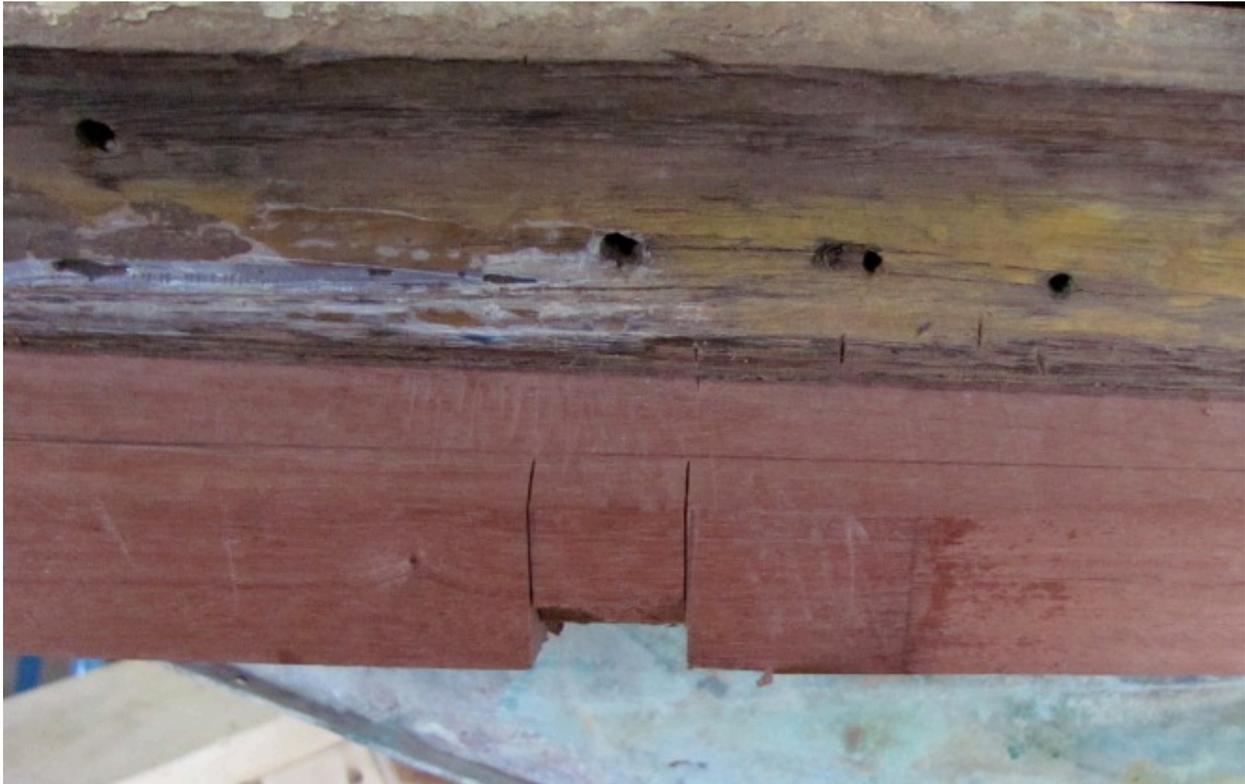
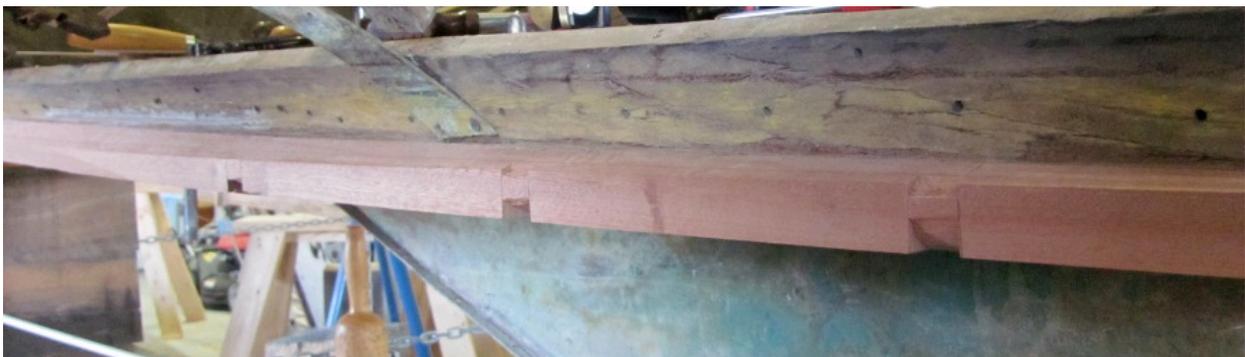
Next I trim the repair to the correct thickness. First I trace the shape of the top of the deadwood onto the bottom of the repair, using the template I made earlier. Then I draw a line 1" from the middle line. These are my two reference lines. I make a pair of saw kerfs connecting the two reference lines and chop out the wood between. These slots make it easier to judge the depth of cut when removing the bulk of the wood with a power plane.
