More Stopwaters

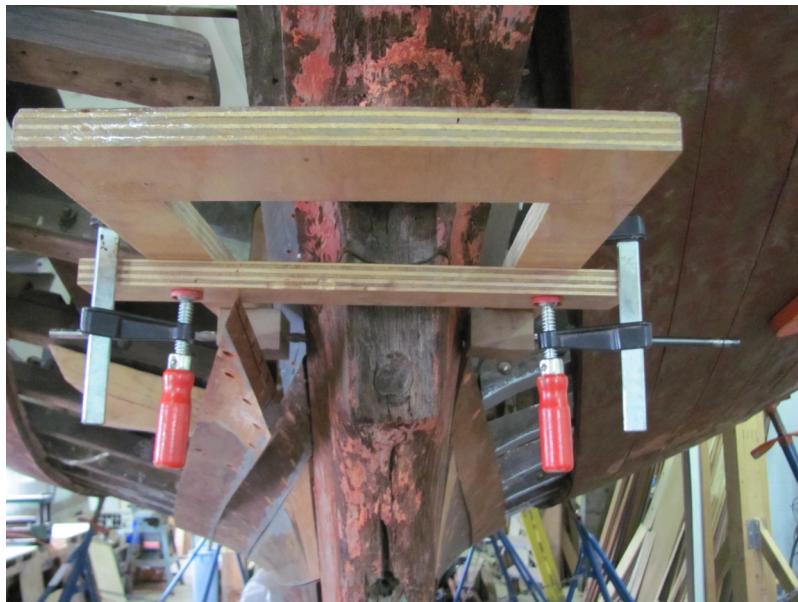
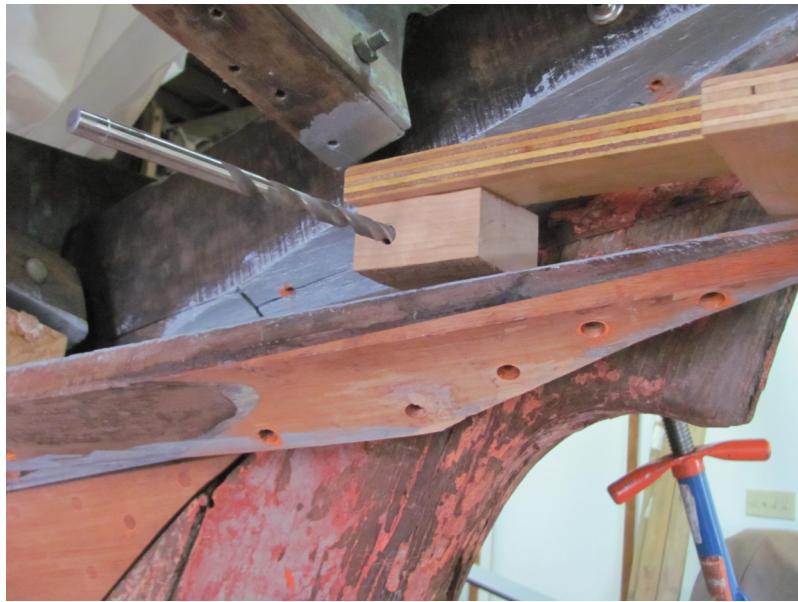
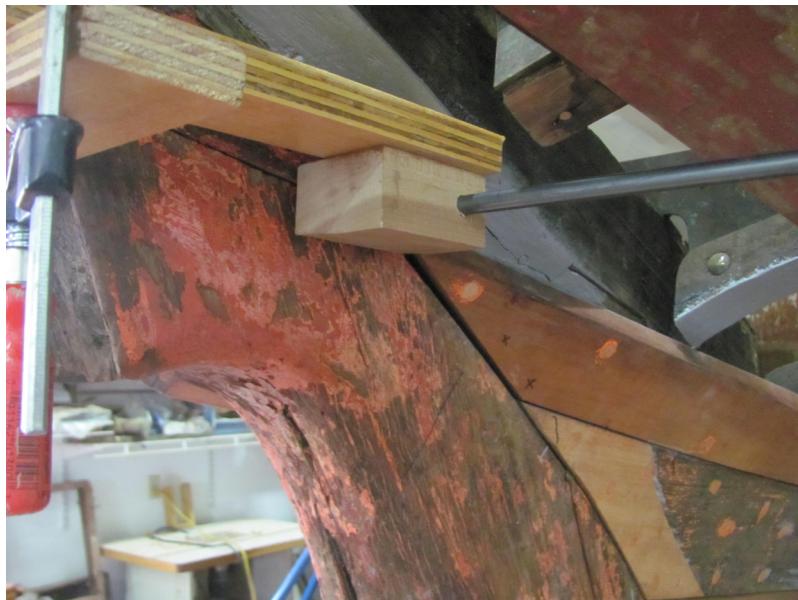
I drilled from both sides toward the middle, but the jig insures that the hole is fairly straight.

The next step is to drill a proper thru-hole, using the jig show below.

The replacement stopwaters were made from Western Red Cedar, left over from my kayak-building days. You start with a cedar stick about 9" long and just over 3/8" in diameter. Using a small block plane, you convert the four-sided stick to 8 sides and then 16. Then drive the stick through a 3/8" diameter hole in a piece of steel plate. This leaves you with a nice round 3/8" stopwater.

I also made a couple of Mahogany bungs and epoxied them into the hole in P7.
