**Engine  
(Final Assembly)  
(2010)**

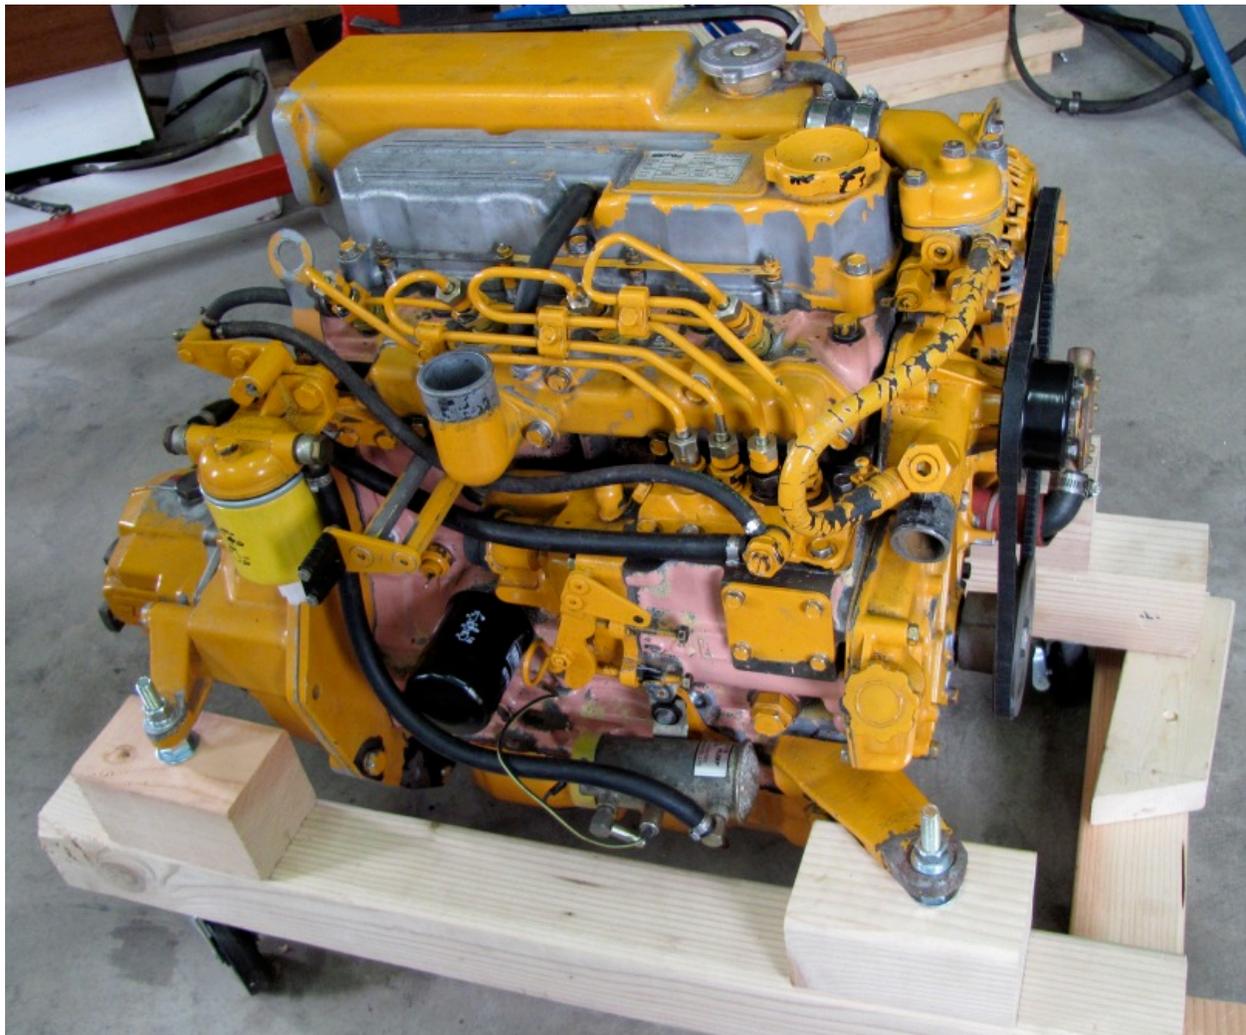
With transmission on the bell housing, I greased (White lithium) the spline, and mounted the bell housing to the engine rear plate. Now that the bell housing is in place, I have the four mounting pads I need to bolt the engine to a frame. Built a frame out of 4x4's and added 4 casters. Then bolted the engine to the frame so that I can roll it around.

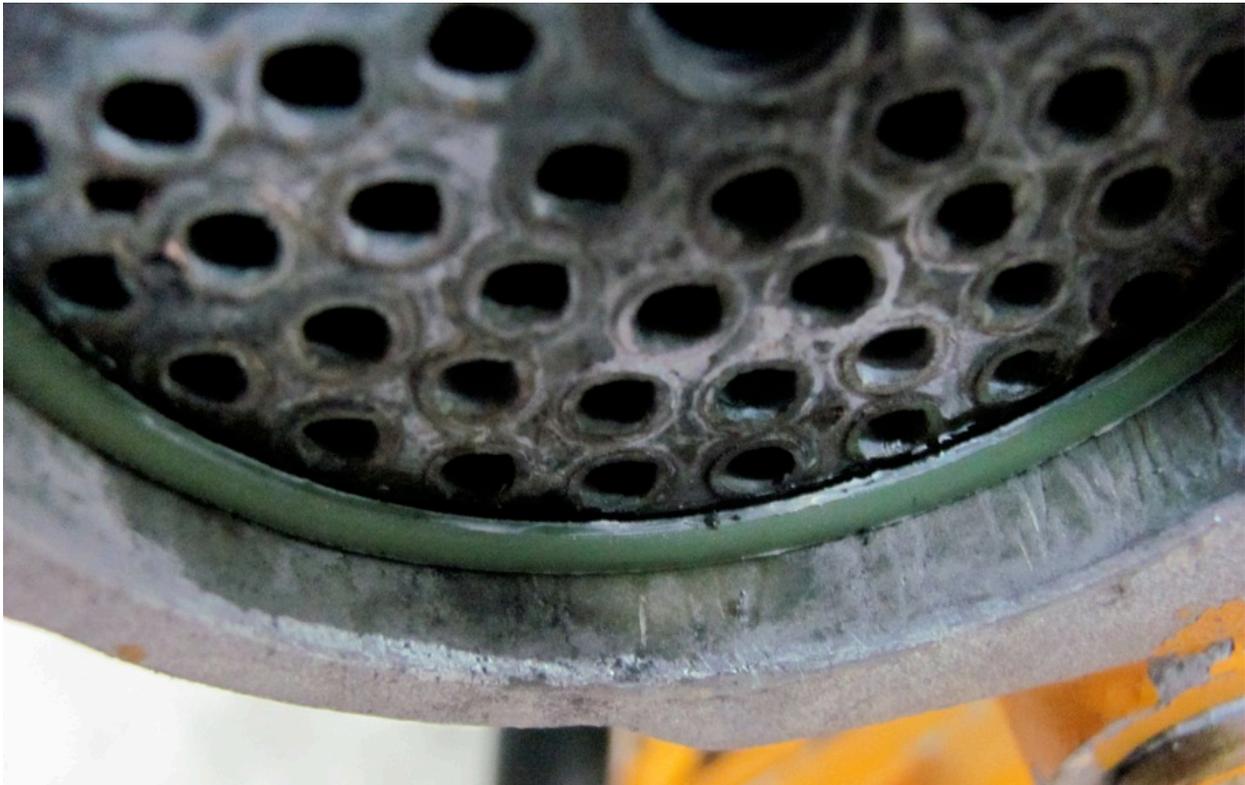
So I decided to fill the pits with epoxy. I decided to use some G-flex with Cabosil from West System, thinking that the added flexibility of the G-flex would better tolerate the expansion of the aluminum. I machined a wooden plug just a few thousandths smaller in diameter than the heat exchanger housing. I removed the exchanger from the engine. I mixed a batch of epoxy/Cab to peanut butter consistency and troweled into the pits, and then inserted the plug with some wax paper as a release. The next day, I removed the plug and cleaned up the squeeze out. Worked well.

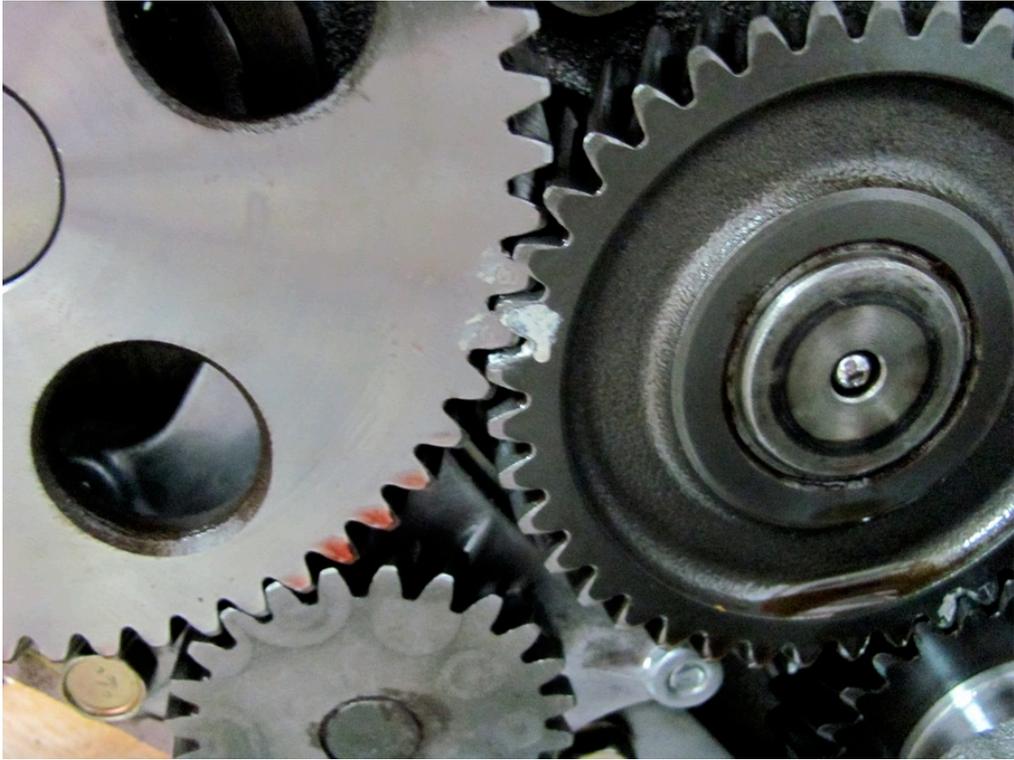
The timing gears are next. First the oil pump. Carson had suggested tearing this apart to inspect it, but I couldn't loosen the screws. I showed Carson the pump and he said that it was ok, even though there was some minor corrosion on one of the lobes. I put the special O-ring in place on the pump and inserted the pump in the block. Two screws hold it in place. Next the injection pump cam shaft (with gear already attached) is inserted into the block and tapped into place with a soft hammer. The oil pump gear meshes with the cam gear. One thrust bolt holds it in place. Next the valve cam shaft. Carefully insert it into the block so as not to damage the cam lobes. You can't see what you're doing, so it's all by feel. Once aligned properly it slides into place without persuasion. Two bolts through a thrust plate holds it in place. Turn the crank so that #1 piston is at TDC and insert the idler gear so that all the numbers line up – crank, injector cam shaft, cam shaft. The alignment of the idler gear and the injector pump cam gear and oil pump are shown below.

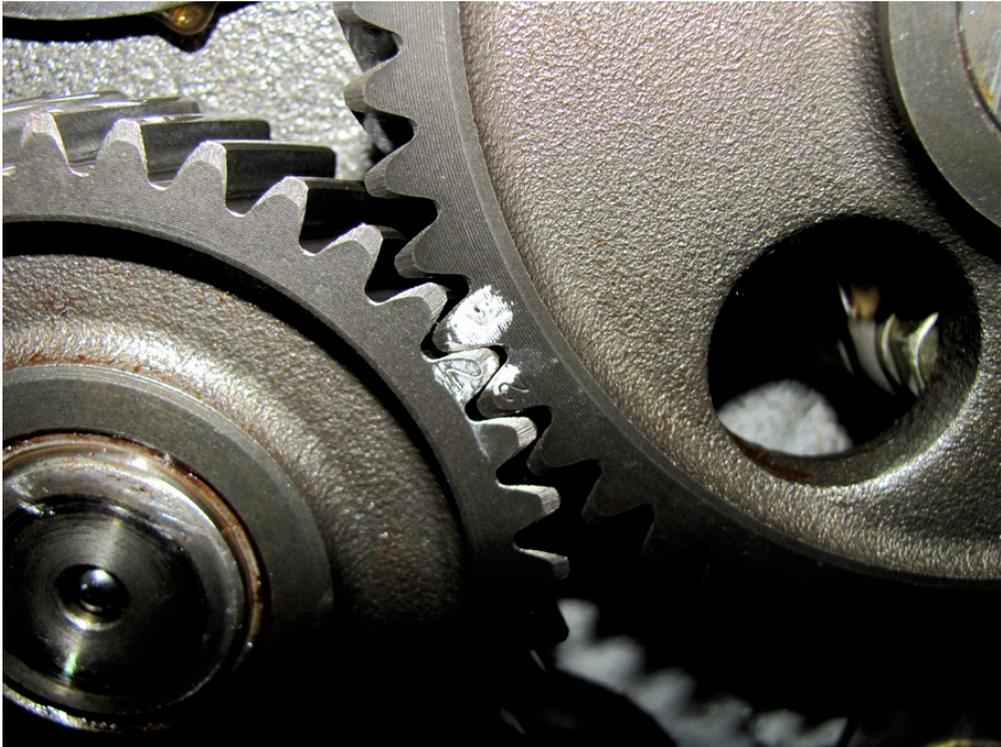
The alignment of the valve cam gear is shown below.

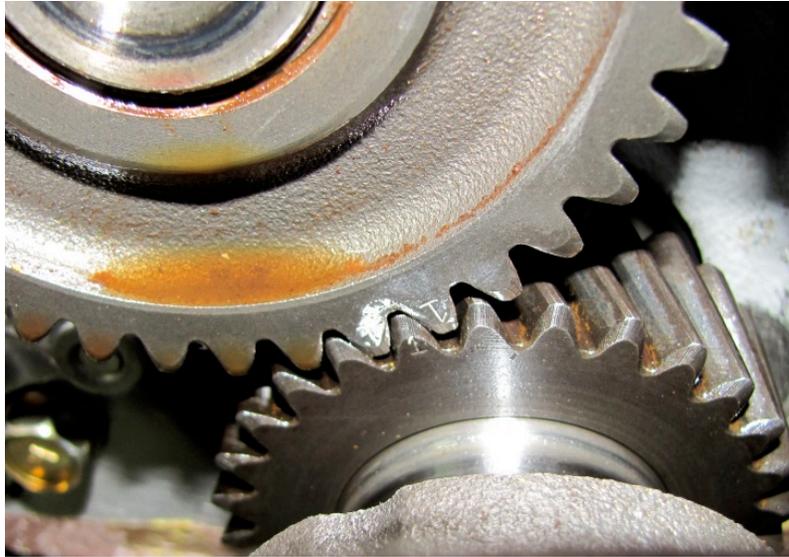
The crank alignment is shown below.

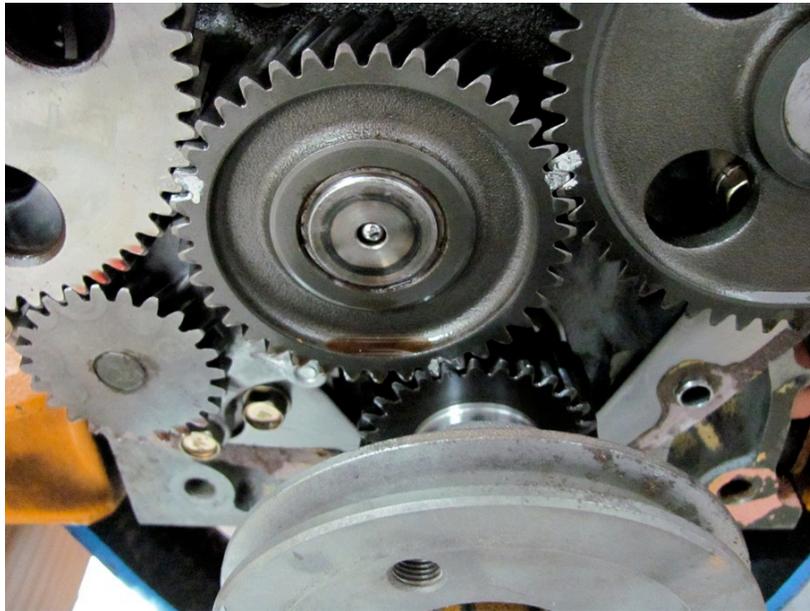
Finally the complete timing gear configuration is shown below.

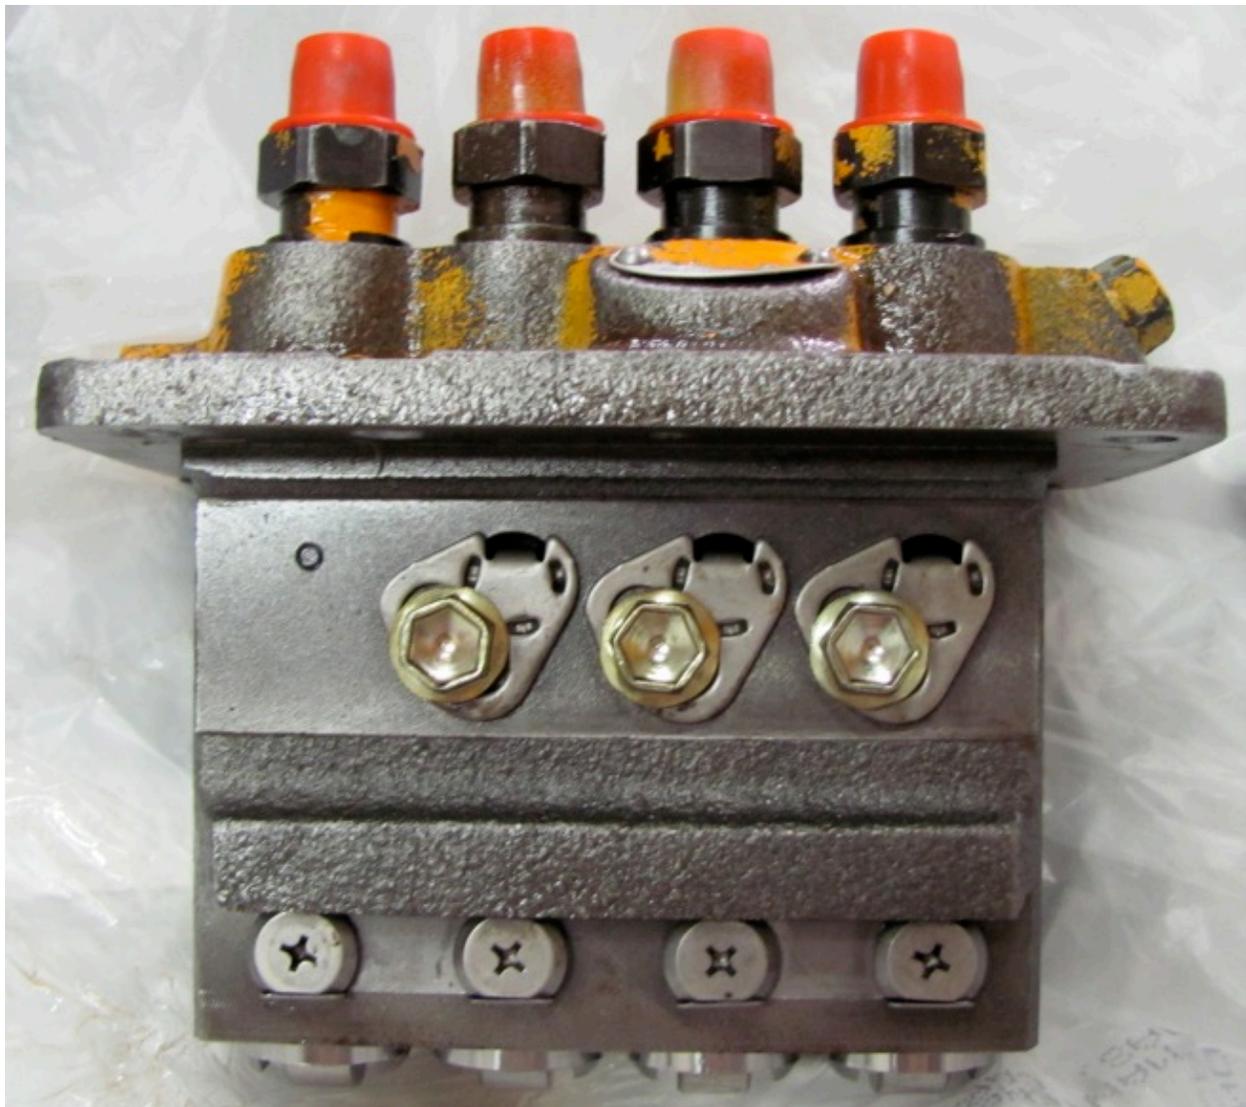
Next the fuel injection pump. I never heard from Mitsubishi or Vetus about the timing problem. Stauffer said to just leave it as is. So I cleaned up the shims, applied red RTV to all mating surfaces and bolted the pump in place. I put plastic caps on all the fuel ports when I tore the engine down (caps that I got from Proformance when they serviced the injectors). Pump with caps shown below.

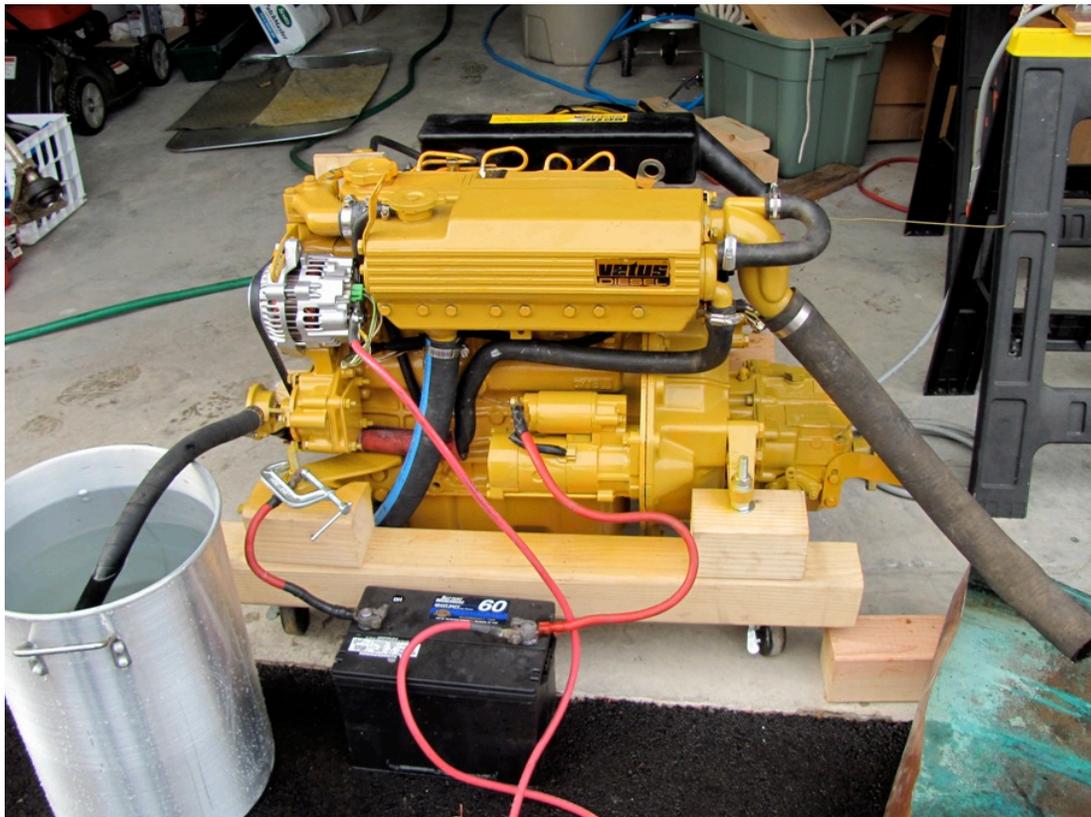
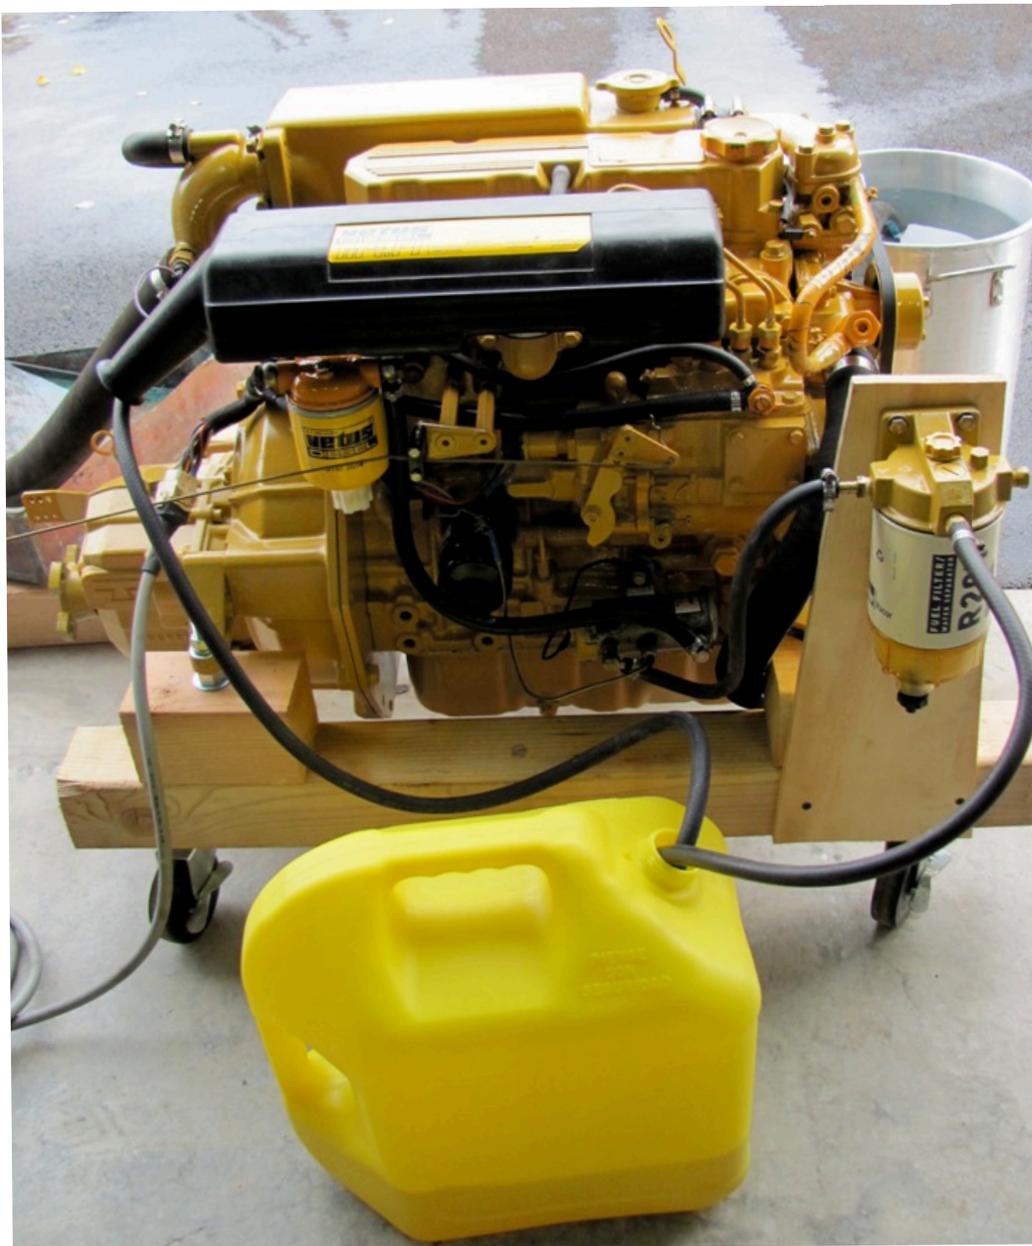
The next day, I connected the battery and ran the hoses to the fuel can, and the raw water pump to a bucket filled with tap water.
