Choosing a Sealant for Double Planking

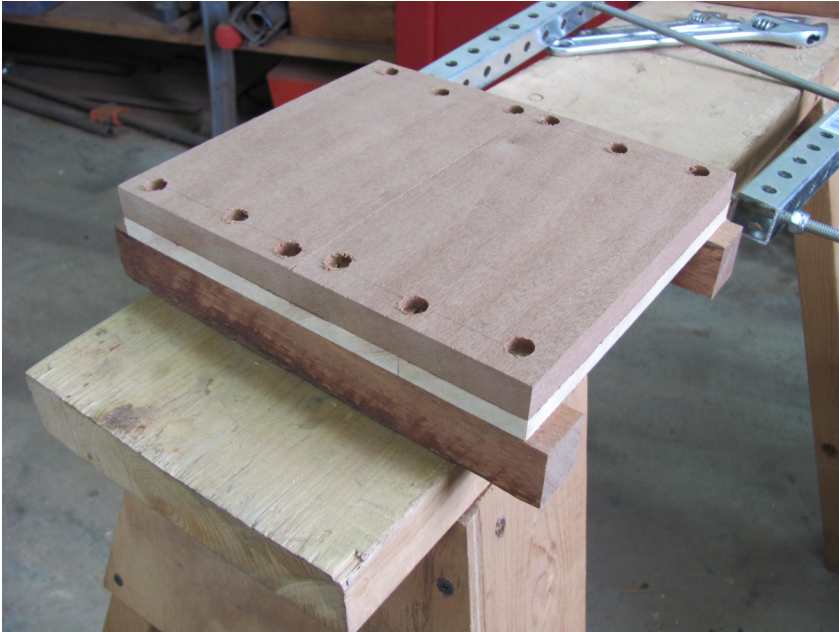
The picture above shows a sample of double planking with two 5/8" x 4" Wana outer planks on top of three 3/8" Alaskan Yellow Cedar inner planks, with Sikaflex 291 LOT between the two layers (about .6 mm; no primer). The planking is then screwed to two H. Mahogany frames.

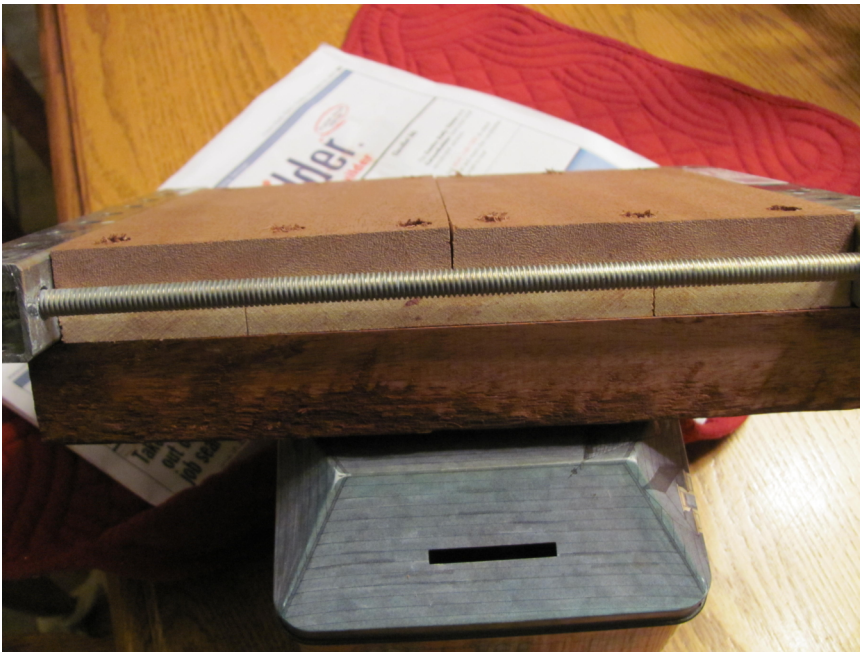
After 7 days of immersion, the sample was allowed to dry for 7 days at room temperature and low relative humidity. The picture above shows the sample after this drying period.

Note that the seams for both the Wana and the AYC have opened up (they were tight originally). Also the frame is now loose, where it was snug at the start of the experiment. This is evidence of compression set – failure of the plank to return to its original width because it was compressed beyond its elastic limit.

Although not visible in the picture, the planking also shrunk away from the frames (compression set due to the fasteners).

Overall, the gaps caused by compression set were less than 1/32", which is less than I anticipated. In my boat, some of the outer-plank seams have opened up as much as 1/8", causing the inner planks to split. I plan to repeat the cycle over a longer period of time (2 weeks wet/2 weeks dry) to see what happens. (Ideally, I would like to monitor the moisture content over time, but I don't have an accurate scale that can handle the weight of the sample.) I'll then unscrew the plank from the frames and try to separate the inner/outer planks to see how well the sealant held up.
